# Site Accessibility Evaluation

### **Black Forest Regional Park**

**Accessibility Evaluation**

***Inspection Date: 08/09/2017  
Inspector: David Mejia***

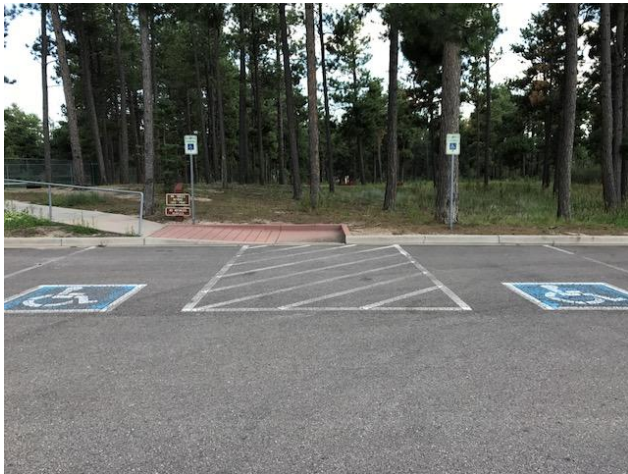
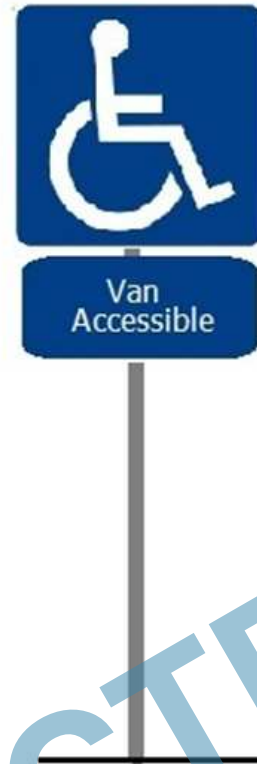
## Finding #1 Continued

The van stall is missing a sign identifying it as a van accessible stall.

Van accessible sign  
not installed

CORRECTED

Add Van Accessible signs (X2) below International Symbol of Accessibility 60 inches minimum above the finish or ground surface measured to the bottom of the sign.

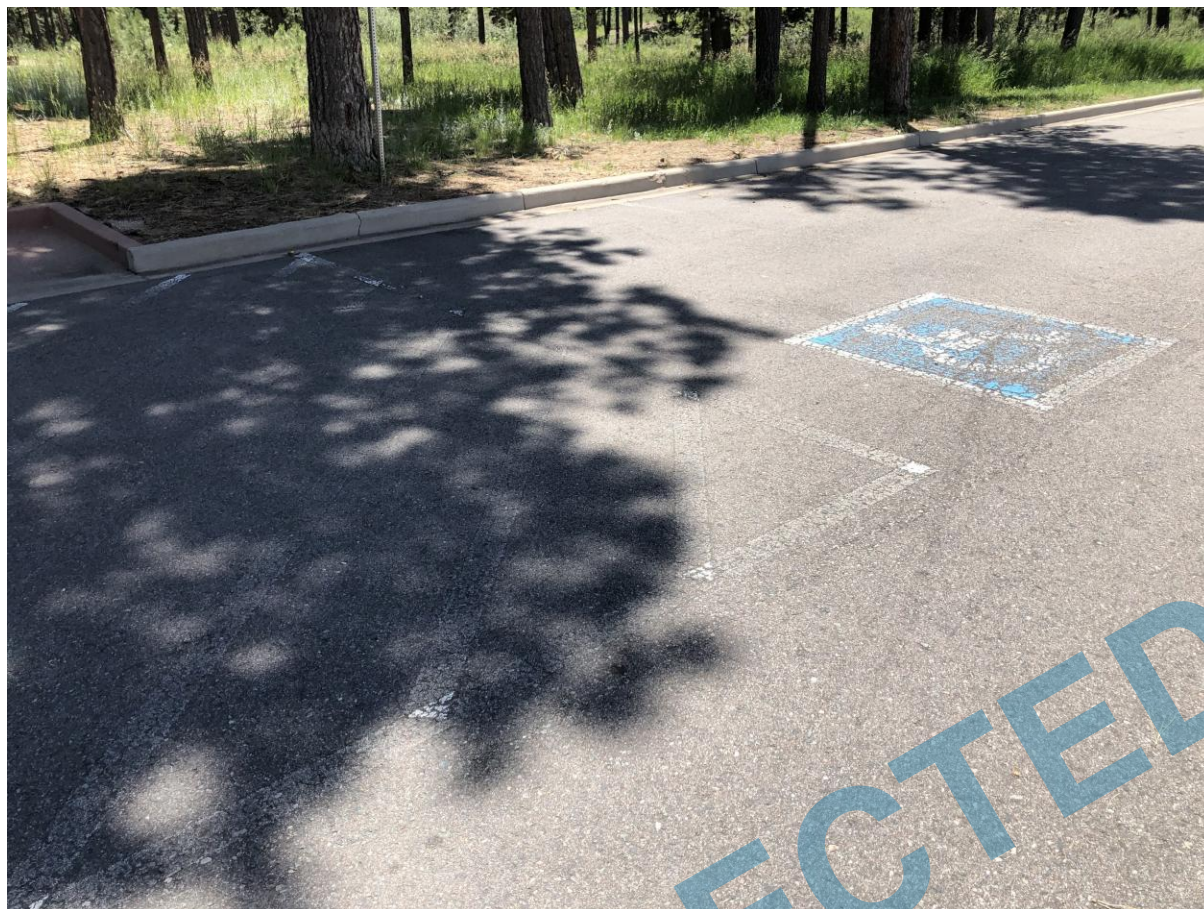
**Finding #2 Continued**

The striping and markings for the accessible parking stall, access aisle are dilapidated and in need of repair and/or maintenance.

Accessible parking  
stalls and access aisle  
striping barely visible

Re-stripe 2 van accessible stalls, access aisle and single accessible parking stall. Add International Symbol of Accessibility to single accessible parking stall.

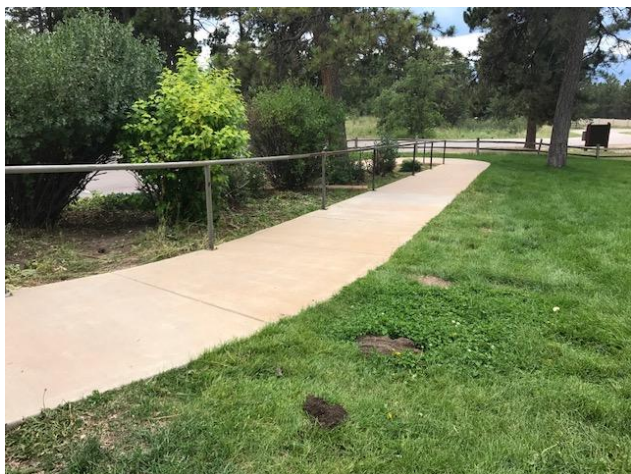
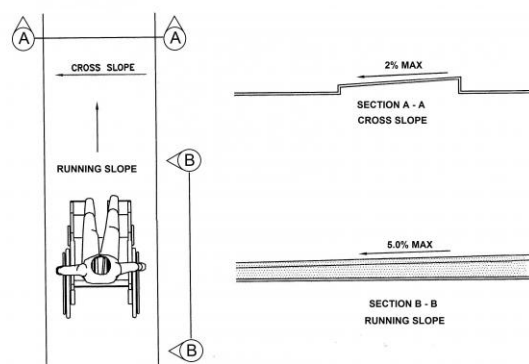
## Finding #3 Continued

The accessible route contains running slopes greater than 5 percent and cross slopes greater than 2 percent across the width of the walk and has not been constructed as a ramp (i.e. handrails, wheel guides, etc.).

**Running slope ranged  
from 6.6% to 7.3% //  
Cross slope ranged  
from 2.1% 3.0%**

**Install handrails on both sides that comply with 505 due to the running slope exceeding the maximum slope allowed (1:20 or 5.0%).**

**Add level landings at the top and bottom of the ramp run and every 30 feet in between complying with 405.6**

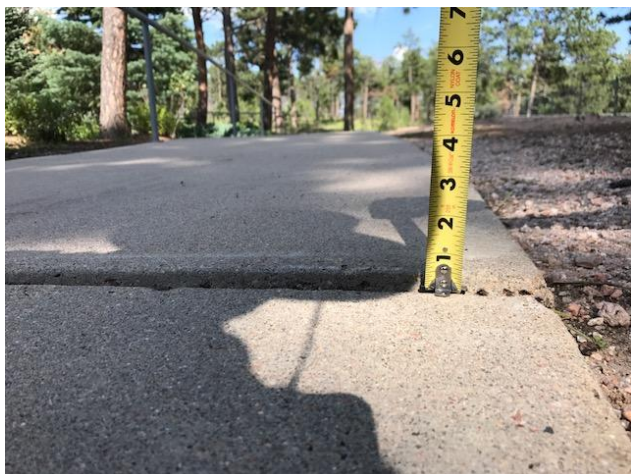
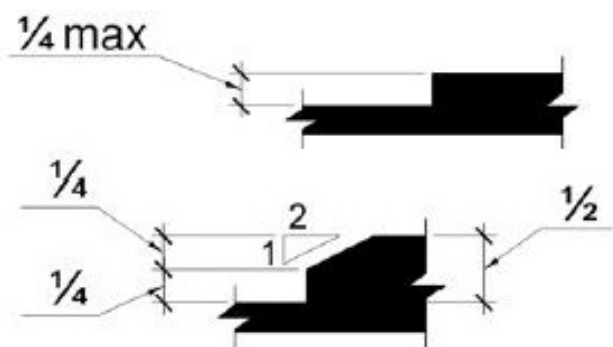
## Finding #4 Continued

The walkway contains abrupt vertical edges and/or variations over 1/4 inch.

3/4 inch upheaval

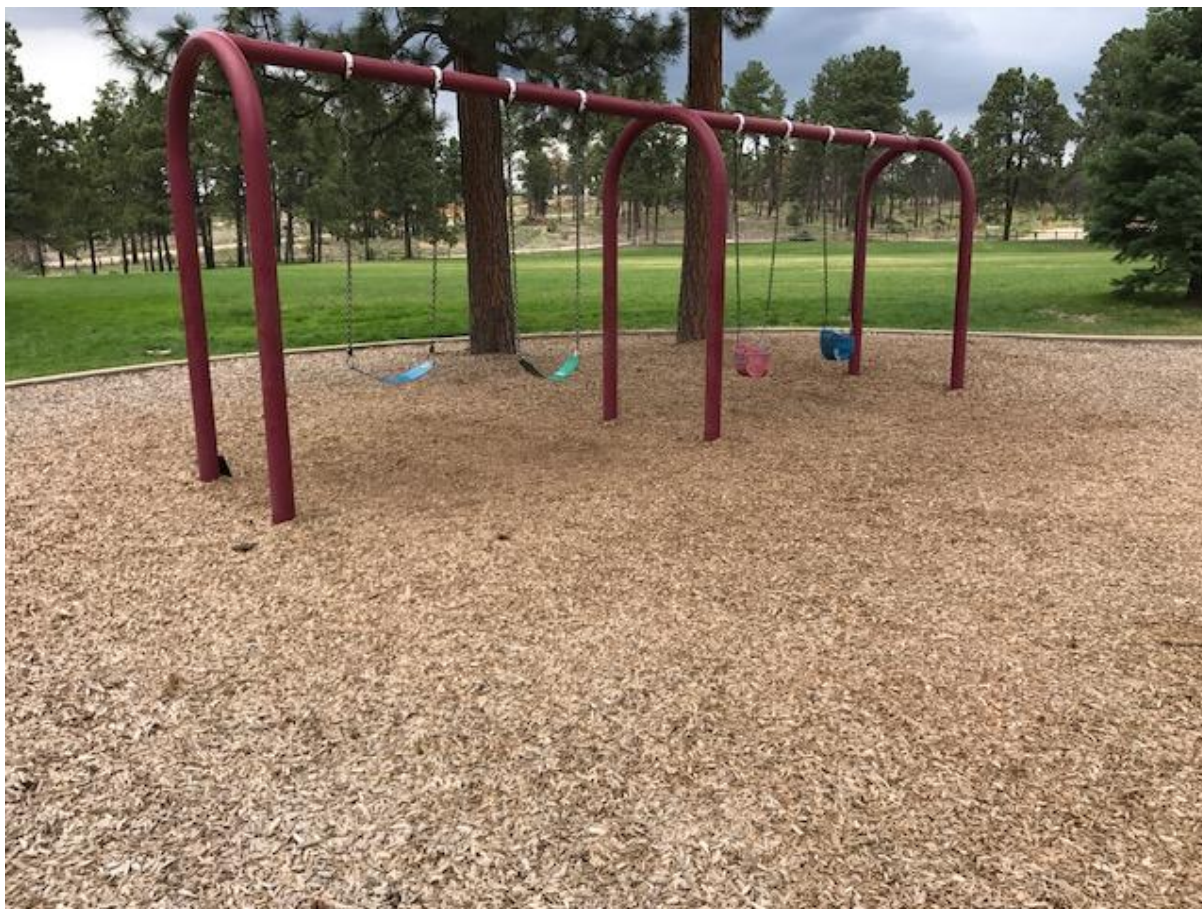
## **Finding #5 Continued**

**A minimum of one of each type of ground level play components is not on an accessible route.**

**Inaccessible ground  
play component**

**Make ground level and elevated play components accessible including the entry and exit points of those components by installation of a compliant playground surface.**

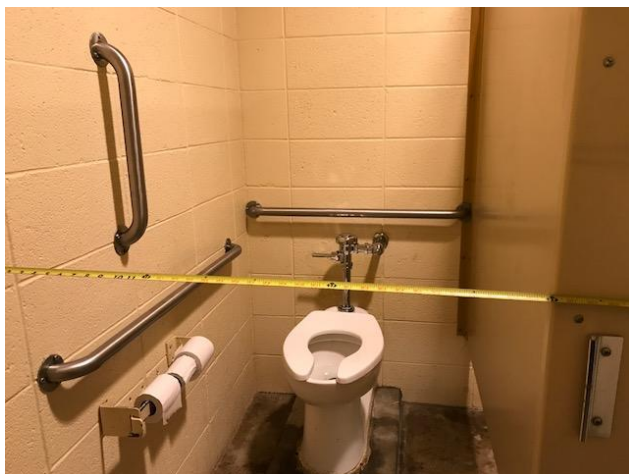
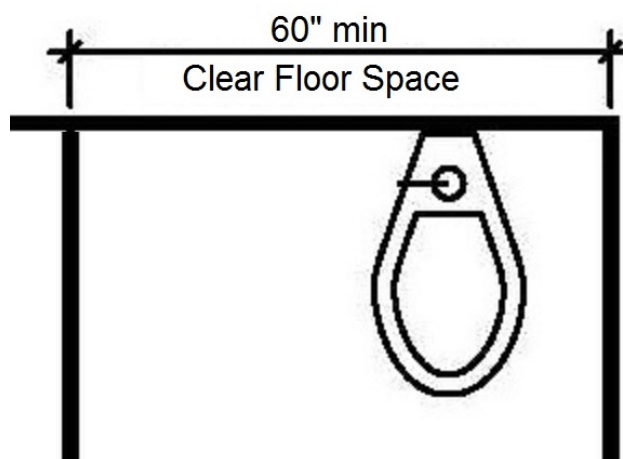
## Finding #6 Continued

**The toilet compartment is not wide enough.**

**Toilet closet measured  
36 inches wide.**

**Major remodel/construction will be required to meet current ADA Standards.**

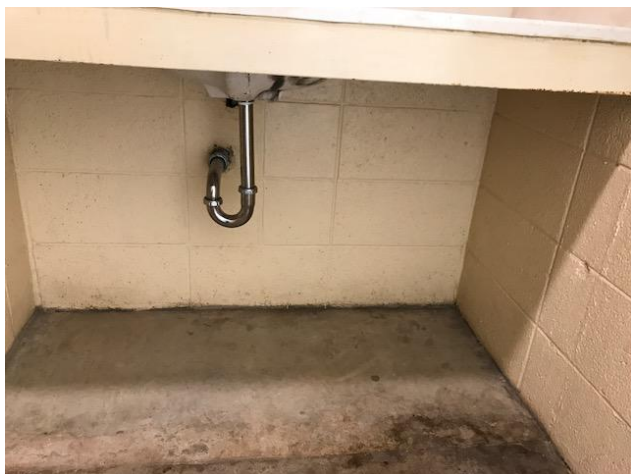
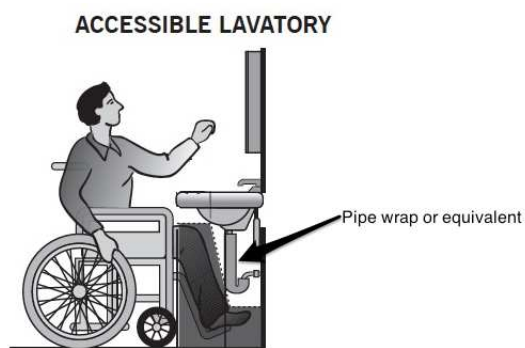
## Finding #7 Continued

The water and drain pipes under the lavatory are not adequately insulated.

Drain pipes not insulated

CORRECTED

Insulate drain pipes underneath lavatory.

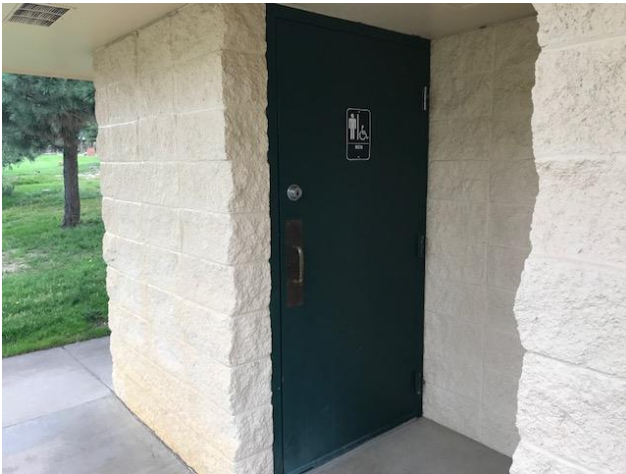
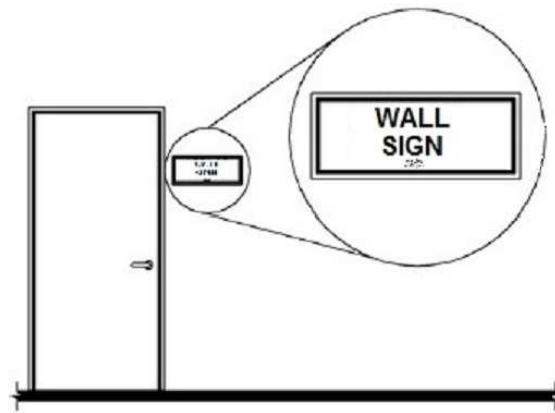
## Finding #8 Continued

**The tactile sign is incorrectly located.**

**Tactile sign mounted directly on door.**

CORRECTED

**Move sign to left/latch side of door 48 inches minimum above finish floor or ground surface measured from the lowest tactile character or 60 inches maximum from the highest tactile character.**

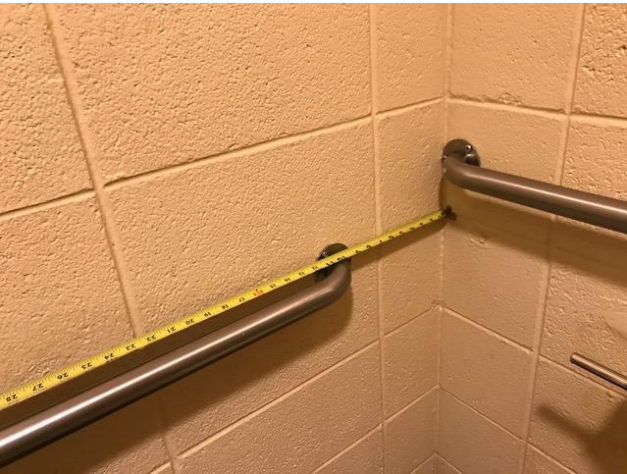
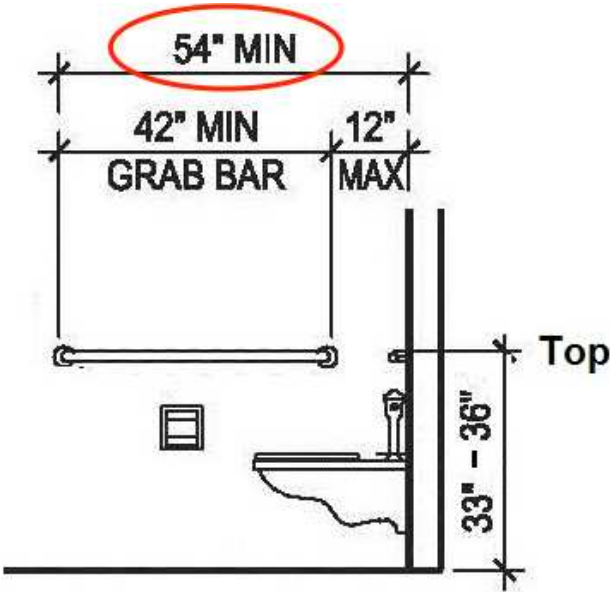
Finding #9 Continued

The side grab bar does not extend far enough from the rear wall.

Side grab bar does not extend the 54 inches required per ADA.

CORRECTED

Re-position side grab bar an additional 1.75 inches away from rear wall to meet the 54 inch minimum required per ADAS.

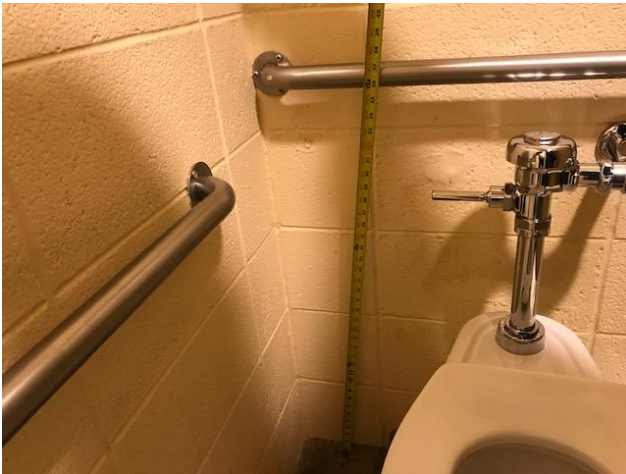
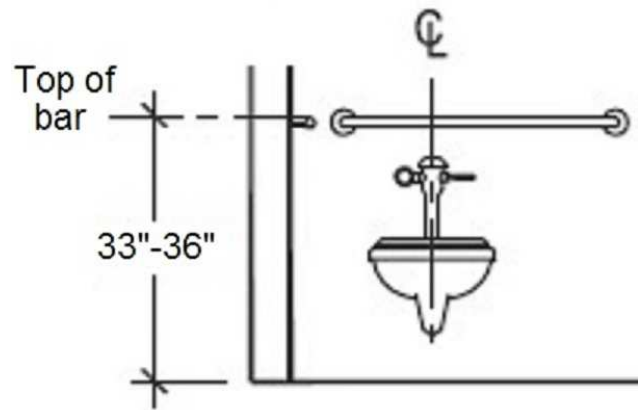
**Finding #10 Continued**

The rear grab bar is too high.

Measures 37 inches to the top of the gripping surface.

CORRECTED

Remove and re-position 1 inch lower to comply with ADAS.

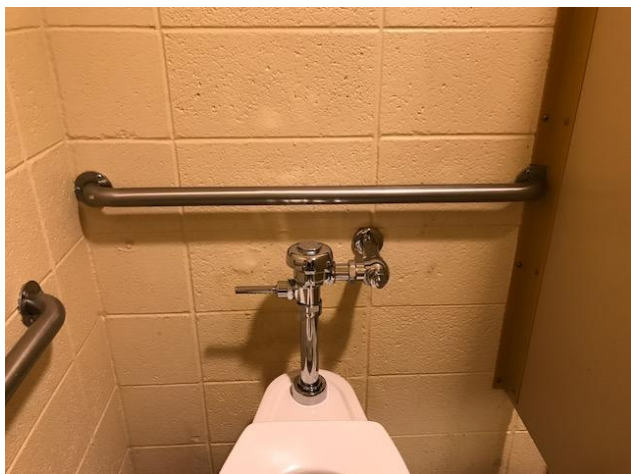
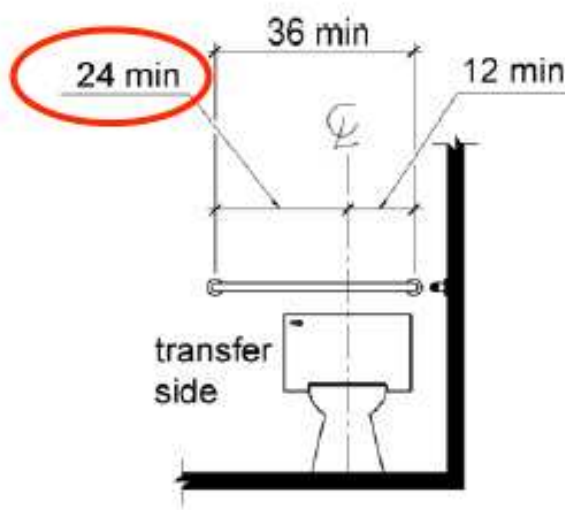
## Finding #11 Continued

The rear grab bar does not extend adequately past the toilet on the wide side.

Width of toilet  
compartment does not  
allow for compliance

Extend width of toilet compartment and re-position rear grab bar to meet ADAS.

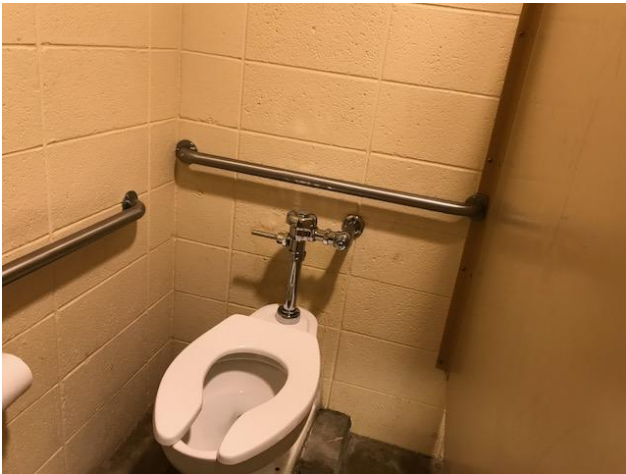
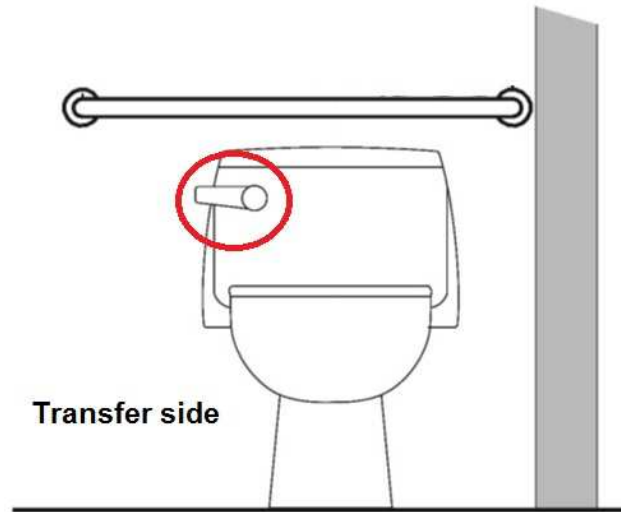
**Finding #12 Continued**

The flush handle is located on the wrong side of the toilet.

Flush handle not on transfer side of water closet

CORRECTED

Extend width of toilet compartment and ensure flush handle is on the open side of the water close.

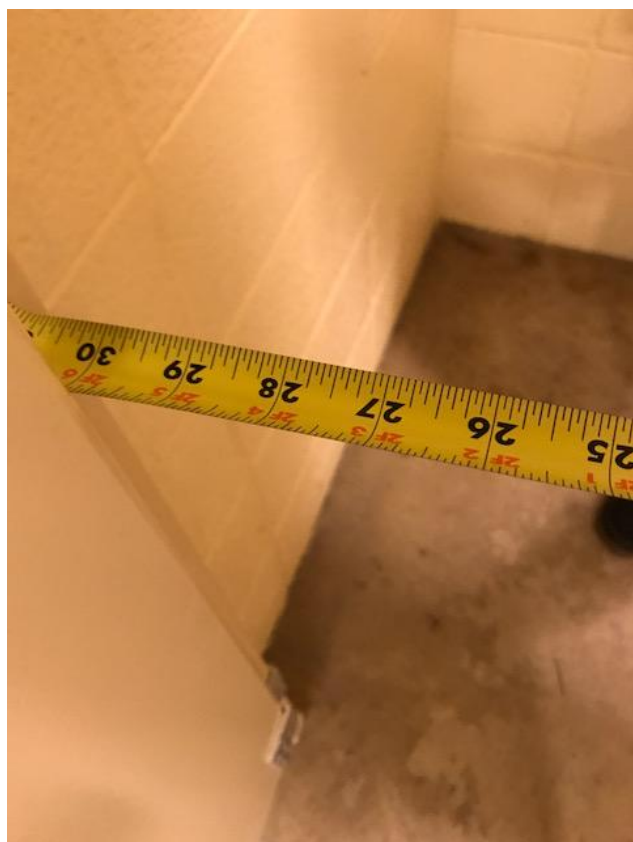
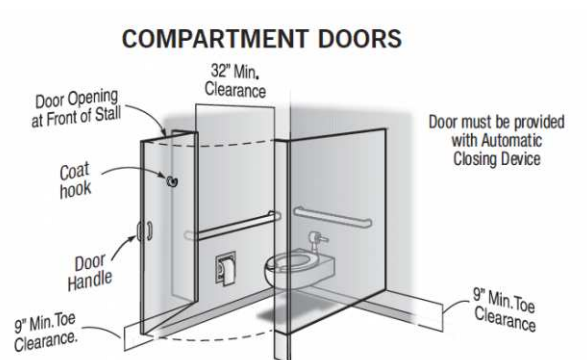
## Finding #13 Continued

**The compartment door does not have an unobstructed clear opening width of 32 inches.**

**Door opening width is  
29 1/2 inches.**

**Upon reconstruction and/or alteration extend water closet door width to 32 inches minimum per 2010 ADAS.**

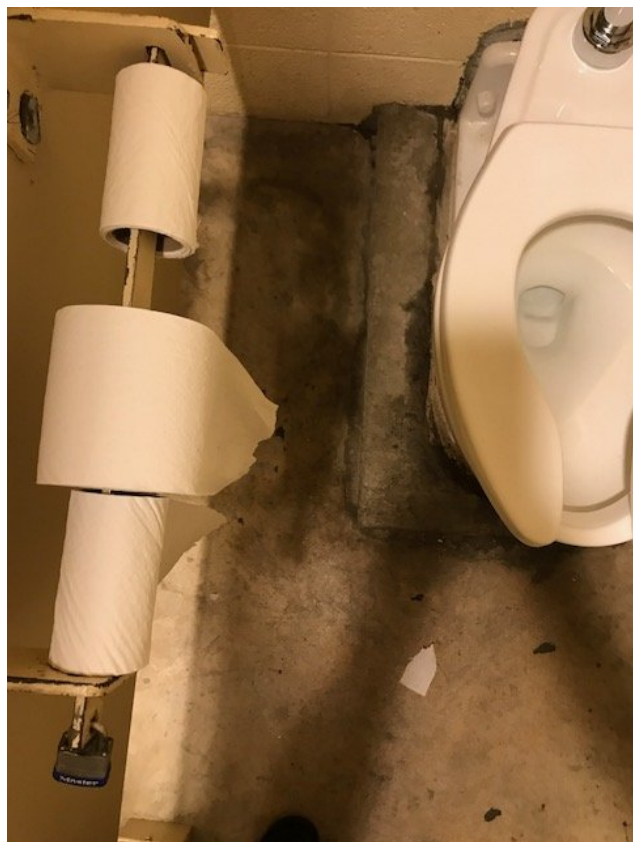
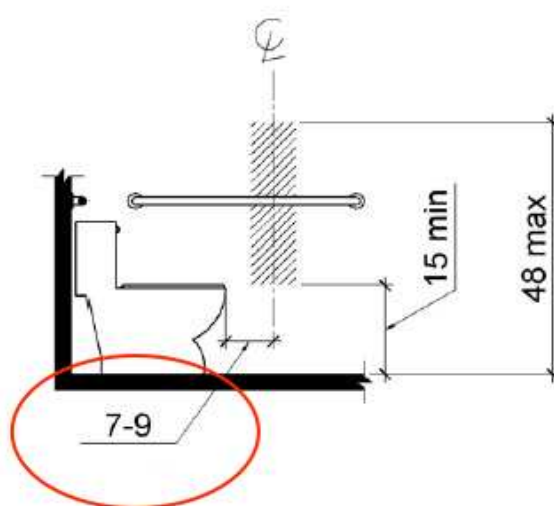
## Finding #14 Continued

The toilet paper dispenser does not allow a continuous flow.

Does not allow  
continuous flow of  
toilet paper.

Replace dispenser with one that will allow continuous flow.

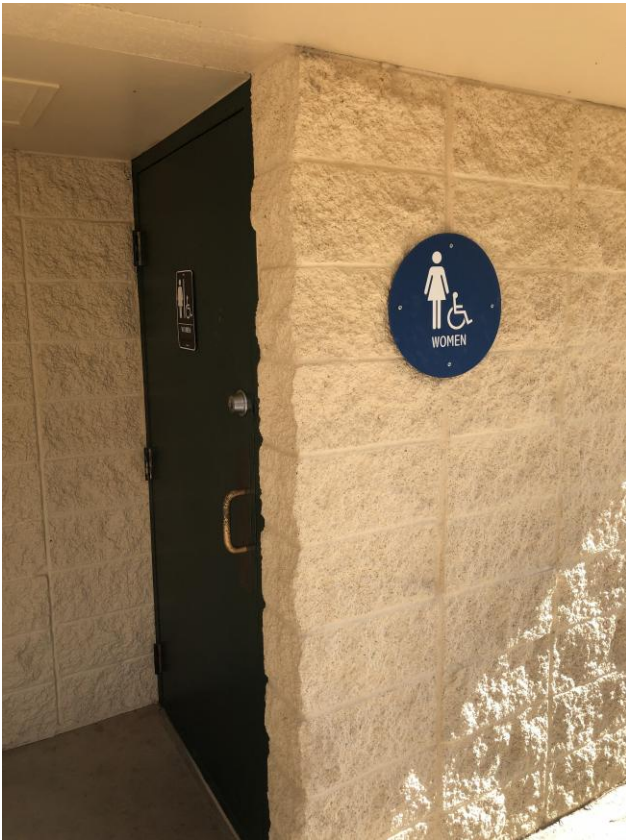
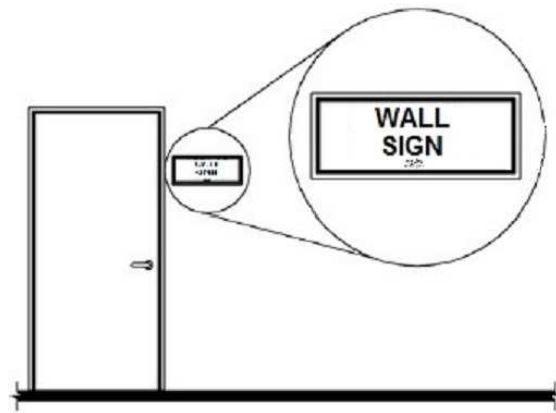
**Finding #15 Continued**

**The tactile sign is incorrectly located.**

**Tactile sign mounted  
directly on door.**

CORRECTED

**Move sign to left/latch side of door 48 inches minimum above finish floor or ground surface measured from the lowest tactile character or 60 inches maximum from the highest tactile character.**
