Site Accessibility Evaluation

Coroner's Office

**2741 E Las Vegas St
Colorado Springs, CO
80906**

Accessibility Evaluation

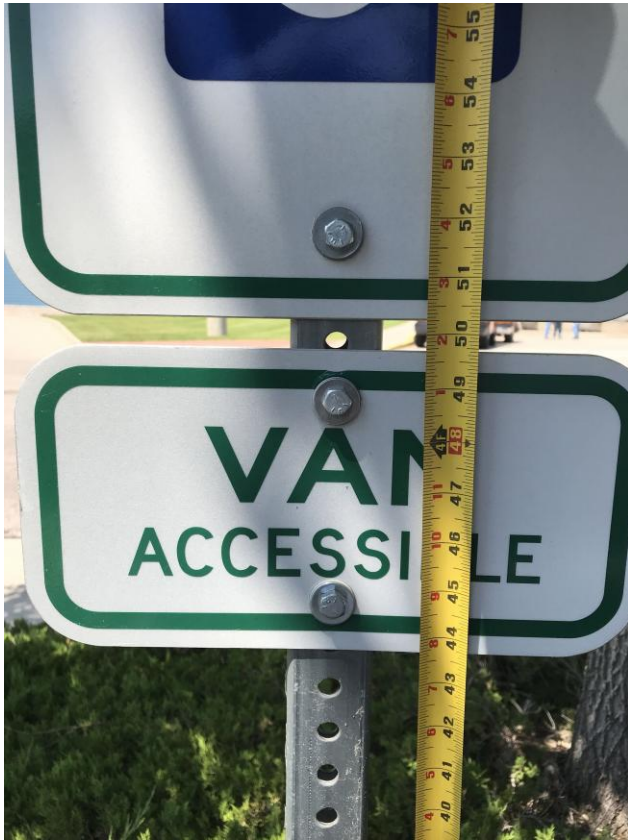
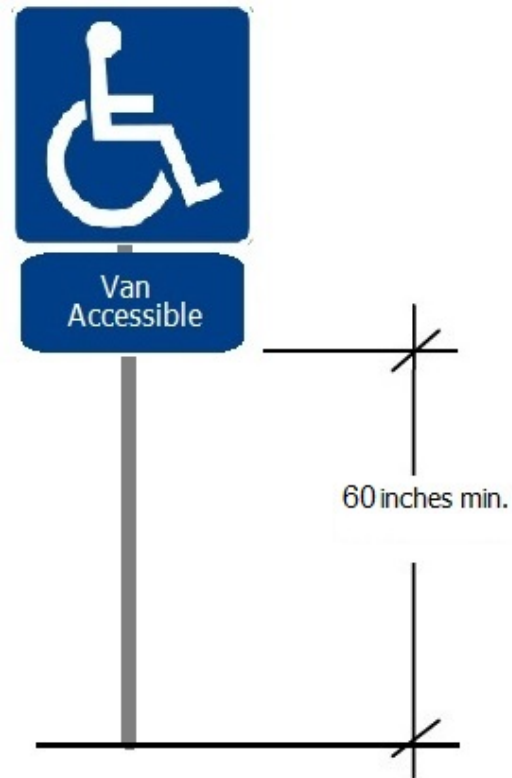
Finding 297164 Main Photo

The parking sign is mounted too low.

2010 ADAS Section 502.6

43.5 inches above
finished floor

Adjust height to meet compliance no less than 60 inches from bottom edge of van accessible sign.

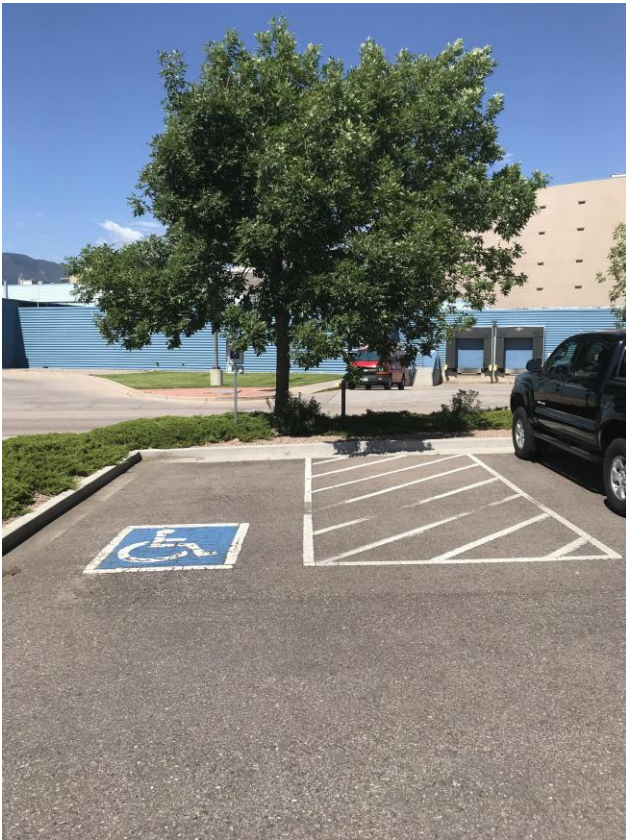
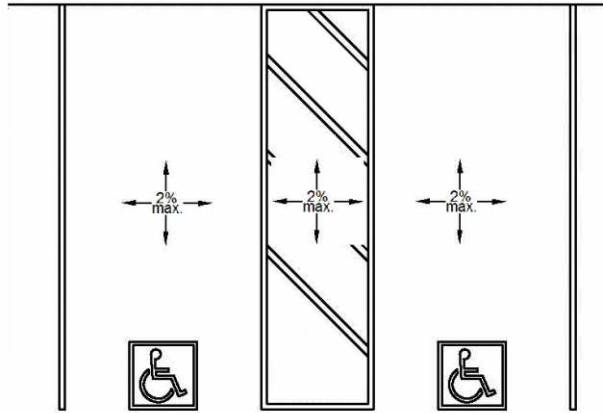
Finding 297165 Main Photo

The cross slope (narrow dimension) of the parking stall exceeds 2%.

2010 ADAS Section: 502.4

2.7% - 3.03% cross
slope

Re-pave existing parking stall and access aisle for cross slope and running slope not to exceed 1:48 / 2%.

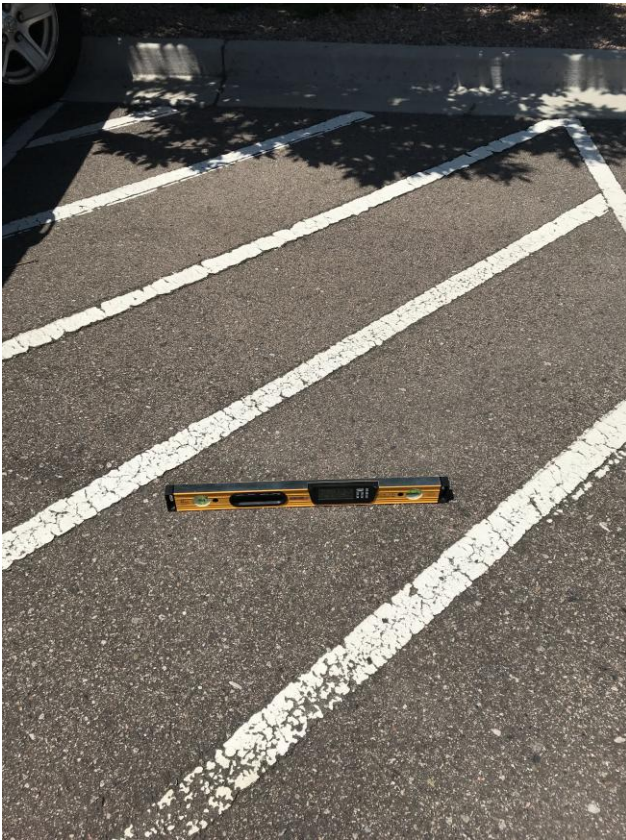
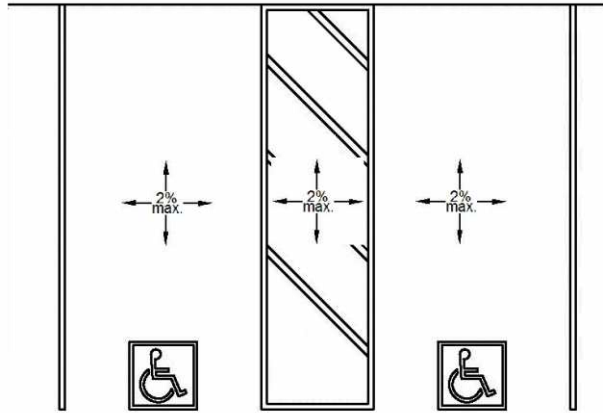
Finding 297166 Main Photo

The cross slope (short dimension) of the access aisle exceeds 2%.

2010 ADAS Section: 502.4

2.67% - 2.97% cross
slope

Re-pave existing parking stall and access aisle for cross slope and running slope not to exceed 1:48 / 2%.

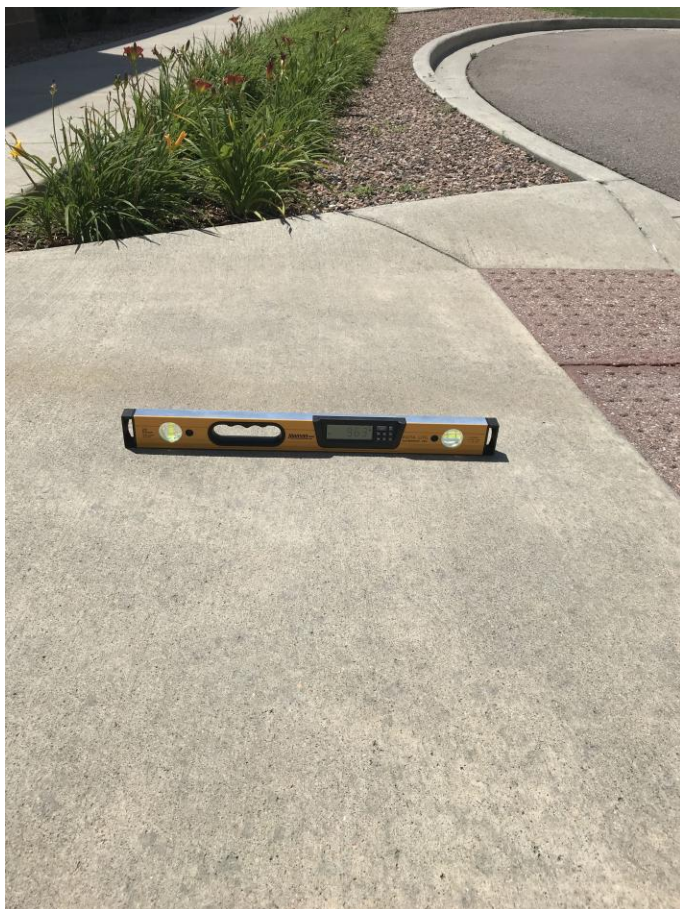
Finding 297167 Main Photo

The curb ramp slope exceeds the maximum running slope (Parallel to the direction of travel) allowable of 8.33%.

2010 ADAS Section: 406.1

8.9% - 10.6% running
slope

Re-construct pedestrian ramp to ensure compliance. Also, detectable warning signs will not be required when new pedestrian ramp is constructed.

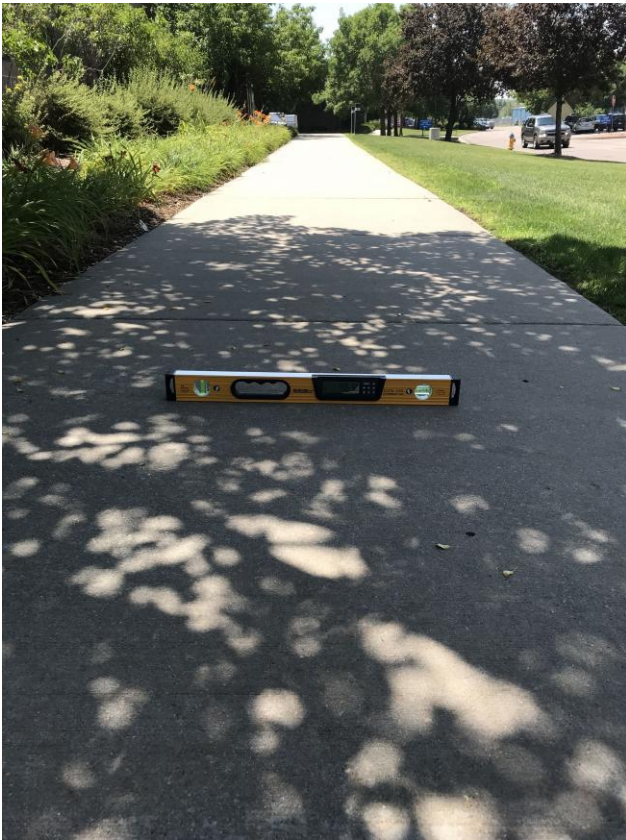
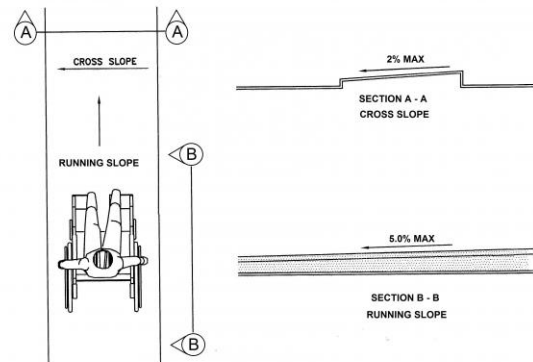
Finding 297168 Main Photo

The accessible path of travel between the building entrance and the accessible parking contains cross slopes greater than 2%.

2010 ADAS Section: 403.3

2.6% - 4.6% cross
slope

Re-pave existing path of travel for cross slope not to exceed 1:48 / 2%.

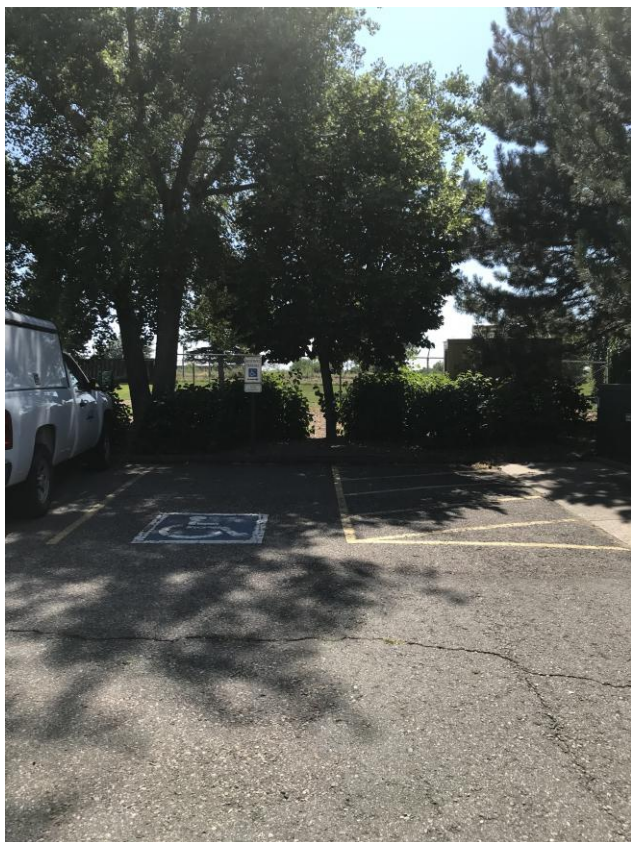
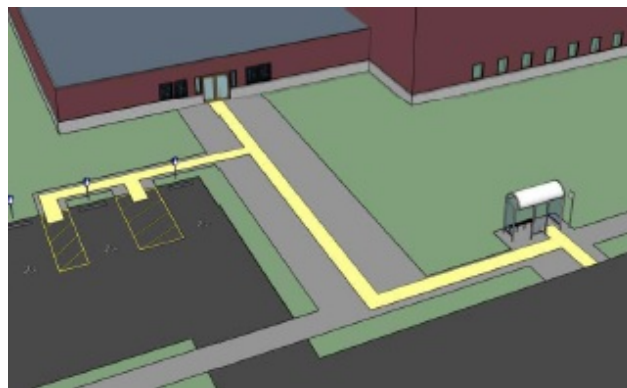
Finding 297177 Main Photo

The accessible parking space is not located on the shortest accessible route to the building.

2010 ADAS Section: 208.3.1

Accessible parking
stall and access aisle
furthest from building
entrance

Re-configure parking lot to provide accessible parking stall and access aisle on the shortest accessible route or post sign identifying parking lot as "coroner's employee parking only".

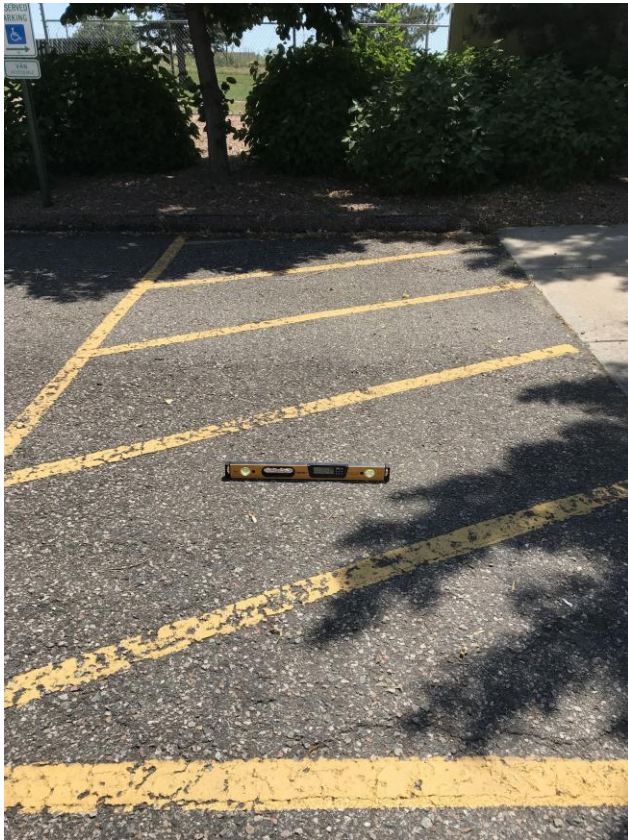
Finding 297176 Main Photo

The cross slope (short dimension) of the access aisle exceeds 2%.

2010 ADAS Section: 502.4

2.6% - 3.5% cross
slope

Re-pave existing access aisle located near front entrance of building for cross slope and running slope not to exceed 1:48 / 2%.

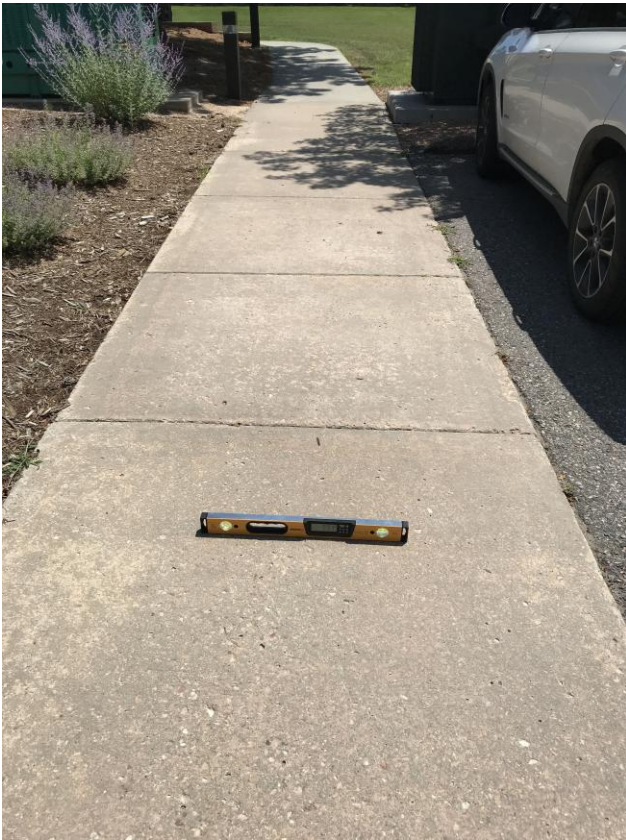
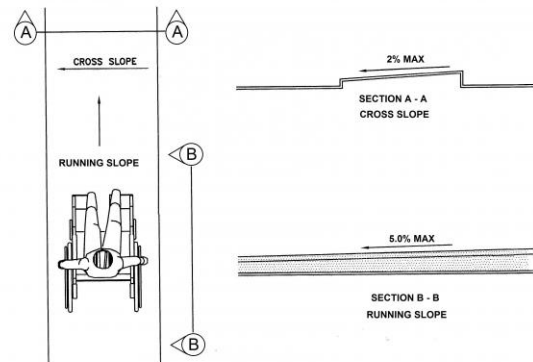
Finding 297178 Main Photo

The accessible path of travel contains cross slopes greater than 2%.

2010 ADAS Section: 403.3

2.6% - 3.5% cross
slope

Re-pave existing path of travel located near front entrance of building for cross slope not to exceed 1:48 / 2%.

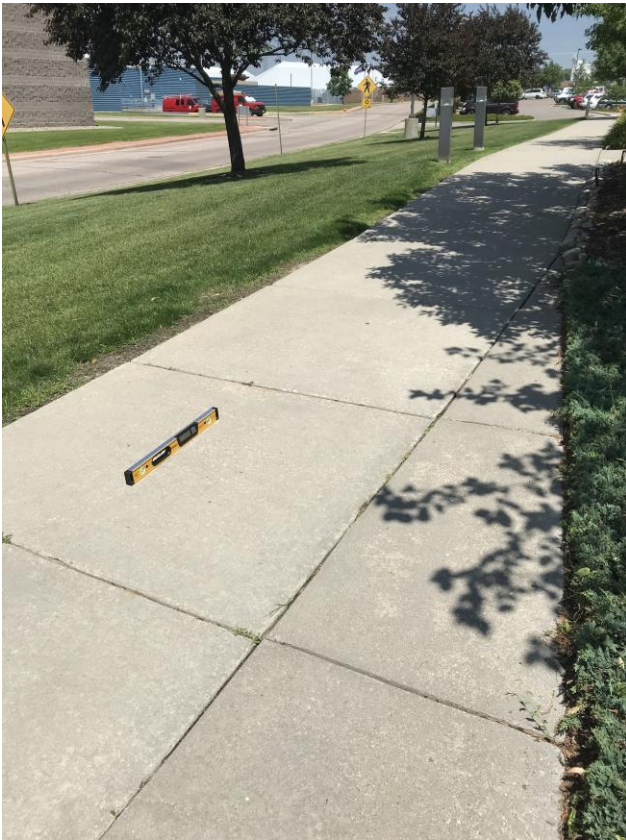
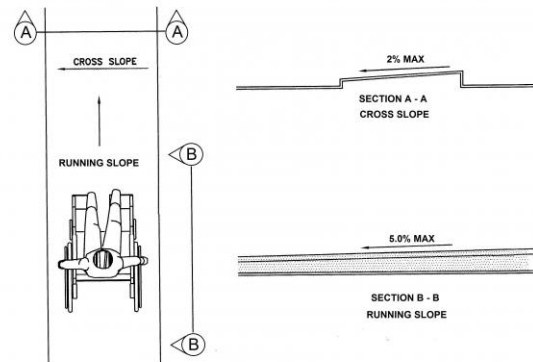
Finding 297179 Main Photo

The accessible route on the site contains running slopes greater than 5% and has not been constructed as a ramp (i.e. handrails, wheel guides, etc.).

2010 ADAS Section: 403.3

5.0% - 6.99% running
slope

Re-pave existing path of travel located near front entrance of building for running slope not to exceed 1:20 / 5%.

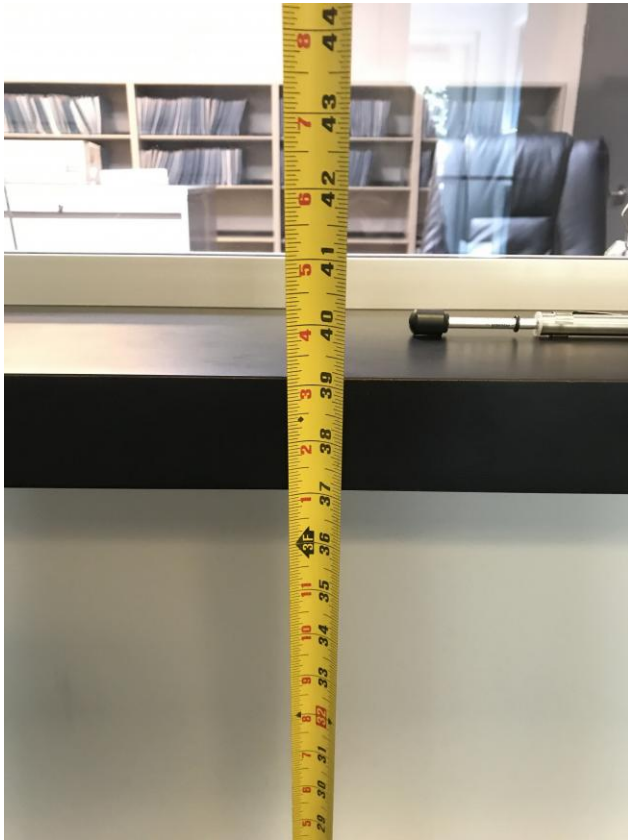
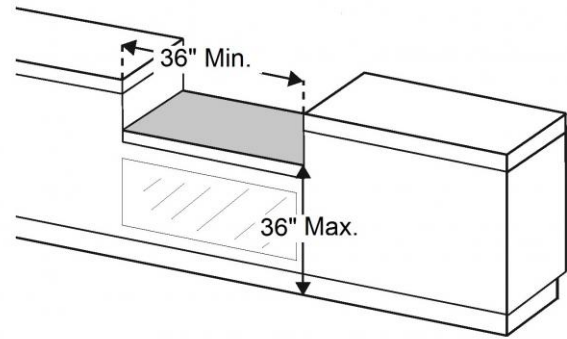
Finding 297180 Main Photo

The transaction counter provides for a parallel approach but does not provide a minimum clear width of 36 inches.

2010 ADAS Section: 904.4.1

39.25 inches above
finished floor

Replace or re-configure a section of the transaction counter to provide a clearance of 36 inches high and a minimum of 36 inches wide.

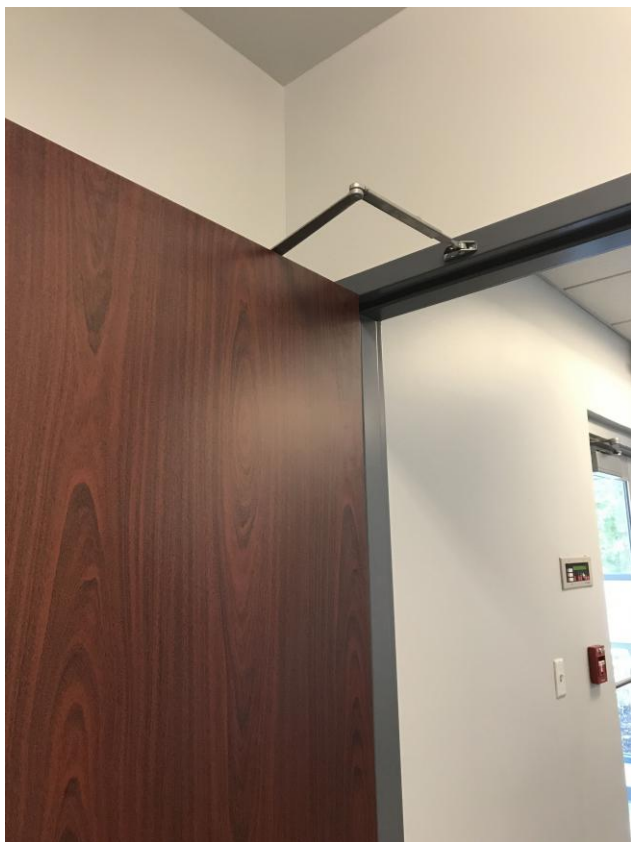
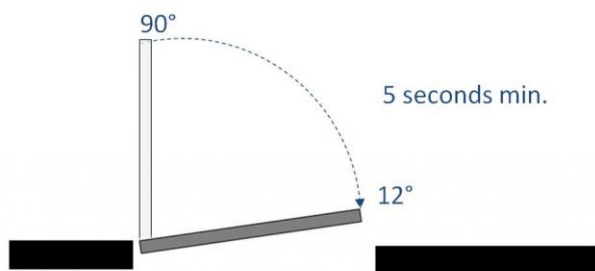
Finding 297169 Main Photo

The door is equipped with a door closer and returns to a closed position too quickly.

2010 ADAS Section: 404.2.8.1

4 seconds to closed position

Re-adjust door closer so that closing speed is 5 seconds or more from an open position to a position of 12 degrees from the latch.

CORRECTED

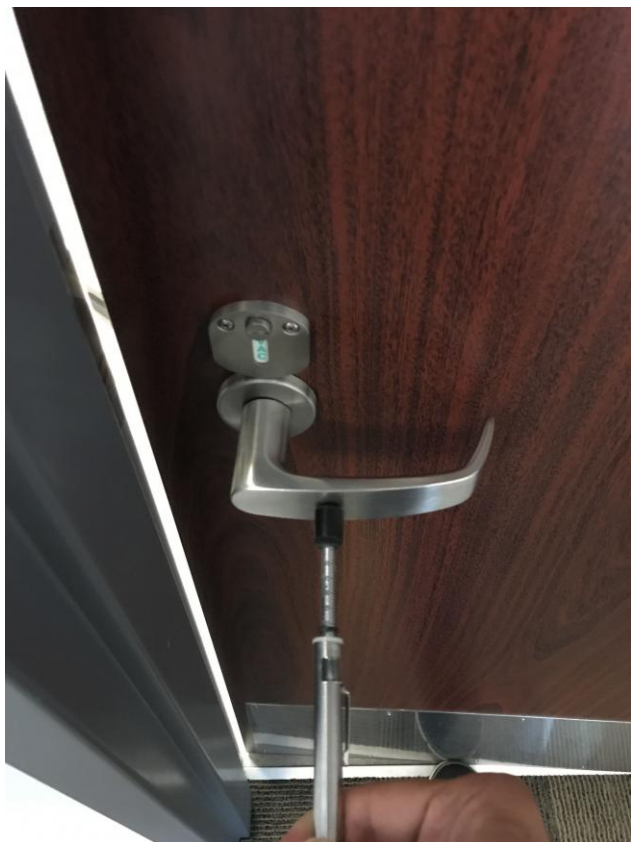
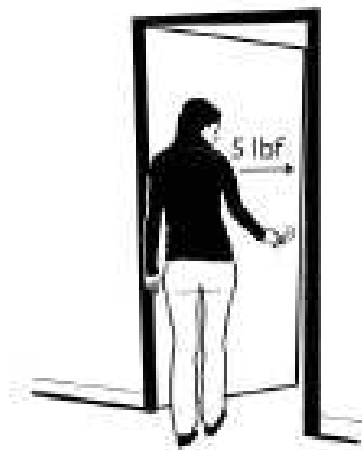
Finding 297170 Main Photo

The door exceeds the maximum pressure to open the door.

2010 ADAS Section: 404.2.9

8 lbs of force required

Adjust door hinges/opener so that the force needed to open door does not exceed more than 5 lbs of force to open.

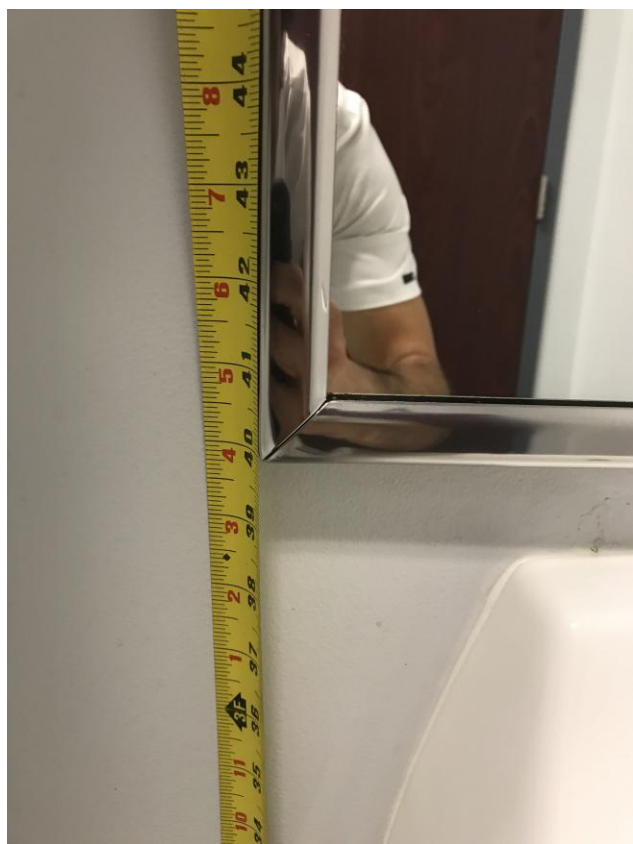
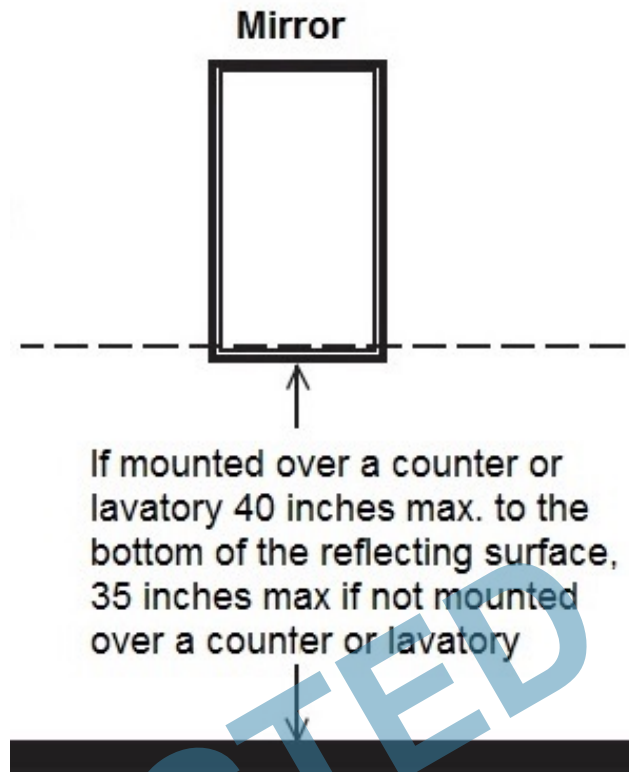
Finding 297171 Main Photo

The mirror is mounted too high.

2010 ADAS Section: 603.3

40.75 inches above
finished floor

Re-adjust mirror so that reflective surface of mirror does not exceed 40 inches above finished floor.

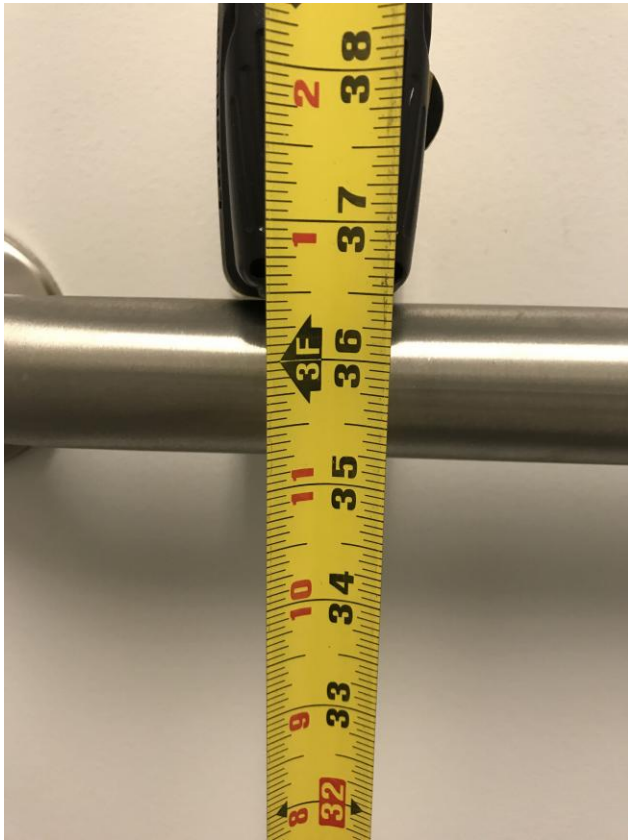
Finding 297172 Main Photo

The rear grab bar is too high.

2010 ADAS Section: 609.4

36.5 inches above
finished floor

Re-adjust grab bar so that top of the gripping surface does not exceed 36 inches maximum.

CORRECTED

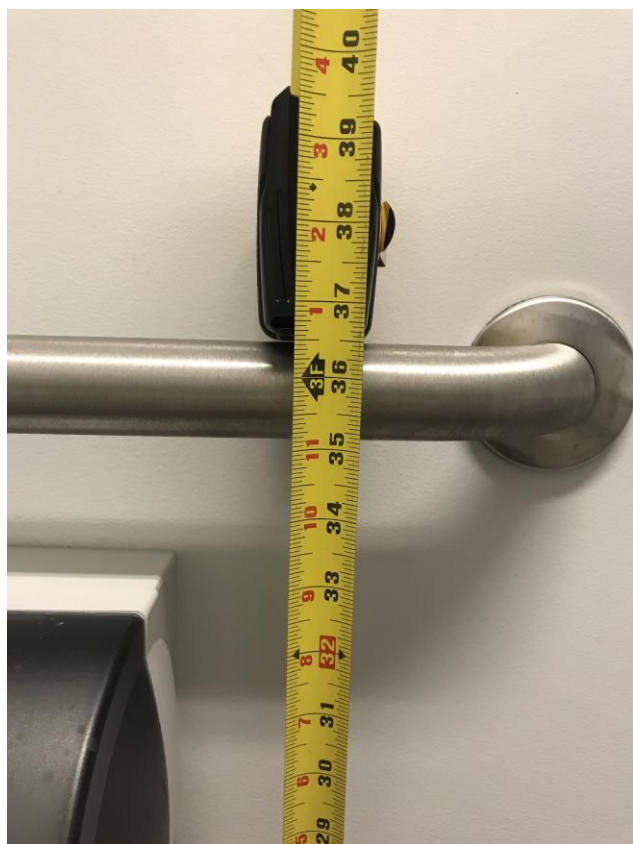
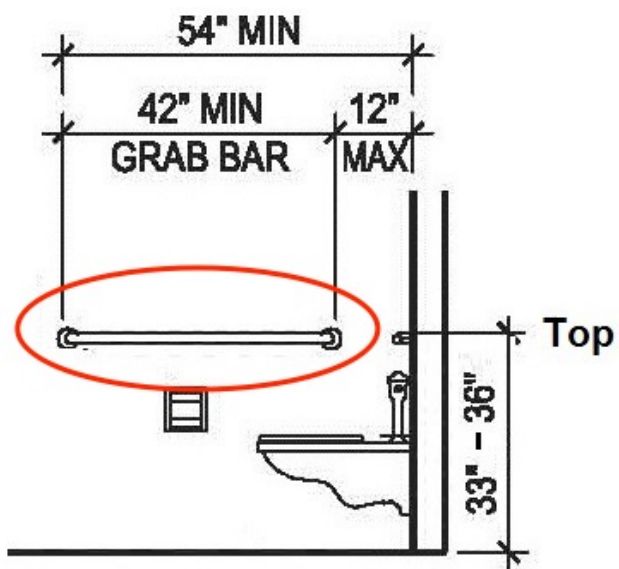
Finding 297173 Main Photo

The side grab bar is too high.

2010 ADAS Section: 609.4

36.5 inches above
finished floor

Re-adjust grab bar so that top of the gripping surface does not exceed 36 inches maximum.

CORRECTED

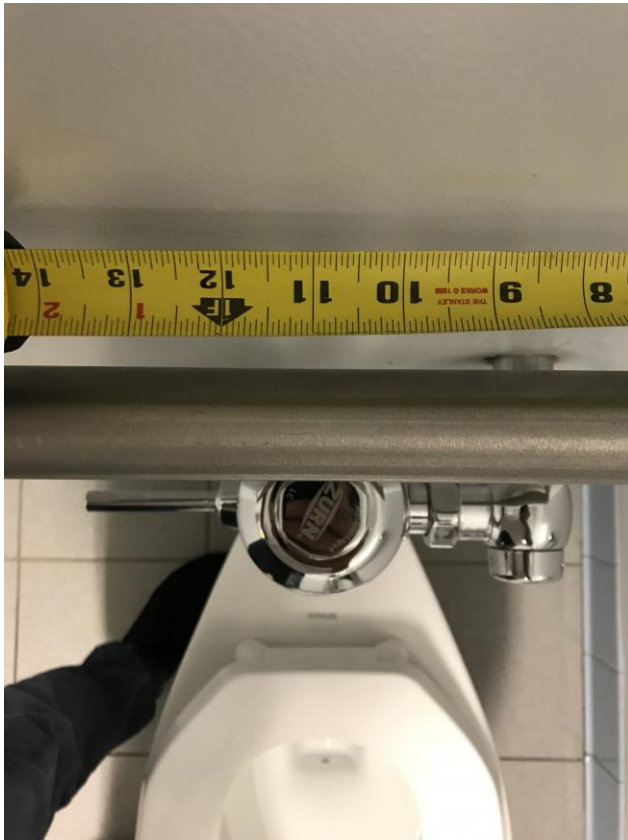
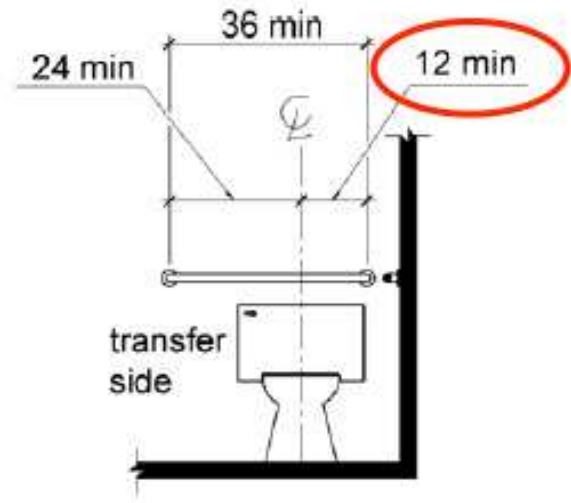
Finding 297174 Main Photo

The rear grab bar does not extend adequately past the centerline of the toilet on the wall side.

2010 ADAS Section: 604.5.2

11 inches from wall
side

Re-adjust rear grab bar to extend 12 inches minimum from centerline of toilet on wall side and 24 inches minimum on transfer side.

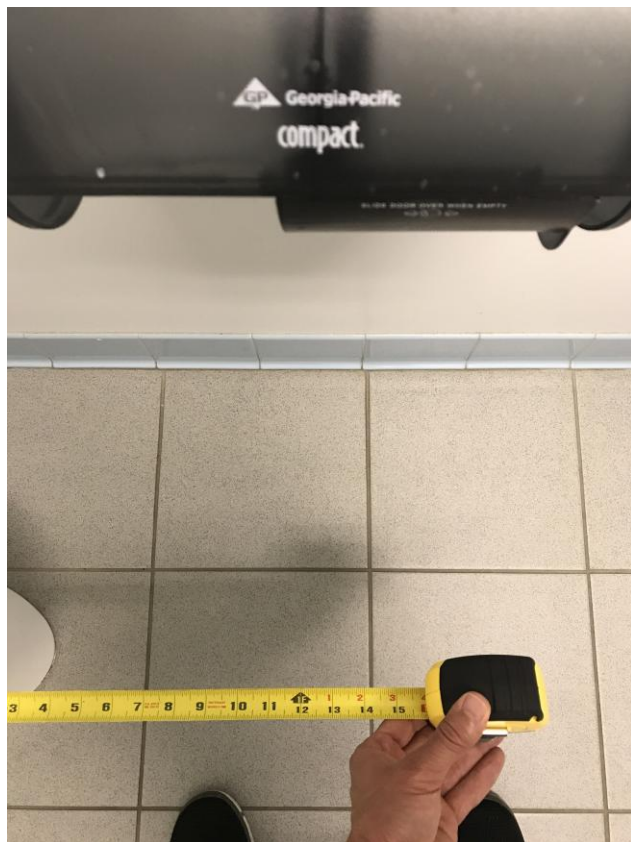
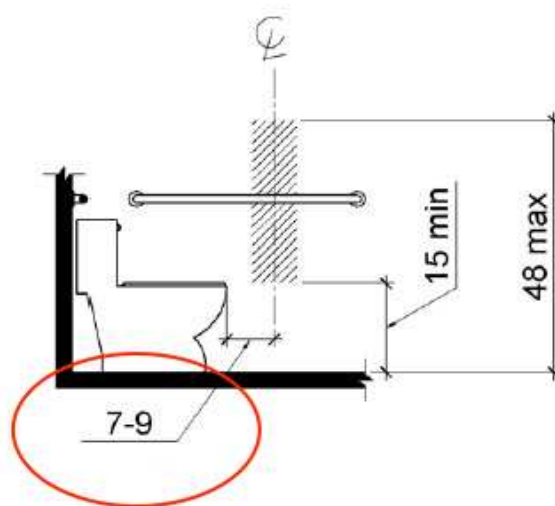
Finding 297175 Main Photo

The toilet paper is not installed within the compliant range in front of the toilet.

2010 ADAS Section: 604.7

13 inches in front of toilet

Re-adjust toilet paper dispenser 7 inches minimum and 9 inches maximum in front of toilet measured to the centerline of the dispenser.

CORRECTED
