Site Accessibility Evaluation

DOT Calhan Office

1010 Golden St **Calhan, CO 80808**

Accessibility Evaluation

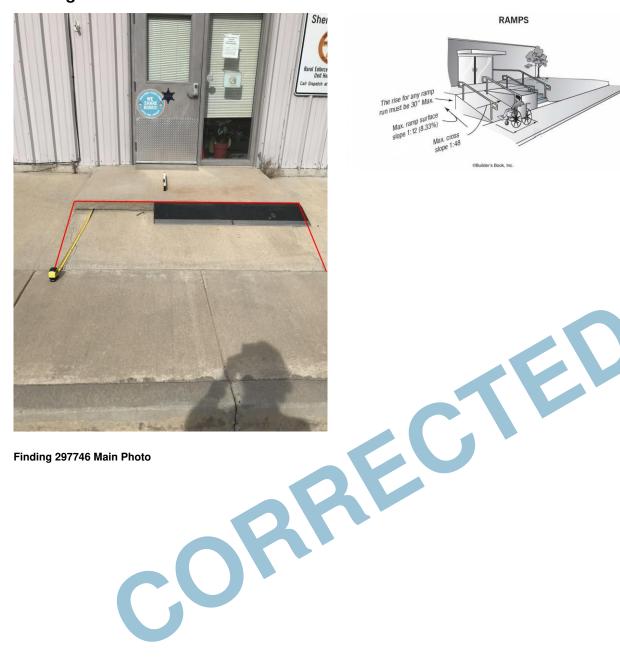
Finding 297746 Main Photo

The ramps slope exceeds the maximum running slope (direction of travel) allowable of 8.33%.

Ramps should have the least possible slope but in no case more than 8.3% (1:12).

2010 ADAS Section 405.2

Ramp runs shall have a running slope not steeper than 1:12.

2010 ADAS Section: 405.2 19.20 % running slope

Create new concrete ramp and remove existing detachable metal ramp. New ramp at 4 feet in length would meet ADA compliance at 8.33%.

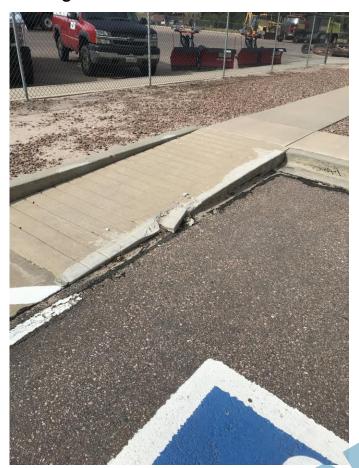
Finding 297747 Main Photo

Re-construct existing path of travel ramp/sidewalk. Built to not exceed a 5.75 inch rise, 5% running slope and 2% cross slope to avoid treating path of travel as a ramp that will require hand rails and edge protection.

2010 ADAS Section: Recommended Damage to existing

path of travel
