Site Accessibility Evaluation

Fountain Creek Nature Center

Accessibility Evaluation

Inspection Date: 12/21/2018

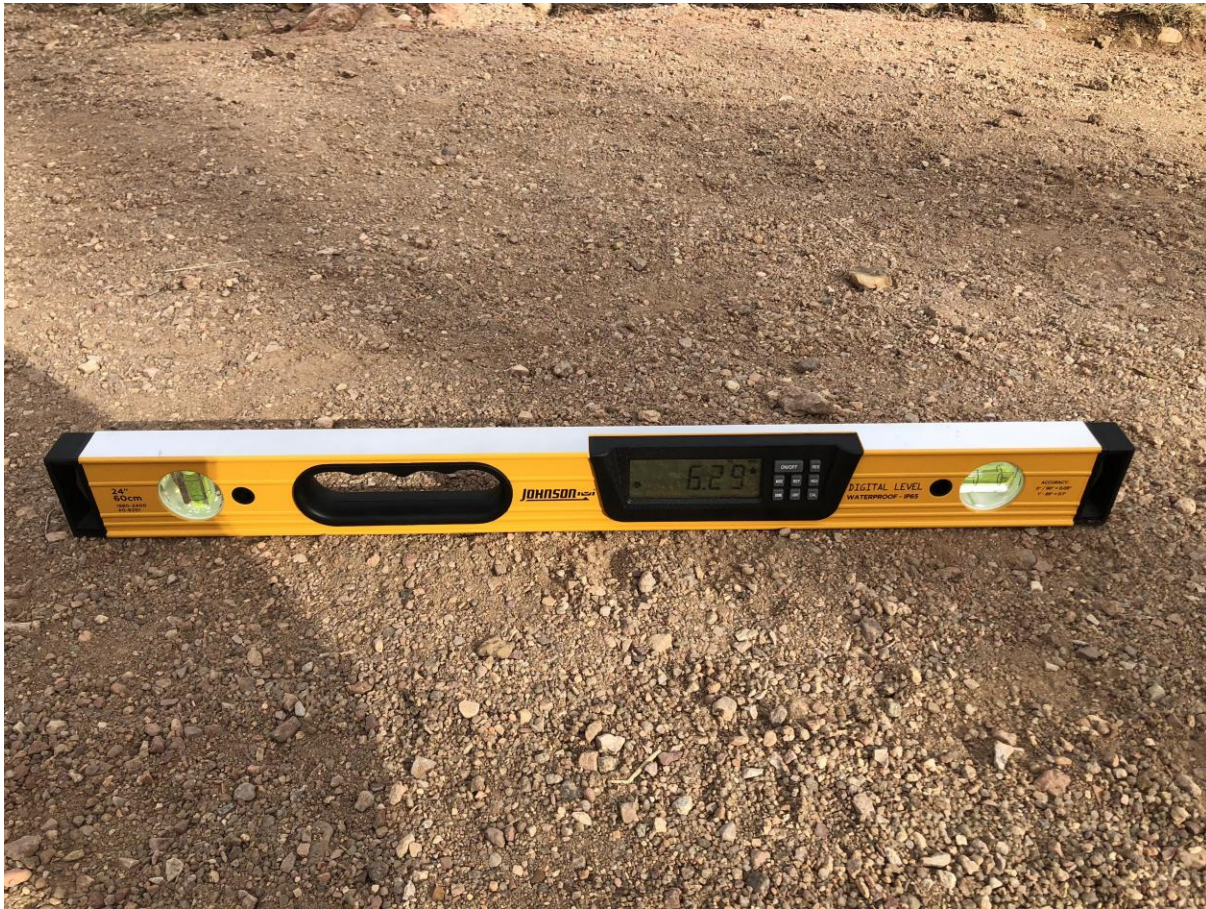
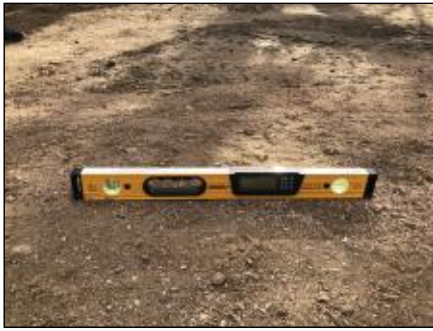
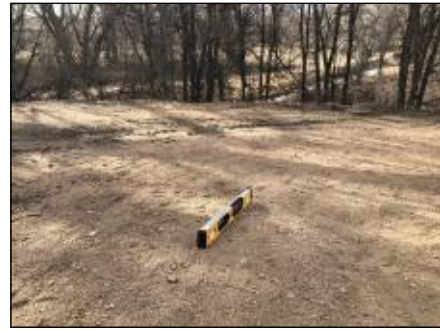
Finding #1 Additional Finding Photos

The running slope of the surface of the trail is too steep and no resting intervals exist of at least 5ft x 5ft.

**Trail running slope
varies from 6.29% to
16.02%**

Re-engineer southern trailhead to try and meet ABA standards to the extent feasible. Grading will be required but some portions of the southern trail will probably not be at 100% compliance.

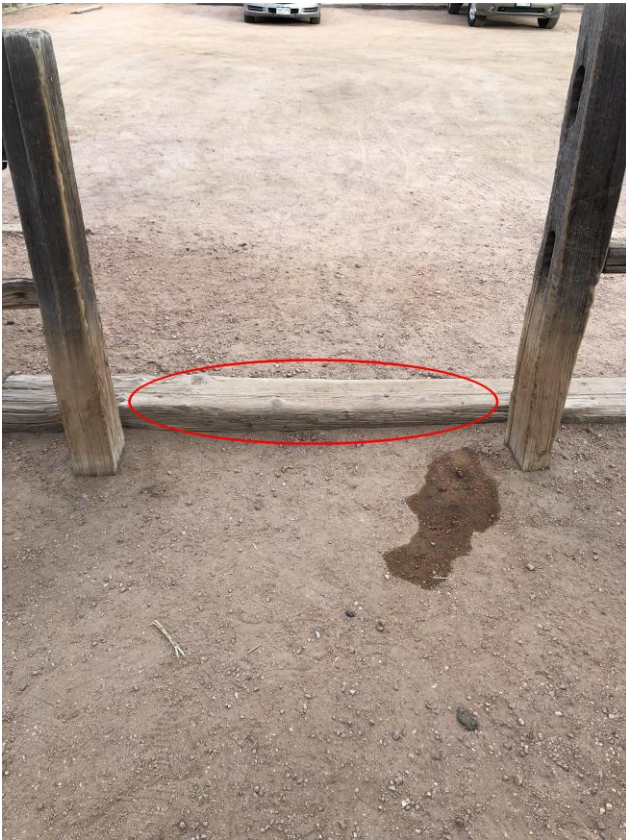
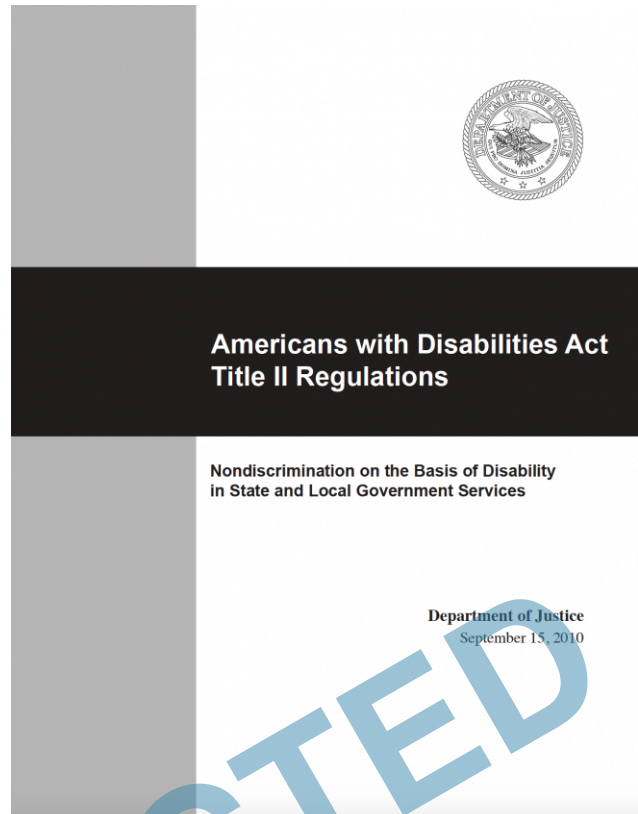
Finding 239405 Main Photo

Make alteration to existing parking lot perimeter enclosure to ensure an unobstructed path of travel from the parking lot to the trail/trailhead.

Obstructed path of
travel to trail/trail head
from parking lot

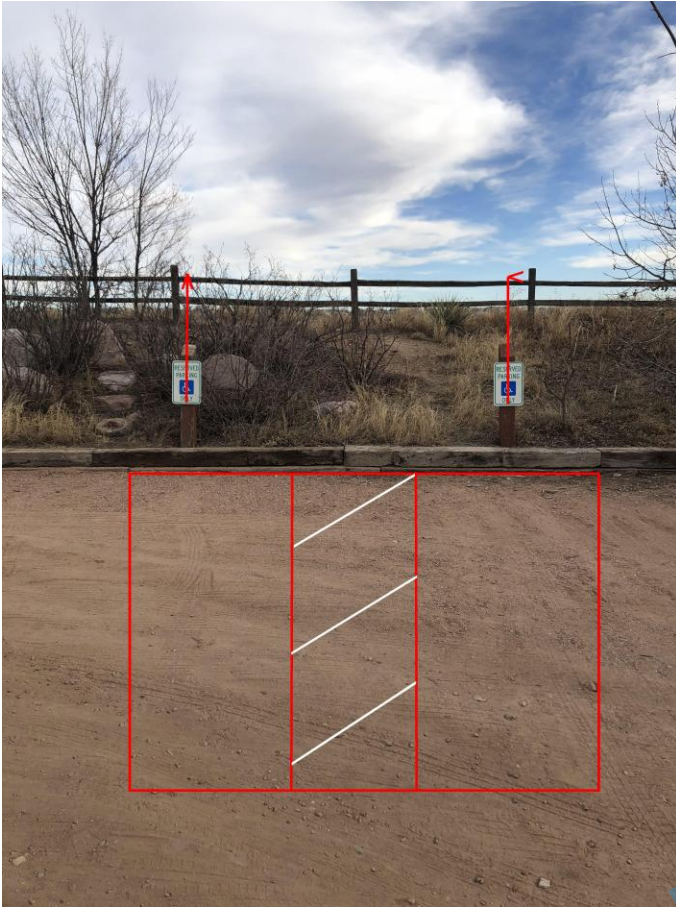
Finding 239244 Main Photo

The surfaces of the accessible parking spaces and access aisles are not firm, stable, and slip resistant.

Accessible parking stalls are not slip resistant

Construct 2 van accessible stalls with an access aisle that connects to the curb ramp and access route closest to the nature center.

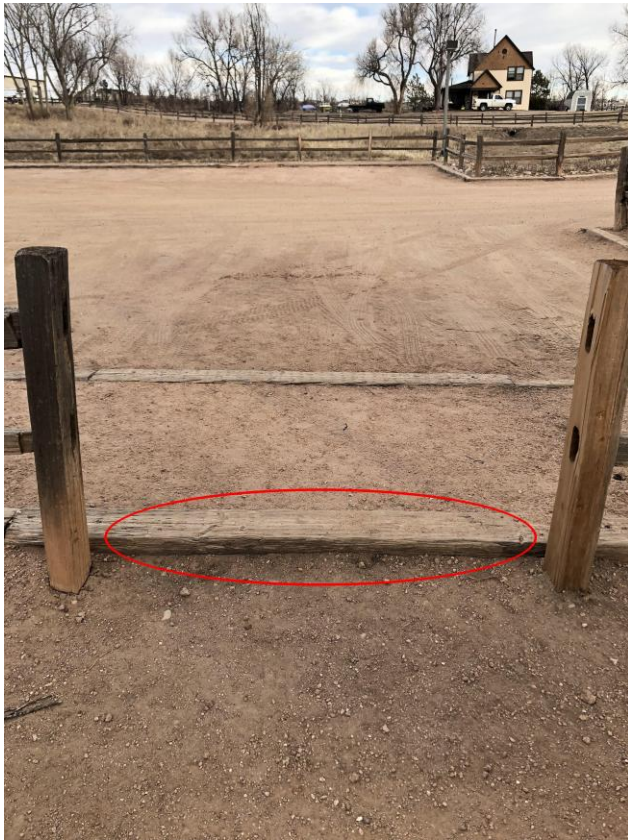
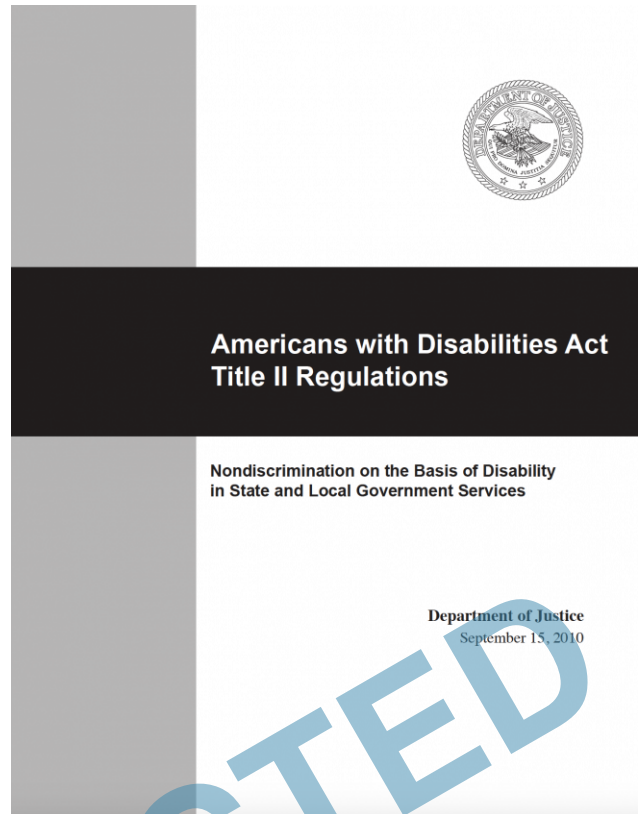
Finding 239404 Main Photo

Make alteration to existing parking lot perimeter enclosure to ensure an unobstructed path of travel from the parking lot to the trail/trailhead.

Obstructed path of
travel to trail/trailhead
from parking lot

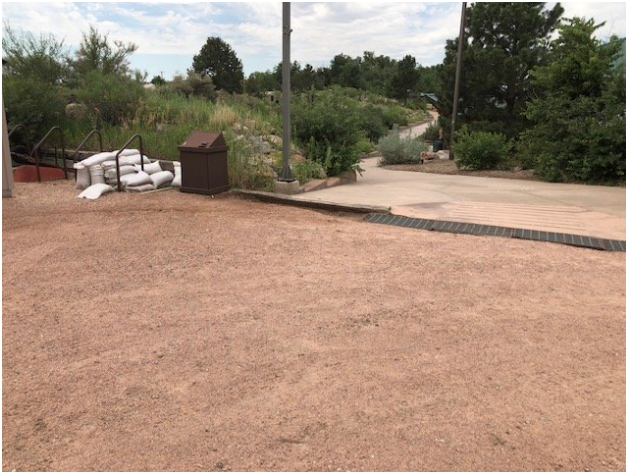
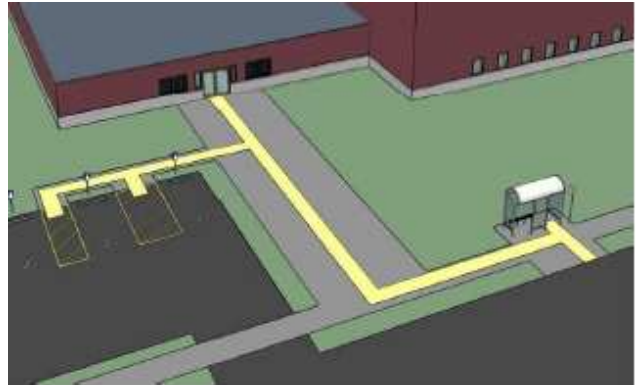
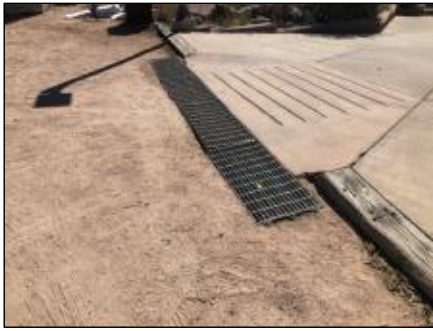
Finding #6 Additional Finding Photos

The accessible parking is not located on an accessible route of travel to the accessible building entrance.

**Accessible route from
accessible parking
stalls non-existing.**

Construct accessible path of travel connecting the accessible parking stalls to the circulation path onto the main sidewalk. Ensure surface material is firm, stable and slip resistant.

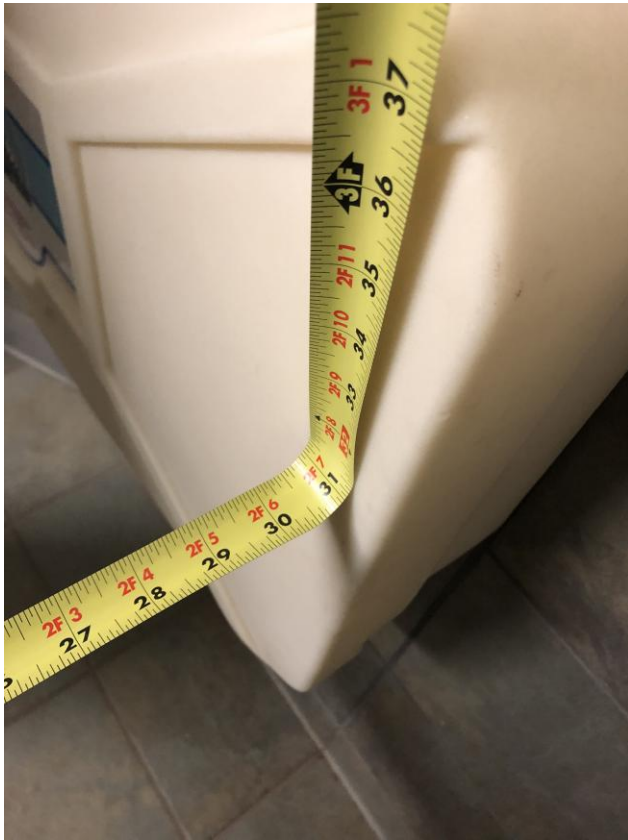
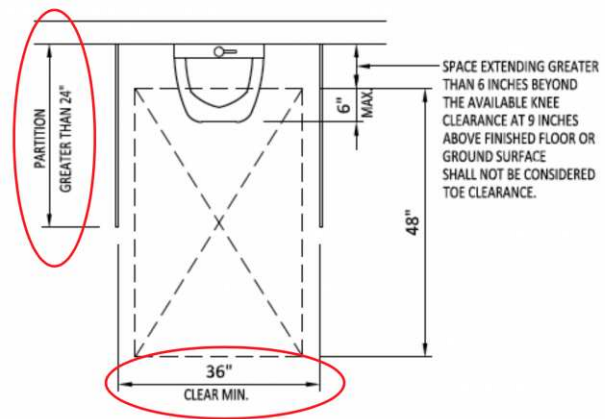
Finding #7 Continued

The urinal is confined on three sides (alcove).

Forward approach
measures 31 inches

Due to limited space and placement/protrusion of the changing table into the minimum required cleared floor space for a forward approach, the required 36 inches may not be met. Recommend reconfiguration if and when renovation/remodel is performed to meet compliance.

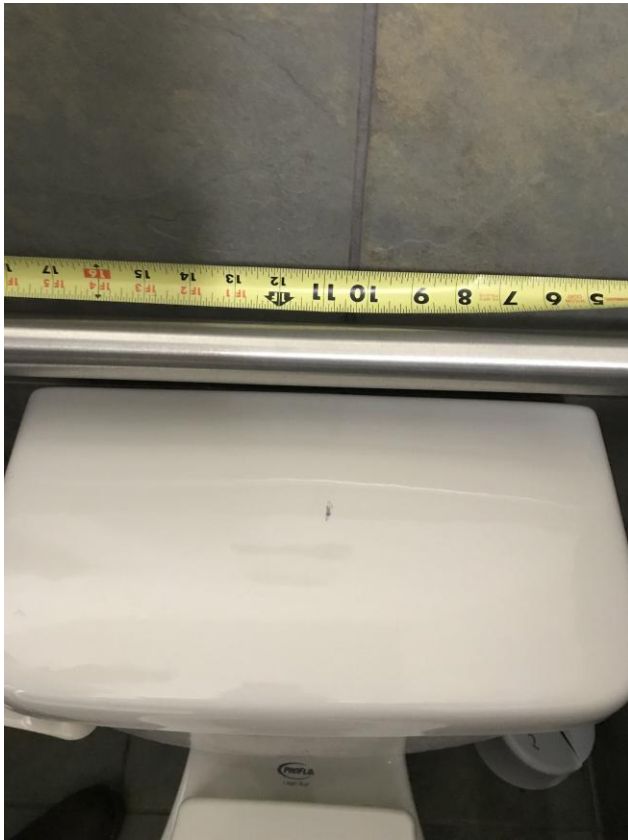
Finding 297132 Main Photo

The rear grab bar does not extend adequately past the centerline of the toilet on the wall side.

10.5 inches from
centerline of toilet

Re-position rear grab bar to extend 12 inches minimum on wall side and 24 inches minimum on the transfer side measured from the centerline of the toilet.

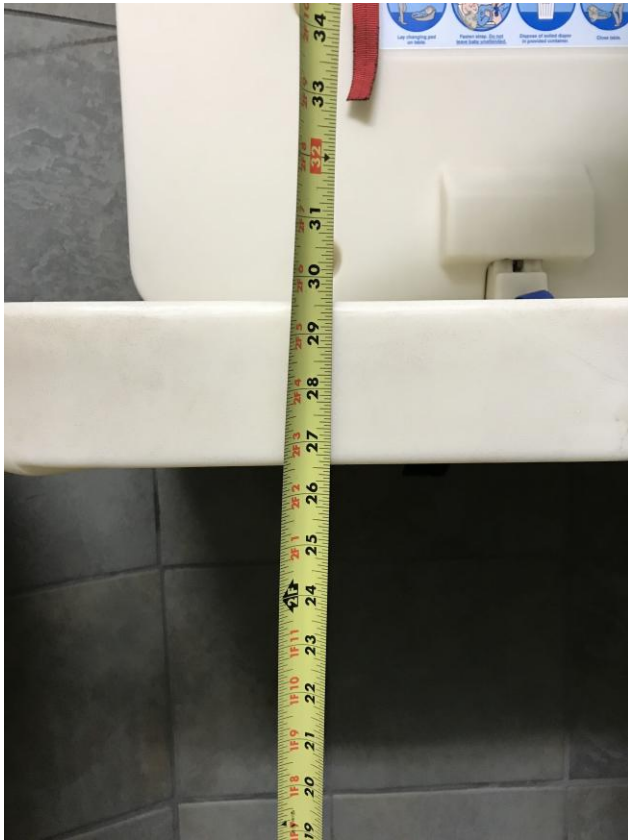
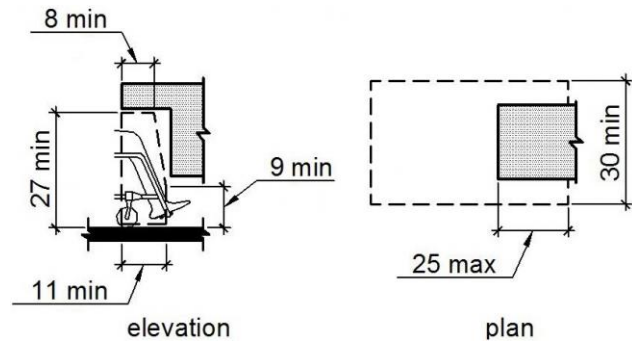
Finding 297133 Main Photo

The knee clearance not compliant.

**26.5 inches above
finished floor**

Lower baby changing station to meet the 27 inches minimum required under an element for knee clearance, 28 inches minimum to 34 inches maximum to the top of the table surface and 48 inches maximum height to operable part measured from the finished floor.

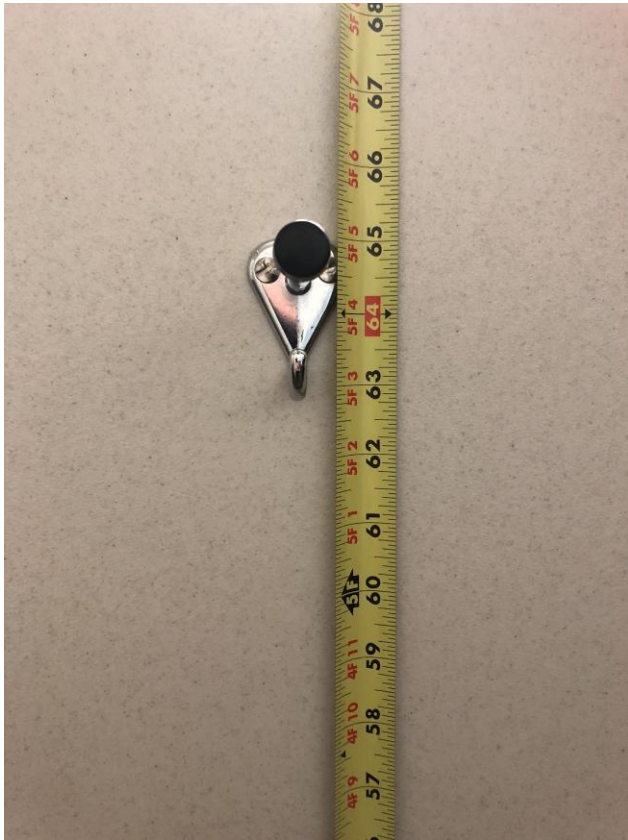
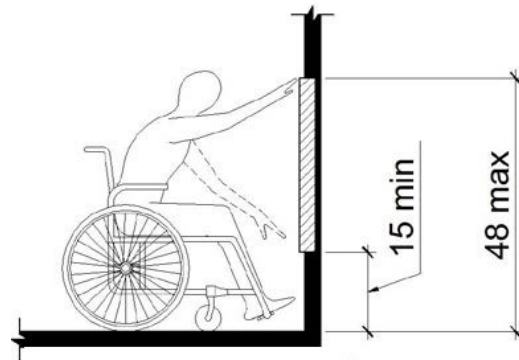
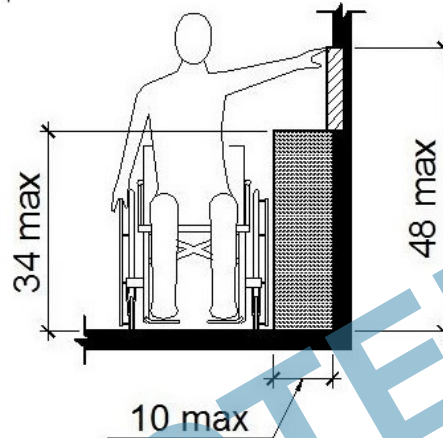
Finding 241320 Main Photo

The coat hook is installed greater than 48 inches above the finished floor.

64.5 inches above the floor

Lower coat hook 18 inches minimum or install another coat hook not to exceed a maximum height of 48 inches above finished floor.

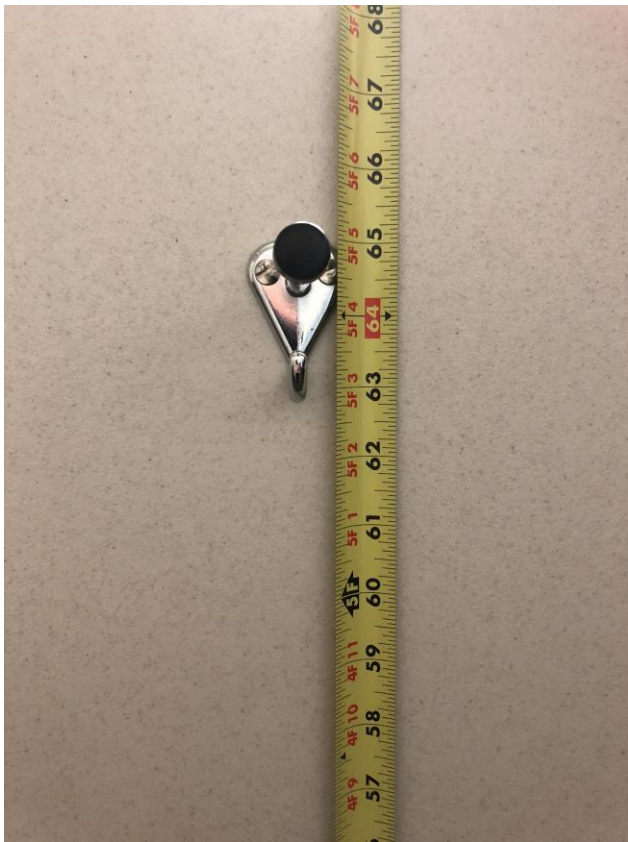
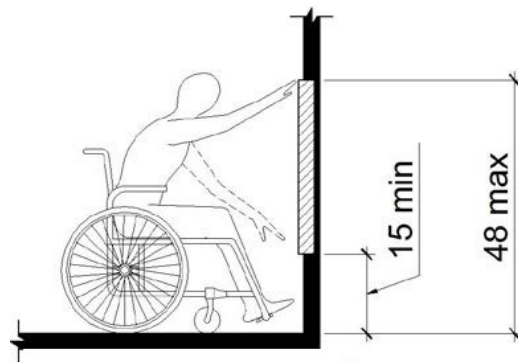
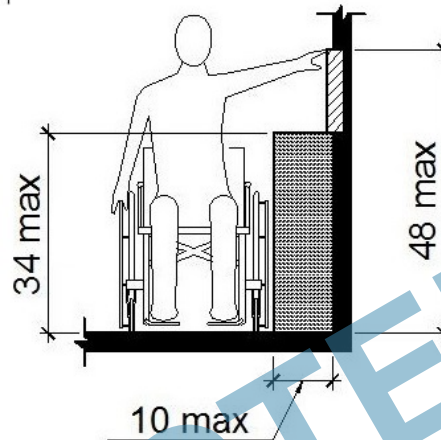
Finding 241321 Main Photo

The coat hook is installed greater than 48 inches above the finished floor.

64.5 inches above the floor

Lower coat hook 18 inches minimum or install another coat hook not to exceed a maximum height of 48 inches above finished floor.

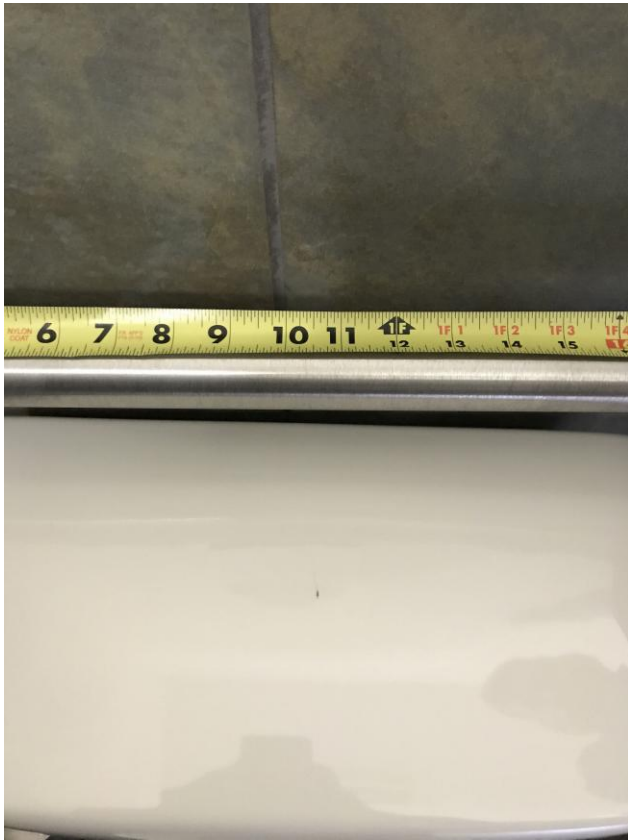
Finding 297134 Main Photo

The rear grab bar does not extend adequately past the centerline of the toilet on the wall side.

10.5 inches from
centerline of toilet

Re-position rear grab bar to extend from the centerline of the toilet 12 inches minimum to the wall side and 24 inches minimum to the transfer/open side.

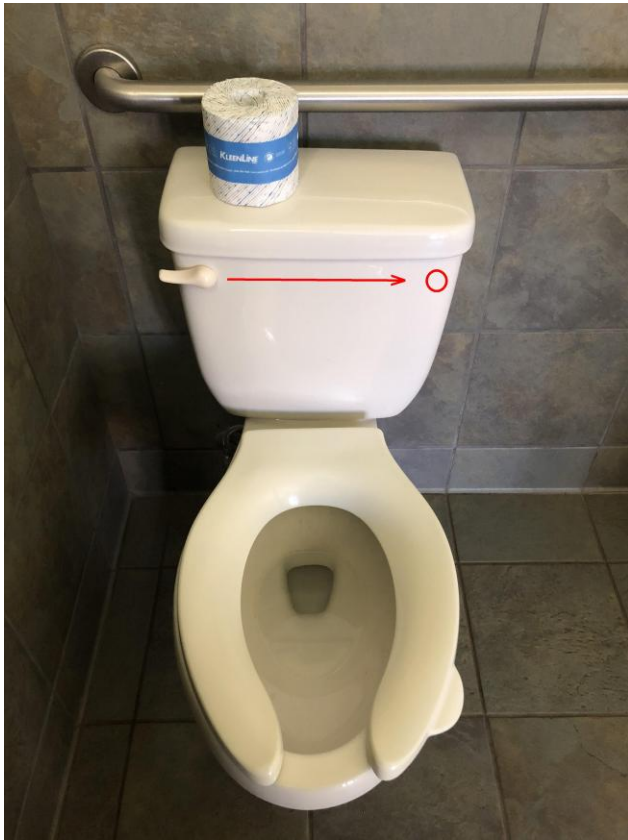
Finding #13 Additional Finding Photos

The flush handle is located on the wrong side of the toilet.

Flush handle located
on the closed side

Replace toilet water tank with one that has flush handle on the opposite side (open side of toilet area).
