Site Accessibility Evaluation

Office of Emergency Management

**3755 Mark Dabling Blvd
Northeast Colorado
Springs, CO 80907**

Accessibility Evaluation

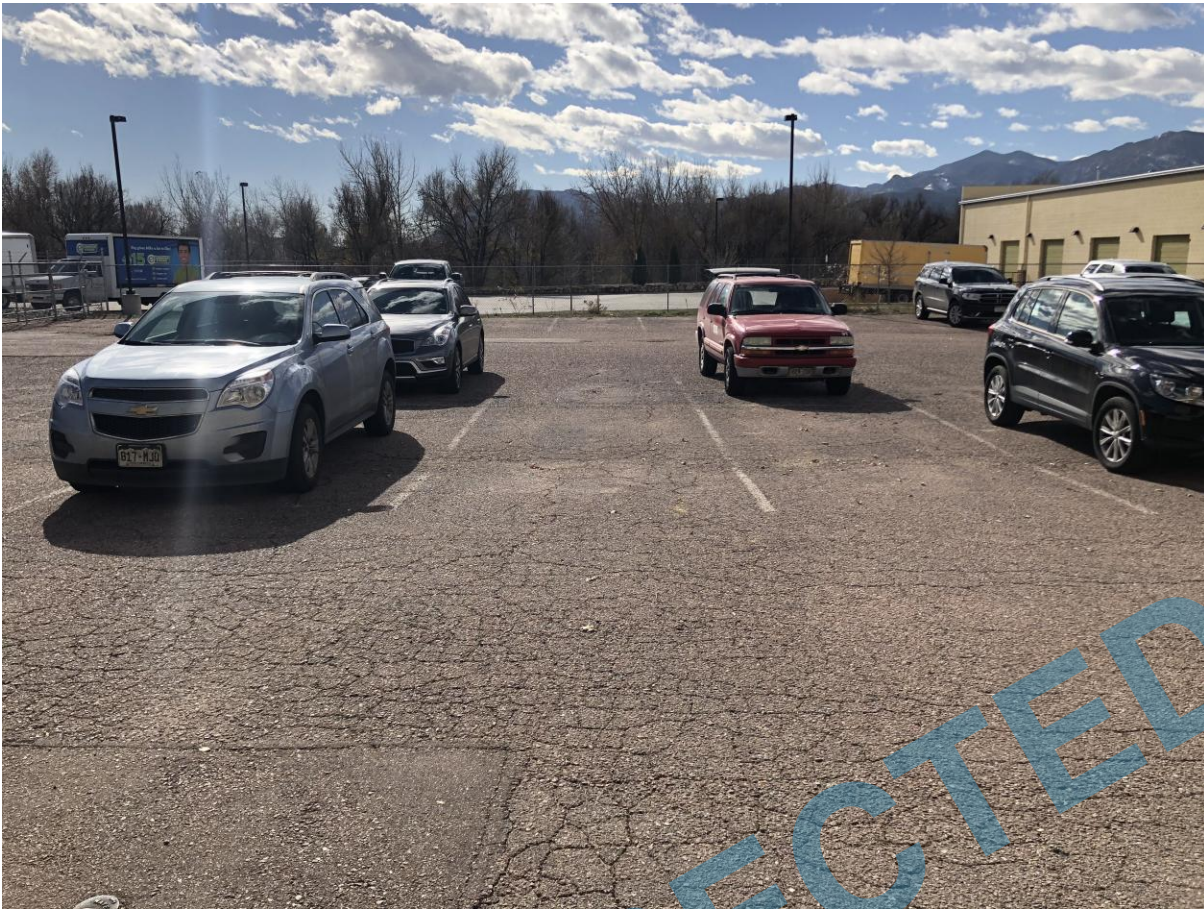
Finding #1 Continued

Parking lot has alligator cracking throughout. Difficult to identify van accessible stalls due to faded paint/stripping.

Parking lot in need of repair

Parking lot needs to be resurfaced and re striped. Also, the 2 van accessible parking stalls need to be relocated closer to the front entrance and have a maximum cross and running slope no greater than 2%.

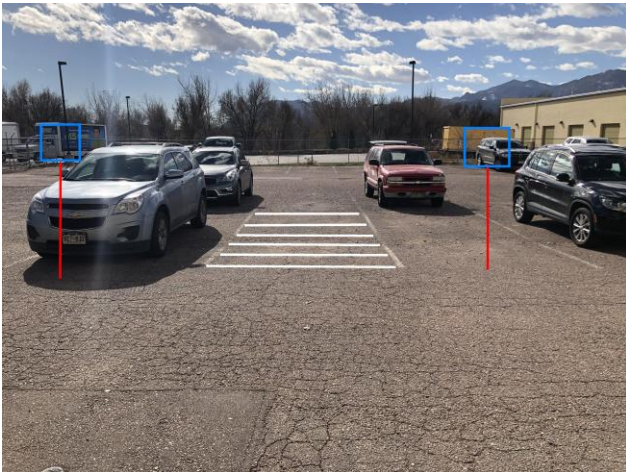
Finding #2 Continued

The van stall is missing a sign identifying it as a van accessible stall.

No van accessible stalls nor International symbol of accessibility.

Install 2 van accessible signs to include posts, van accessible signs and international symbol of accessibility near the front of the building. Also re-stripe and ensure both van parking stalls and access aisle have no more than 2% running and cross slope.

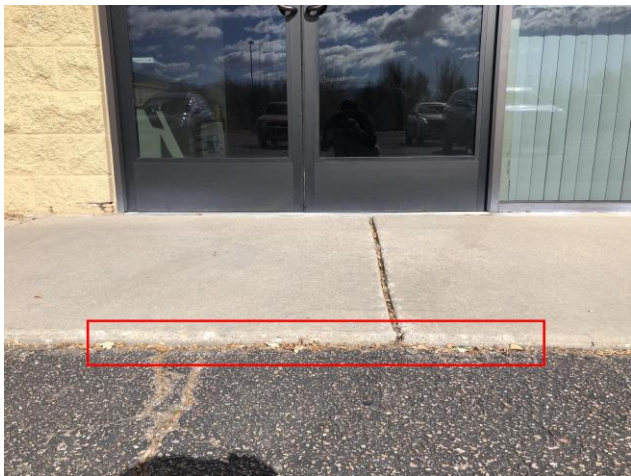
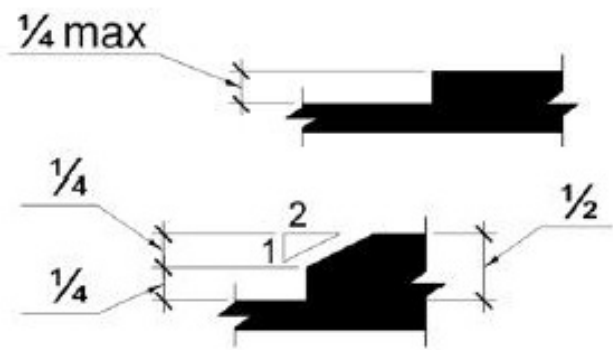
Finding #3 Continued

The walkway contains abrupt vertical edges and/or variations over a 1/4 inch.

Change in elevation
greater than 1/4 inch

When resurfacing parking lot, ensure elevation changes are no greater than 1/4 inch. Also, path of travel from access isle next to van accessible stall should be no greater than 5% running slope and no greater than 2% cross slope leading up to the main entrance.

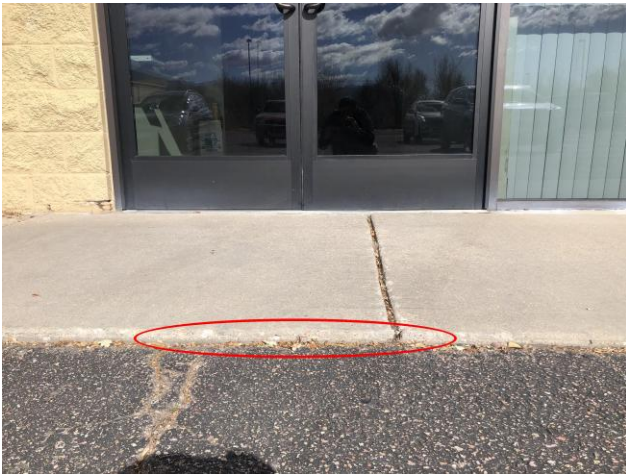
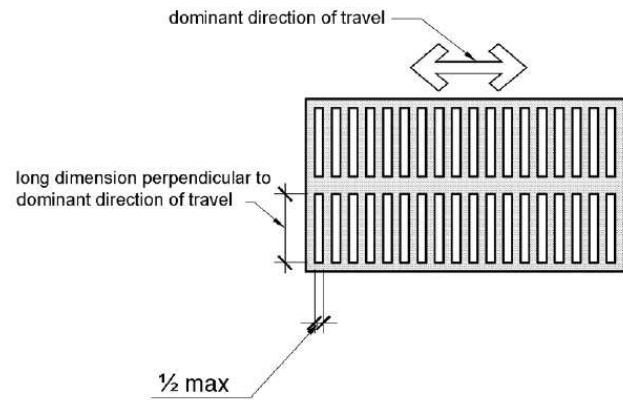
Finding #4 Continued

The concrete expansion joint is spaced greater than a 1/2 inch.

The concrete joint is spaced greater than a 1/2 inch.

When parking lot is resurfaced, ensure a smooth transition from asphalt to concrete to avoid an elongated opening greater than 1/2 inch.

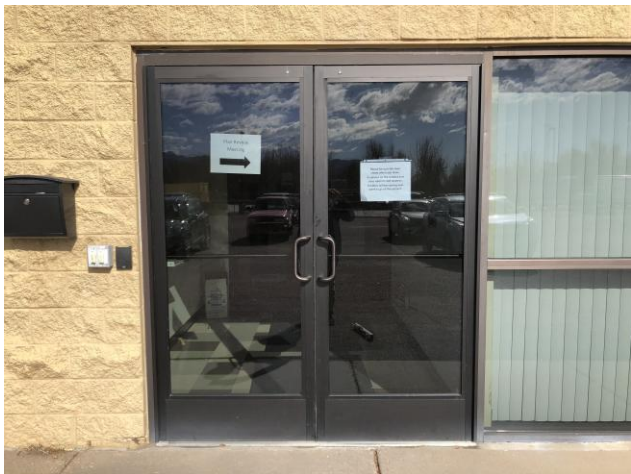
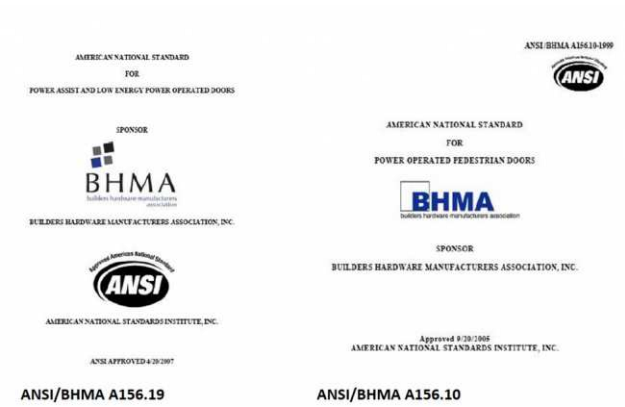
Finding #5 Continued

Recommend installing automatic and power-assisted doors

Recommend installing automatic power-assisted door openers to the main entrance. Door openers should operate both front entrance doors at the same time.

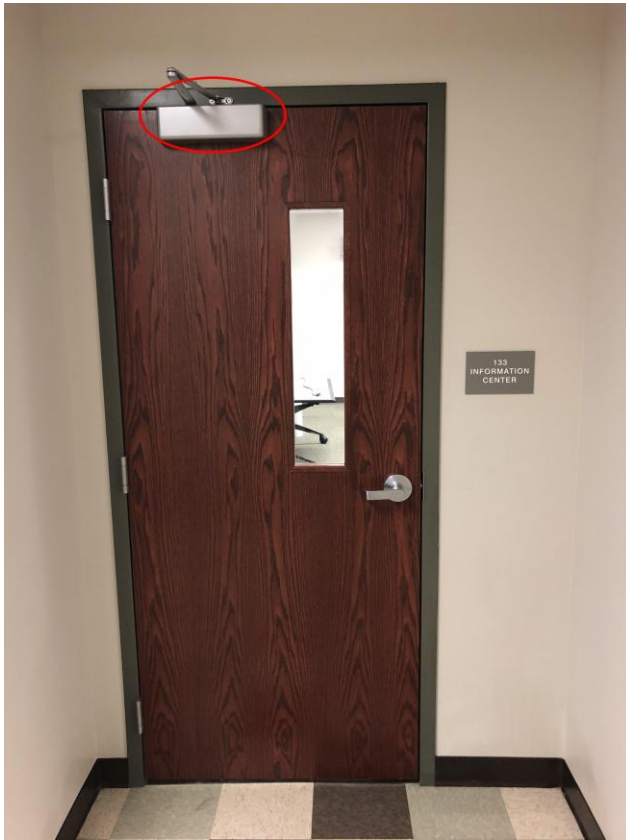
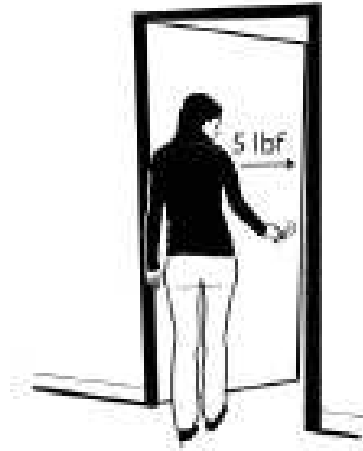
Finding #6 Continued

The door exceeds the maximum pressure to open the door.

Interior doors exceed 5 lbs maximum

Adjust interior doors to conference rooms, restrooms, break rooms, to 5 lbs of pressure maximum. 3-4 lbs if preferred if possible.

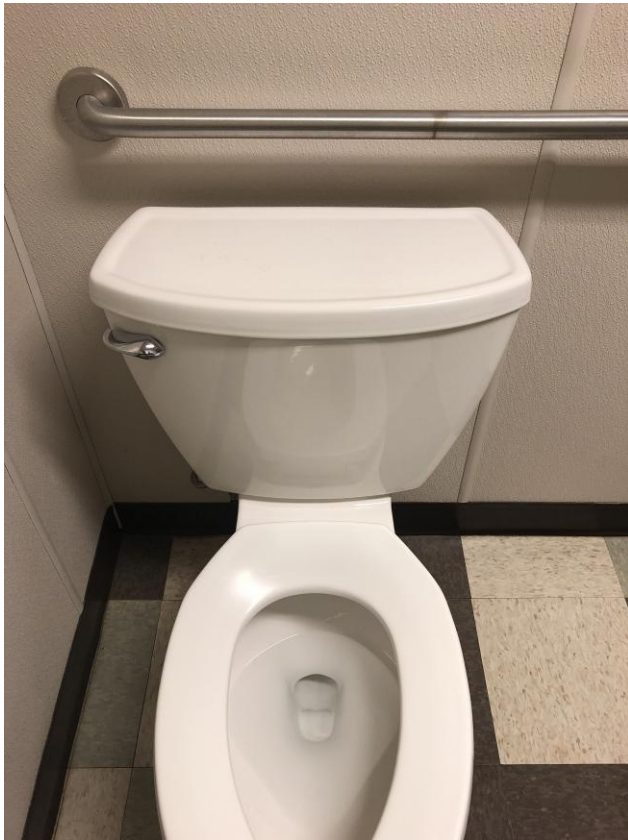
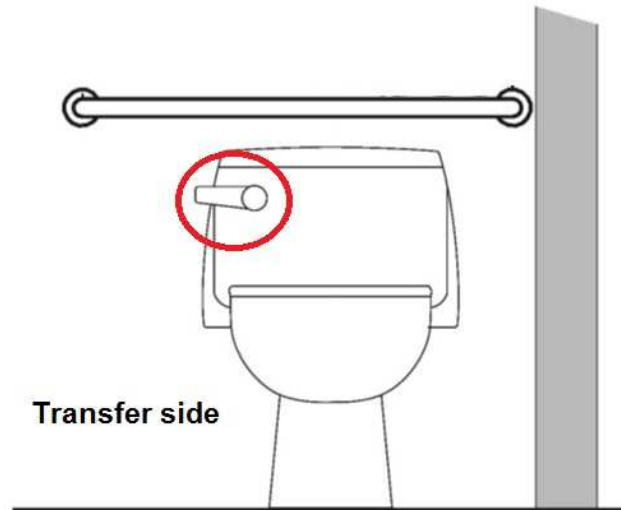
Finding #7 Continued

The flush handle is located on the wrong side of the toilet.

Flush handle on wall side

Replace toilet water tank with one that has flush handle on the opposite side (open side of toilet area).

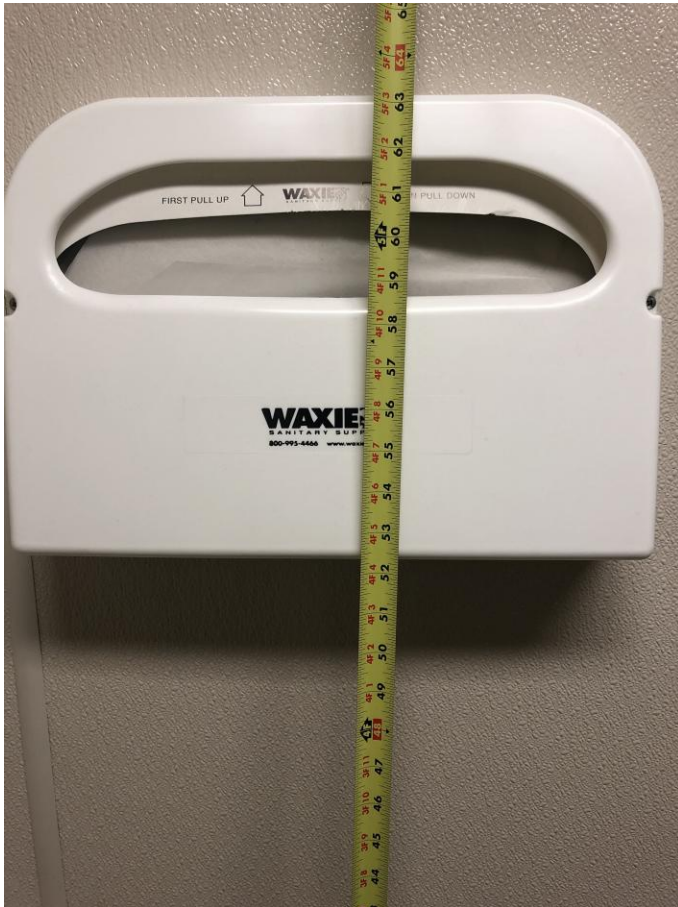
Finding #8 Continued

The toilet seat cover dispenser is mounted too high and are not located in an accessible location.

58 inches above
finished floor

Relocate seat cover dispenser to have operable part between 15 inches minimum and 48 inches maximum above floor. May require relocation below rear or side grab bar at 1.5 inches minimum clearance below grab bar to meet compliance.

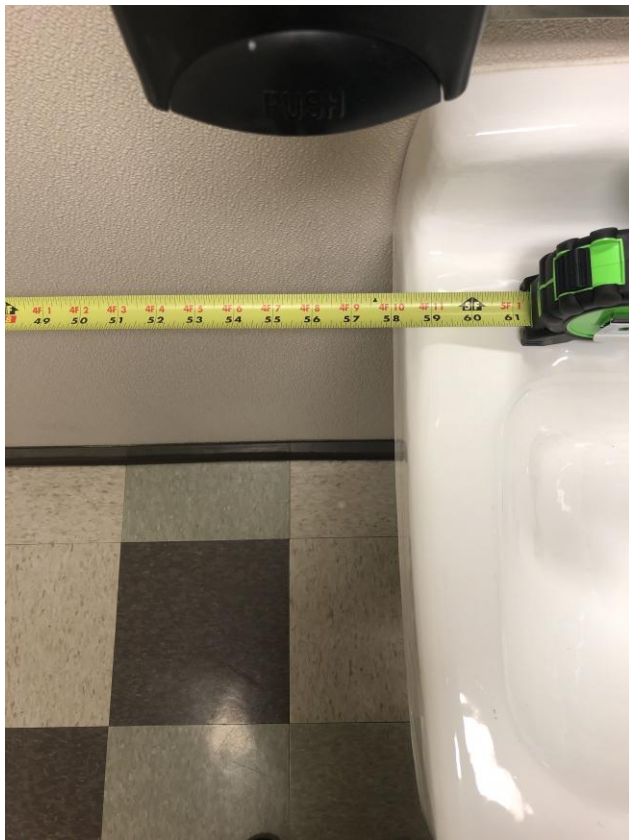
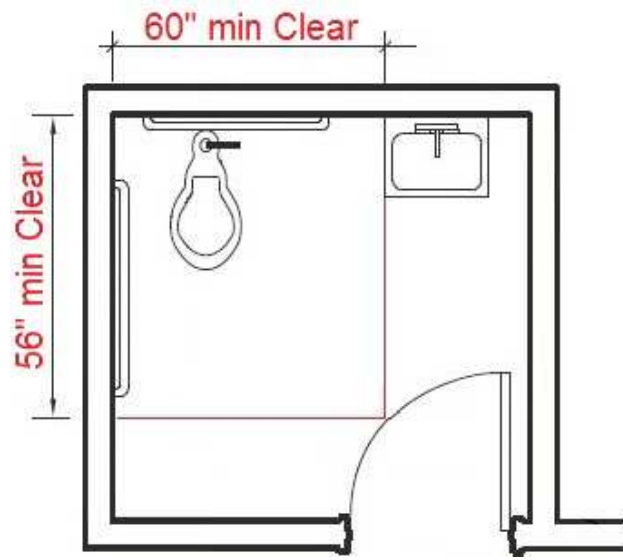
Finding #9 Continued

The clear floor space between the lavatory and the toilet is too narrow.

Lavatory protrudes into required clear floor space of the water closet

Relocate lavatory 2 inches further away from toilet in order to meet the minimum ADA 60 inch requirement.

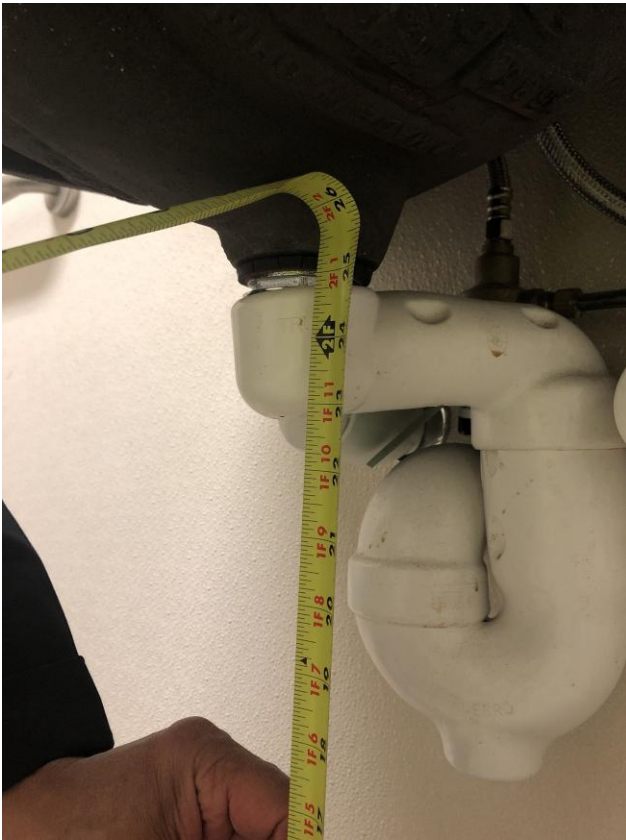
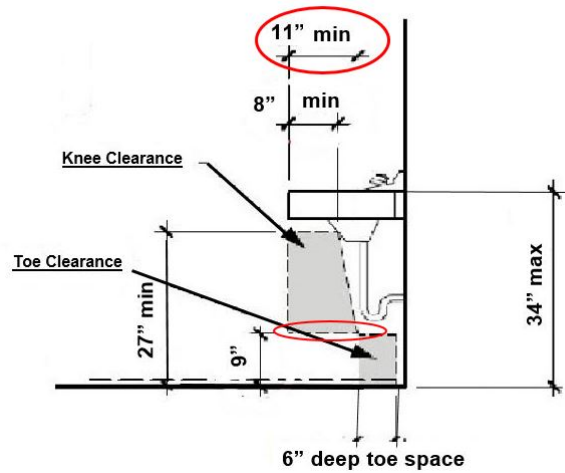
Finding #10 Continued

Compliant knee space has not been provided under the lavatory.

25.5 inches of knee clearance at 8 inches from front

Adjust or replace lavatory with one that provides a minimum height from the bottom edge of no less than 27 inches above finished floor and 8 inches minimum in depth for knee clearance.

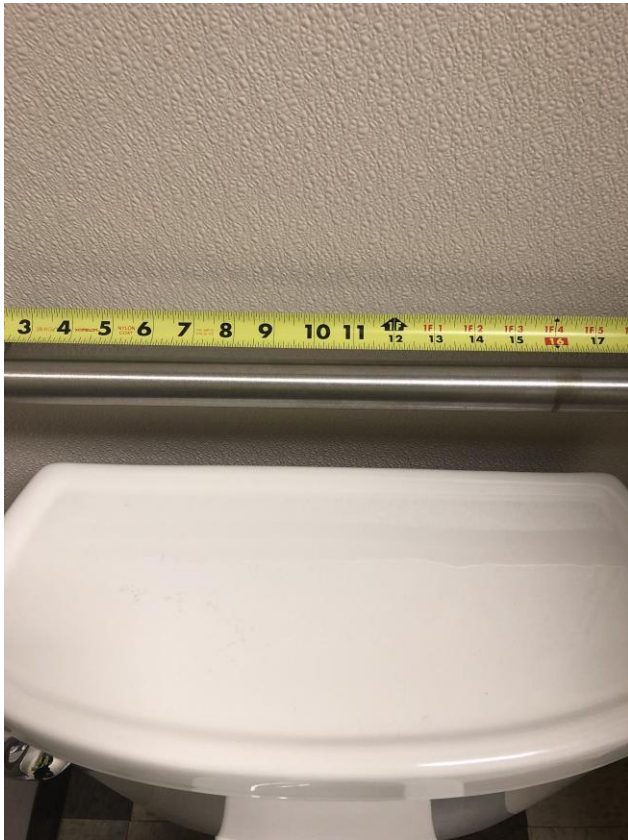
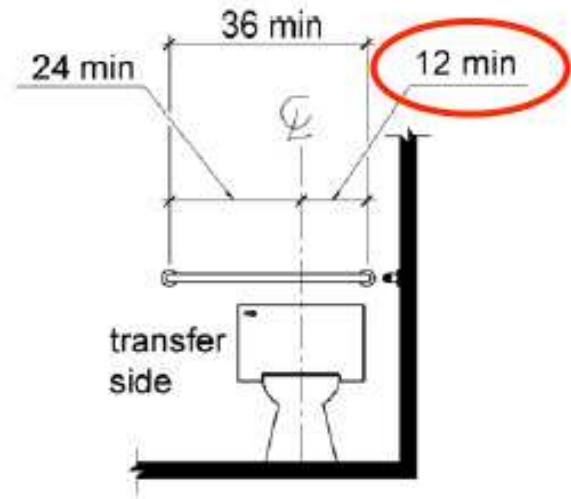
Finding #11 Continued

The rear grab bar does not extend adequately past the centerline of the toilet on the wall side.

10 inches from toilet centerline

Re-position rear grab bar to extend from the centerline of the toilet 12 inches minimum to the wall side and 24 inches minimum to the transfer/open side.

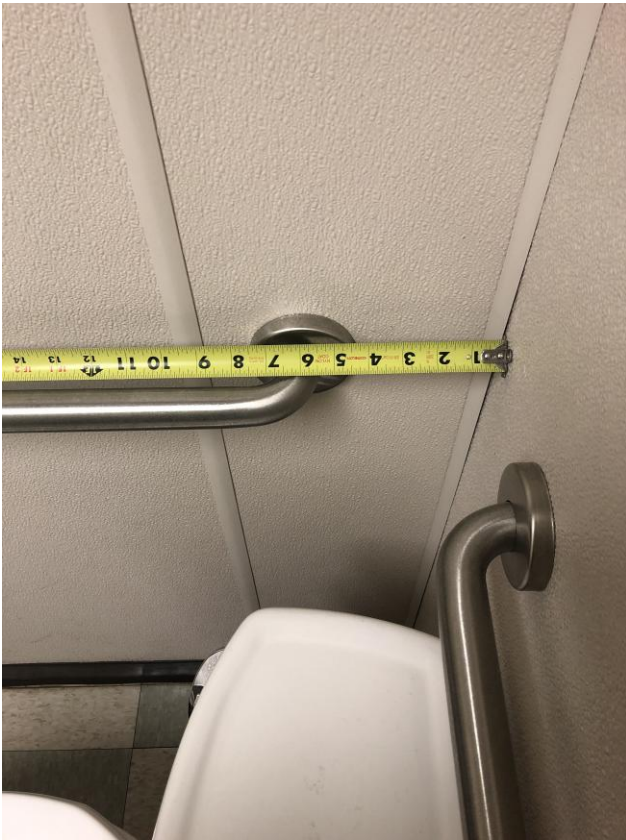
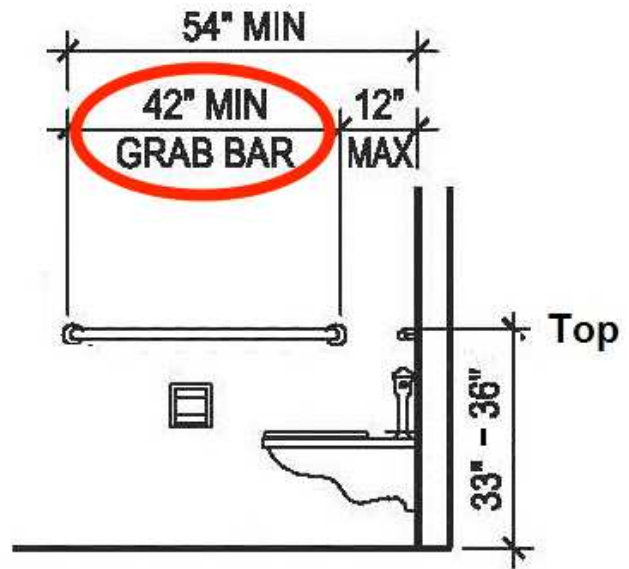
Finding #12 Continued

The side grab bar is not long enough.

6 inches from rear wall

Adjust side grab bar not to exceed 12 inches from rear wall measured to the centerline of the grab bar. The side grab bar must be 42 inches minimum in length and extend at least 54 inches minimum beyond the rear wall measured to the centerline of the grab bar.

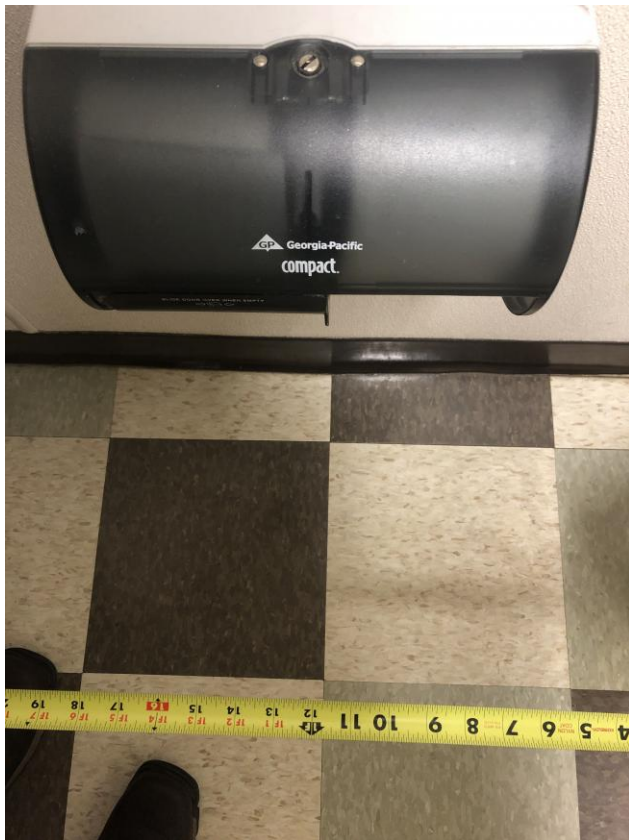
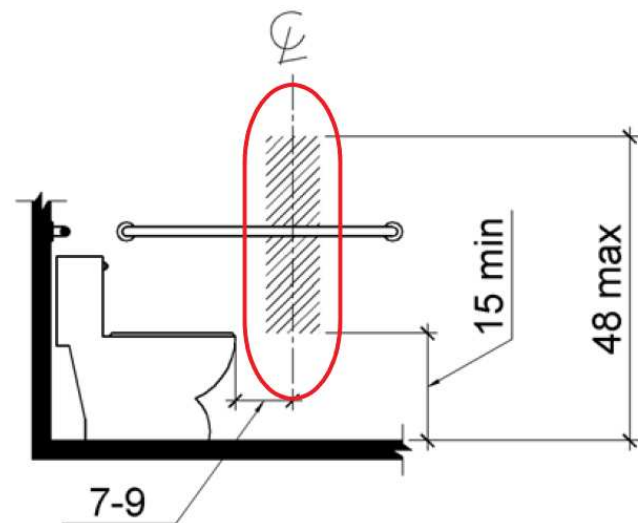
Finding #13 Continued

The toilet paper is not installed within the compliant height range.

12 inches in front of toilet

Re-position toilet paper dispenser to be within 7 inches minimum to 9 inches maximum in front of the toilet measured to the centerline of the dispenser.

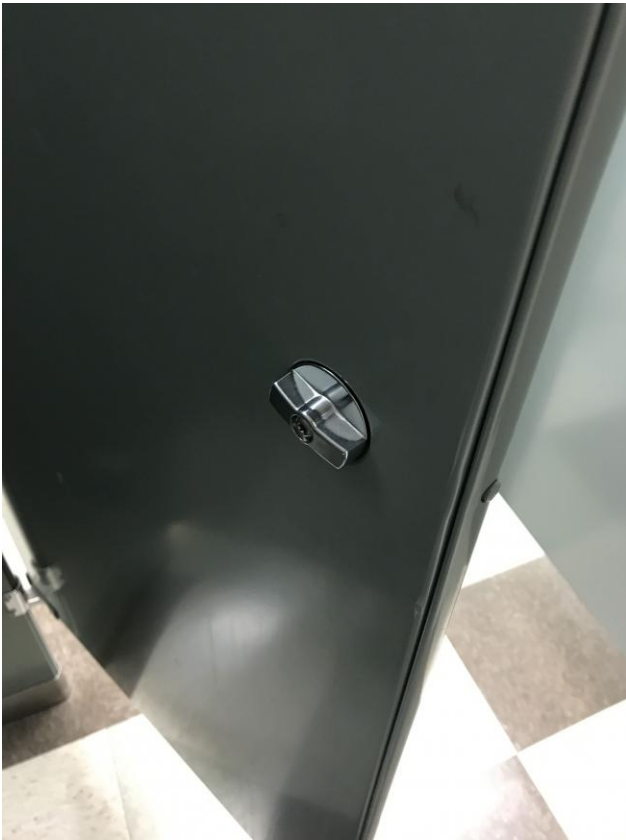
Finding #26 Continued

The water closet compartment door is missing a loop handle on the outside.

Compartment door
missing outside loop
handle

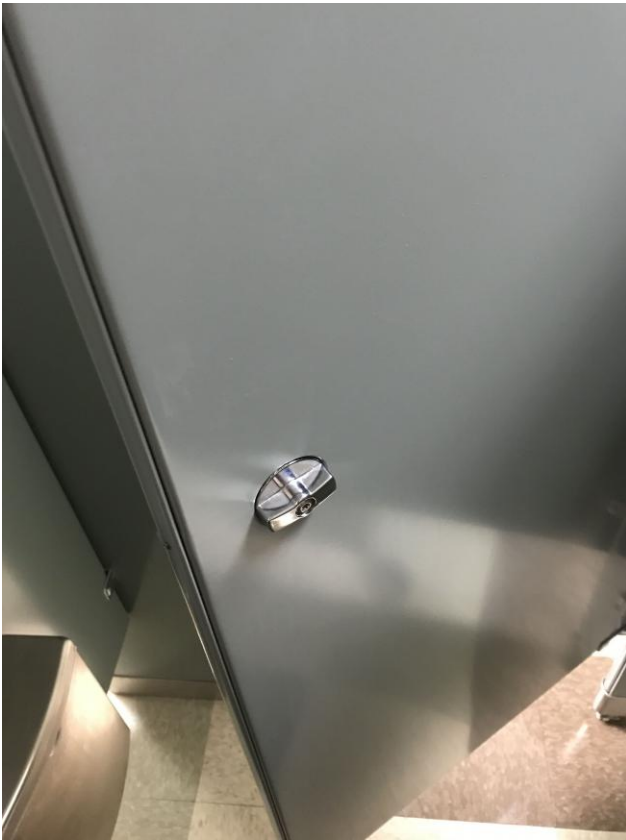
Finding #39 Continued

The water closet compartment door is missing a loop handle on the outside.

Compartment door
missing outside loop
handle
