Site Accessibility Evaluation

Americans with Disabilities Act Title II (Public Services: State and Local Government)

Peak Vista - Jet Wing

Accessibility Evaluation

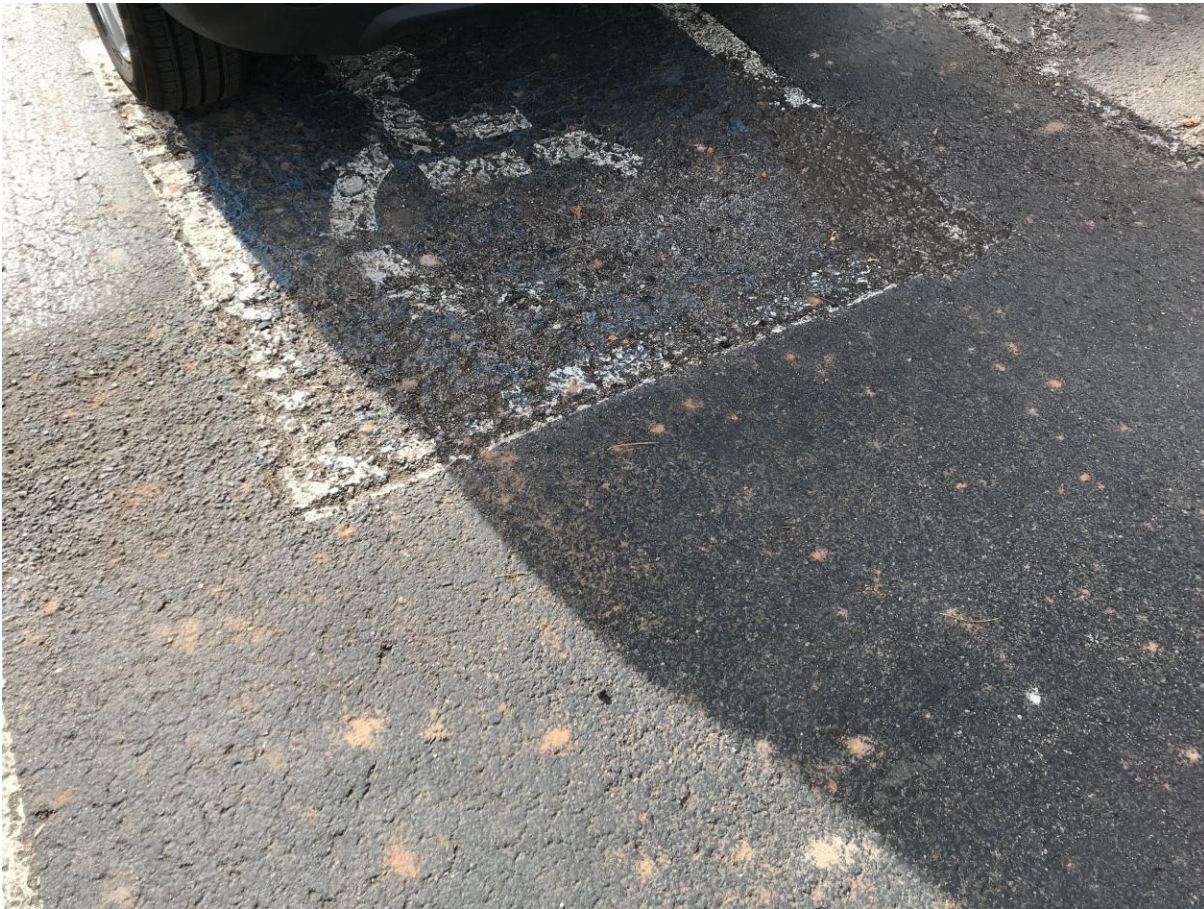
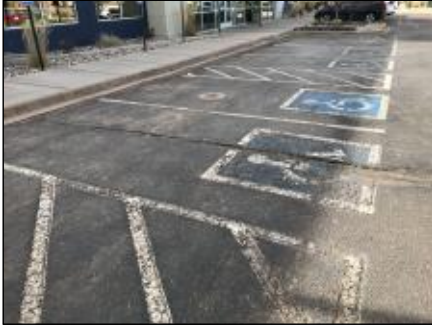
Finding #1 Continued

The striping and markings for the accessible parking stall, loading/unloading access aisle are dilapidated and in need of repair and/or maintenance.

2010 ADAS Section 502.3.3

Striping and markings
in need of repair

Re-stripe parking lot to include 4 accessible parking stalls, 3 5 foot wide access aisles, 2 van accessible parking stalls with van access aisle and the international symbol of accessibility on all the accessible parking stalls.

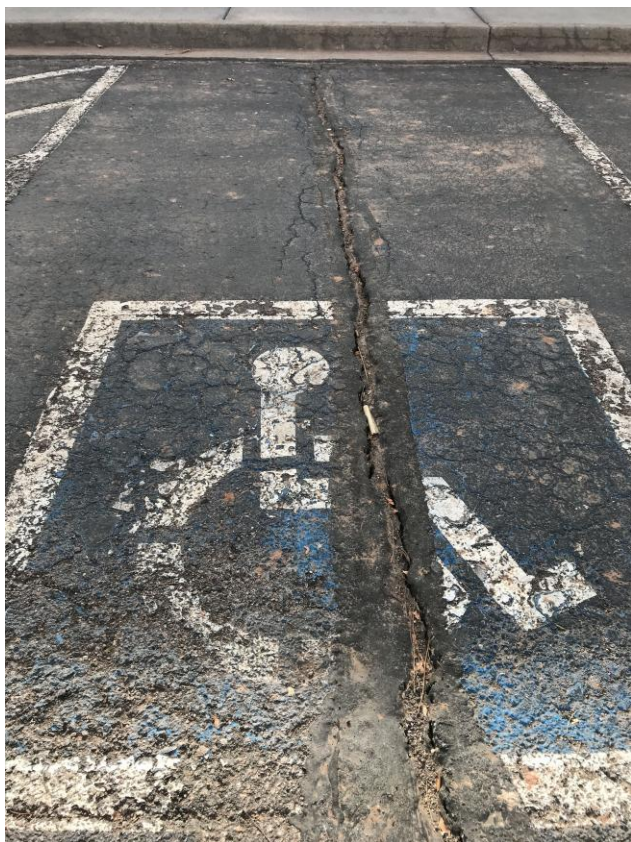
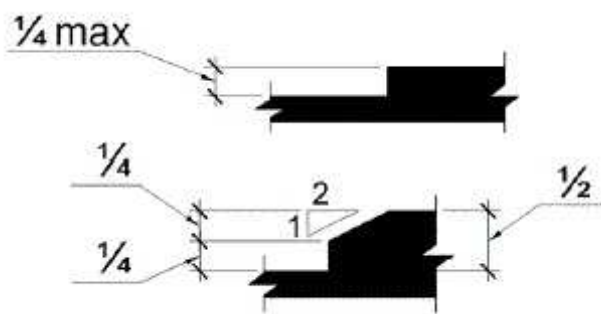
Finding #2 Continued

The parking stall contains abrupt edges and surface irregularities over a 1/4 inch vertical.

2010 ADAS Section 502.4

Contains abrupt edges
and cracking of
asphalt

Parking lot needs to be resurfaced or crack filled and re-striped.

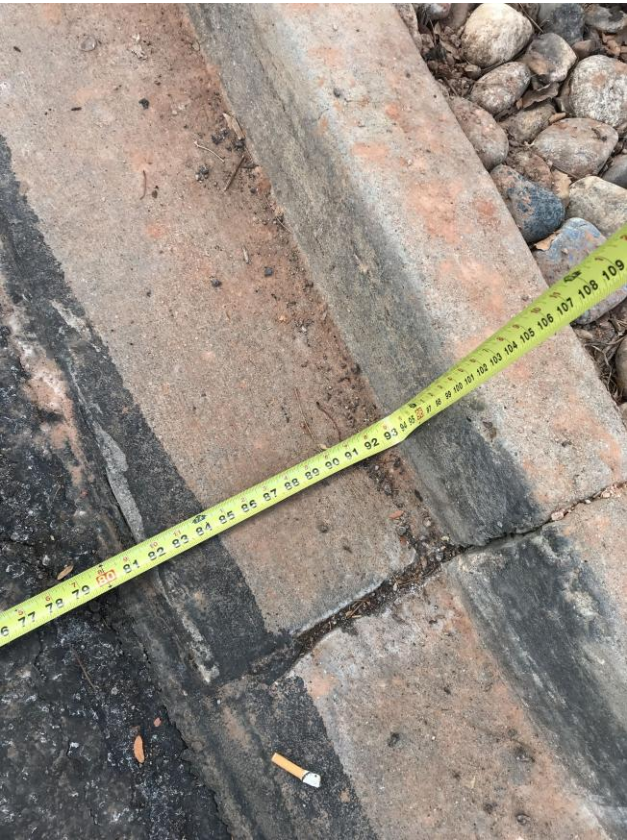
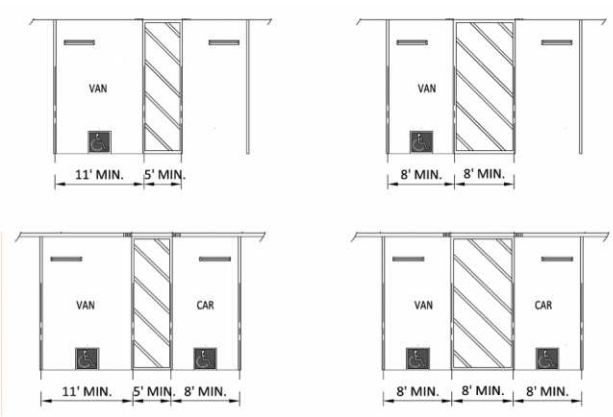
Finding #3 Continued

The accessible parking stall is not wide enough.

2010 ADAS Section 502.2

Van parking stall only
measures 93 inches in
width

Parking lot needs to be resurfaced or crack filled and re-striped.

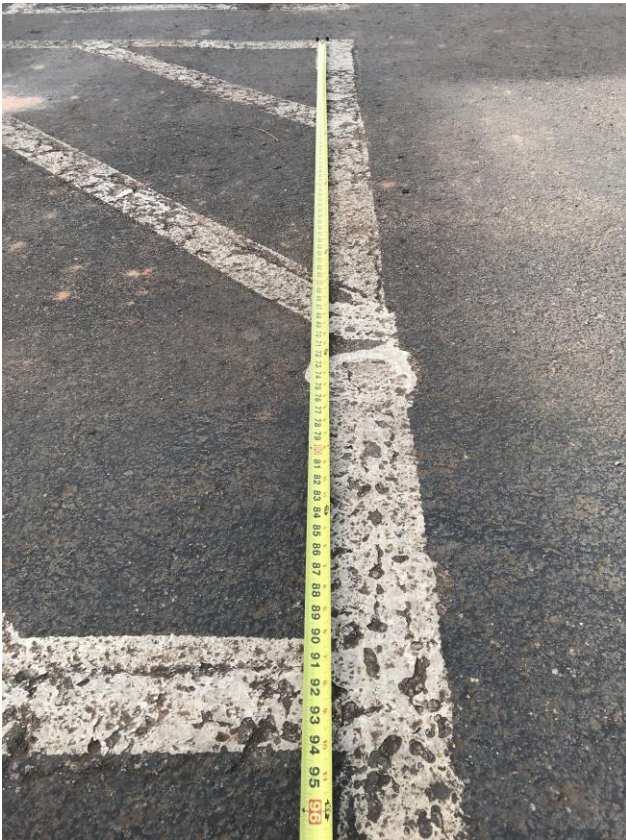
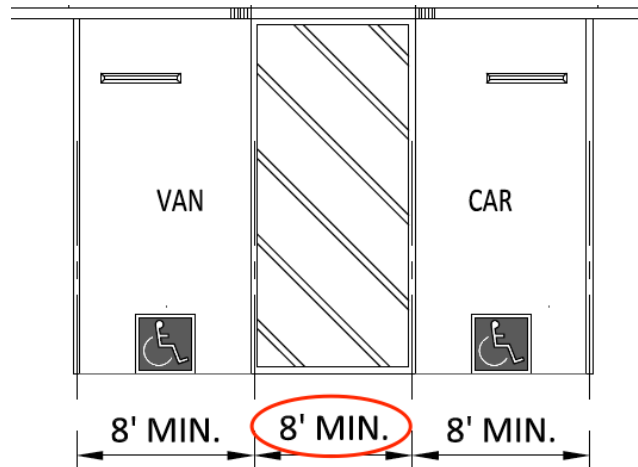
Finding #4 Continued

The access aisle is not a minimum 8 feet to the centerline of the stripe.

2010 ADAS Section 502.2 Exception

Van access aisle only
92 inches in width

Parking lot needs to be resurfaced or crack filled and re-striped.

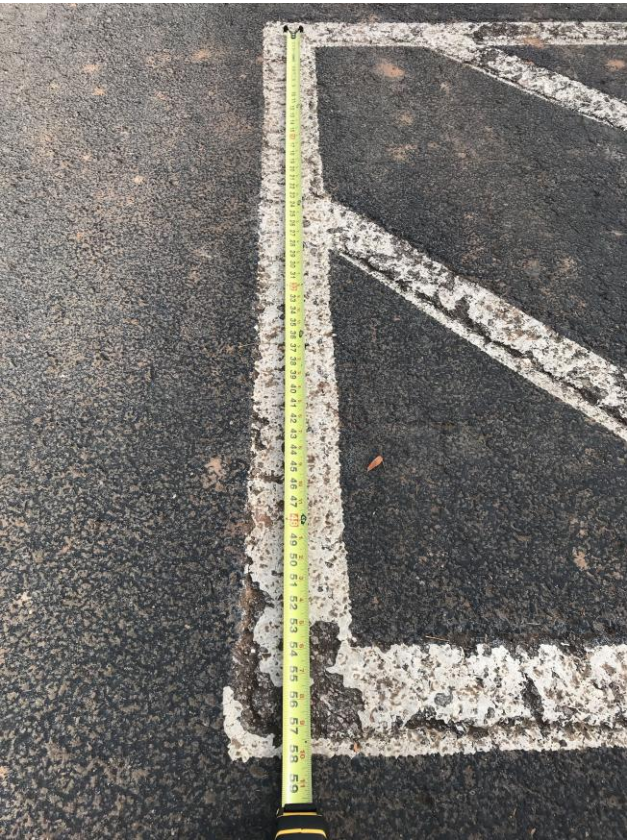
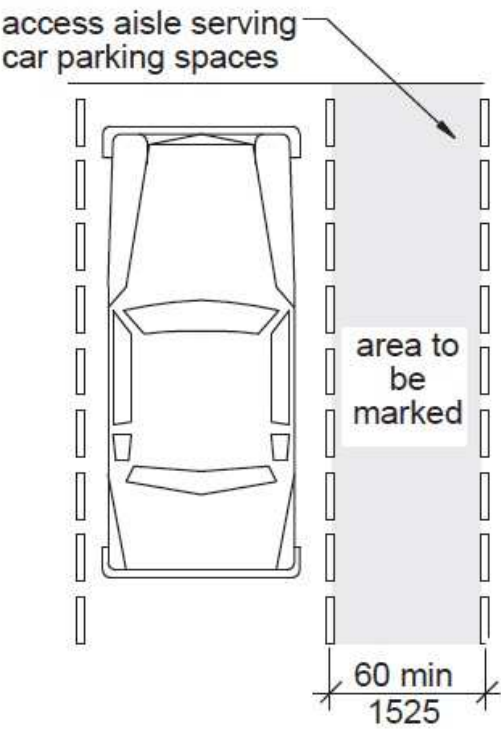
Finding #5 Continued

The access aisle is not a minimum 5 feet wide.

2010 ADAS Section 502.3.1

Both access aisles
between 55 and 56
inches in width

Parking lot needs to be resurfaced or crack filled and re-striped.

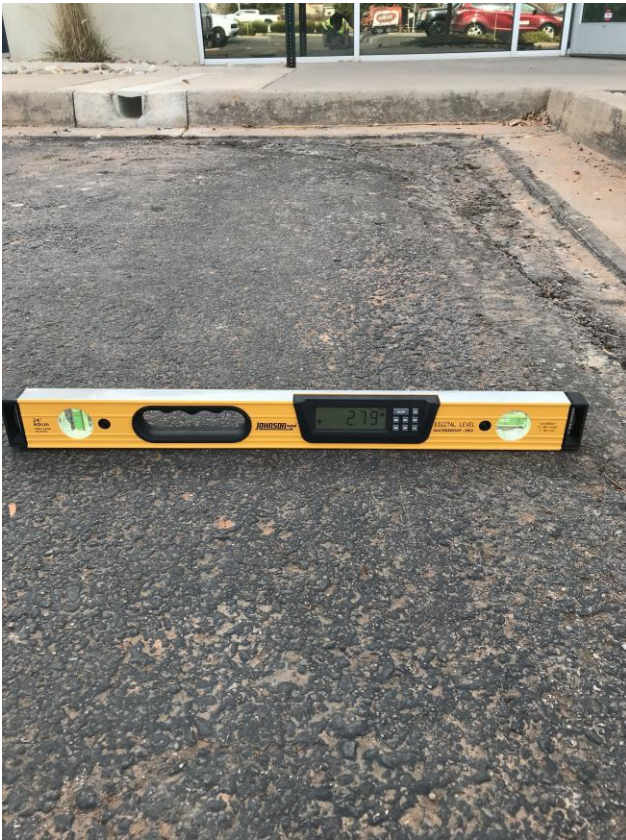
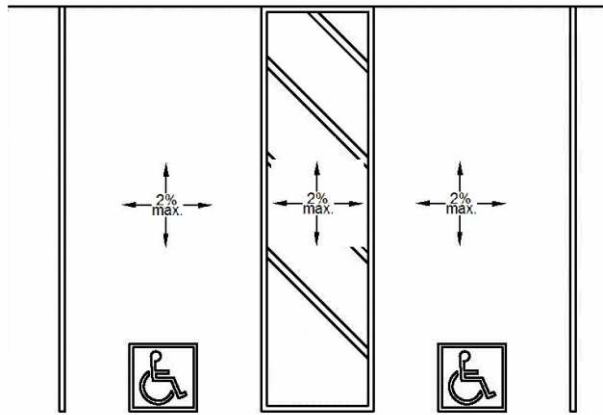
Finding #6 Continued

The cross slope (narrow dimension) of the parking stall exceeds 2%.

2010 ADAS Section 502.4

One of the van access
aisles cross slope
ranges between 2.27%
- 2.79%

Parking lot needs to be resurfaced or crack filled and re-striped.

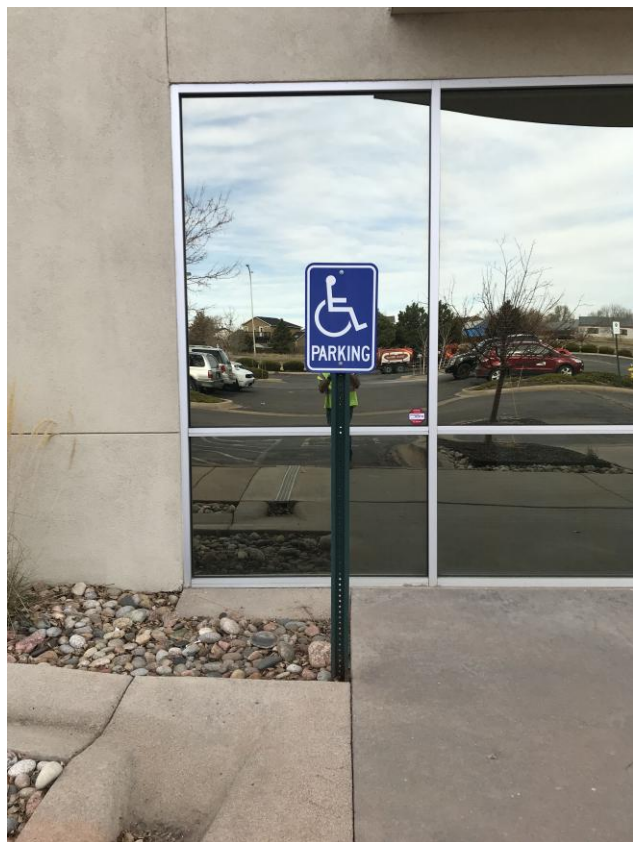
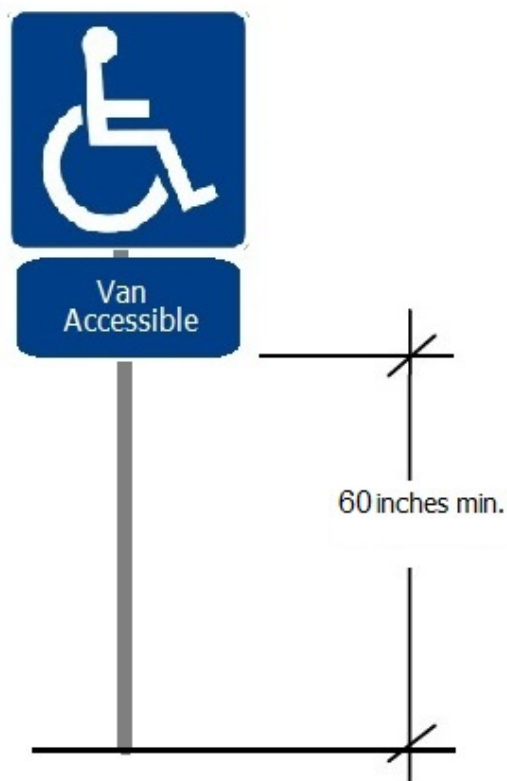
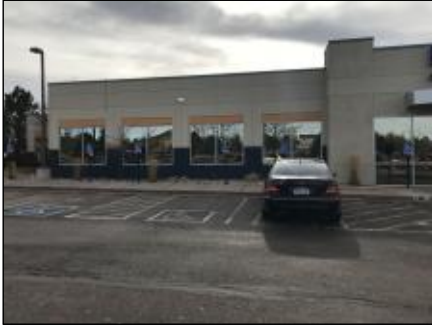
Finding #7 Continued

The parking sign is mounted too low.

2010 ADAS Section 502.6

All accessible parking signs measure below 60 inches above finished floor

Adjust height on all parking signs to a minimum of 60 inches measured from the bottom edge of the sign to finished floor or ground

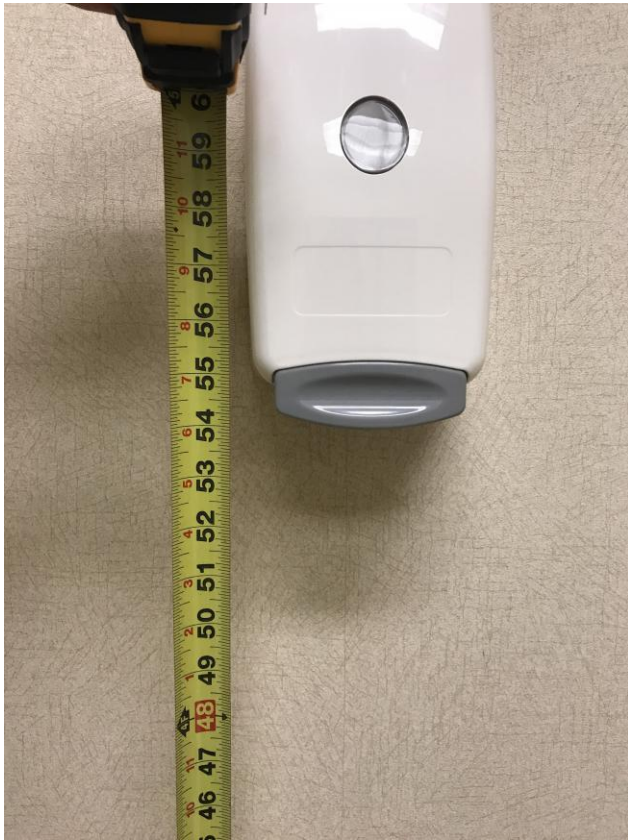
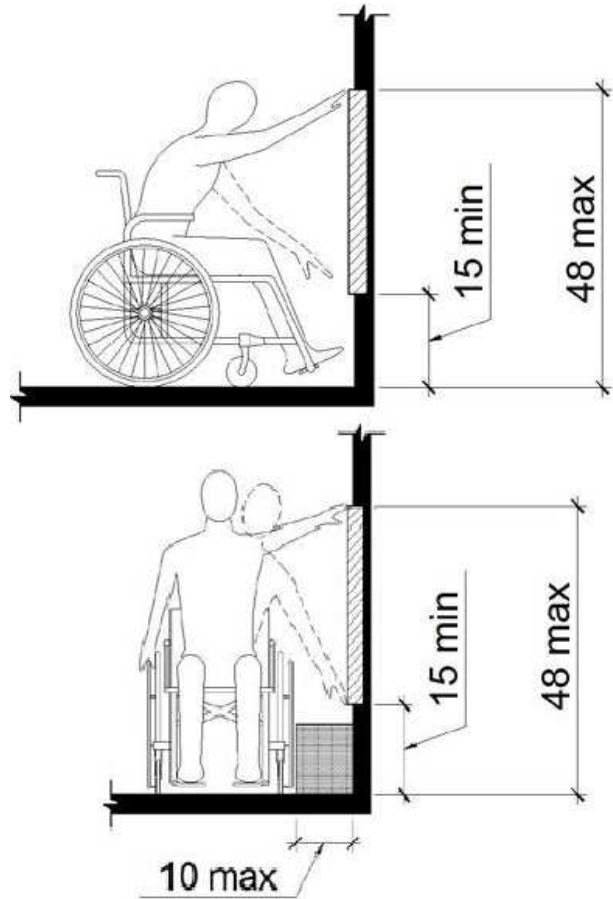
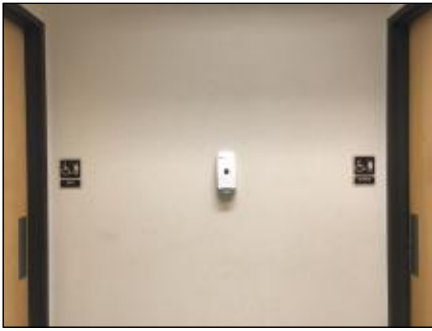
Finding #8 Continued

The hand sanitizer dispenser's operation mechanism is too high off the floor.

2010 ADAS Section 308.2.1

54 inches above
finished floor to
operable part

Lower hand sanitizer 7 inches minimum not to exceed a maximum height of 48 inches above finished floor.

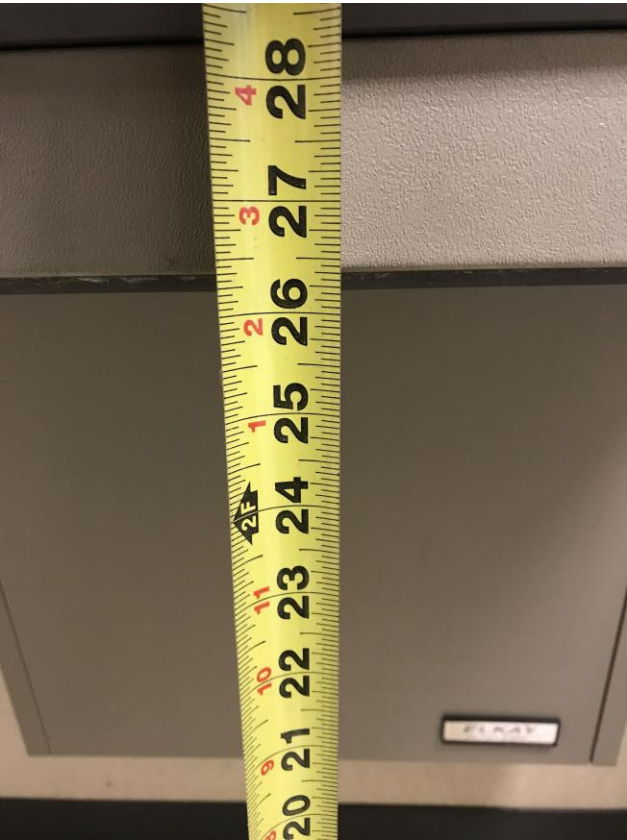
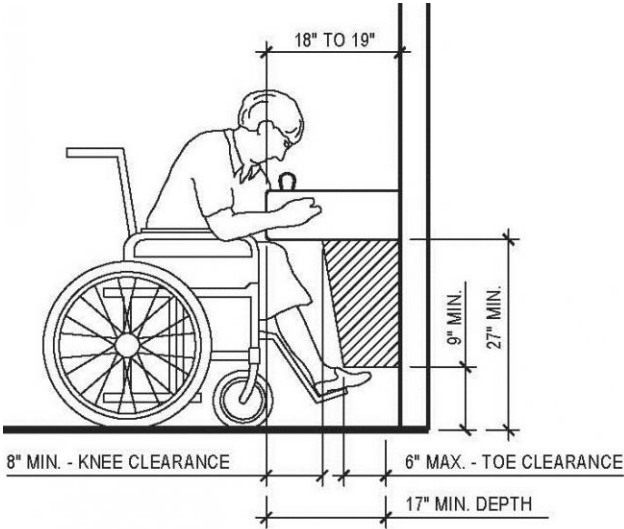
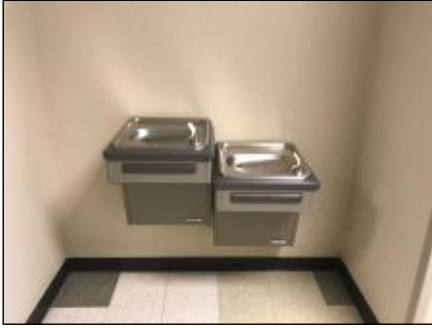
Finding #9 Continued

There is not enough knee clearance under the drinking fountain.

2010 ADAS Section 602.2

26.25 inches above
finished floor to
bottom edge of
drinking fountain

Adjust drinking fountain height to provide exactly 27 inches of clearance from the bottom edge above finished floor.

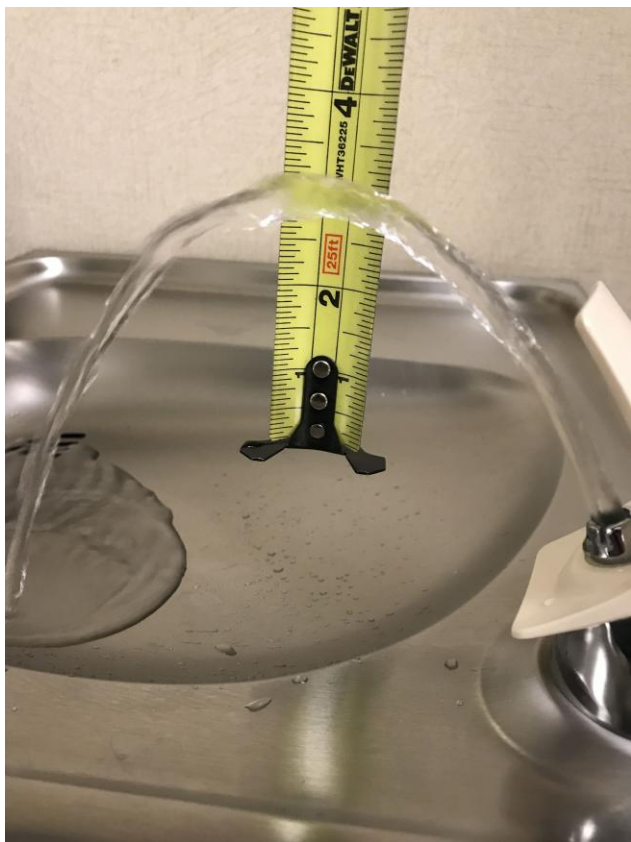
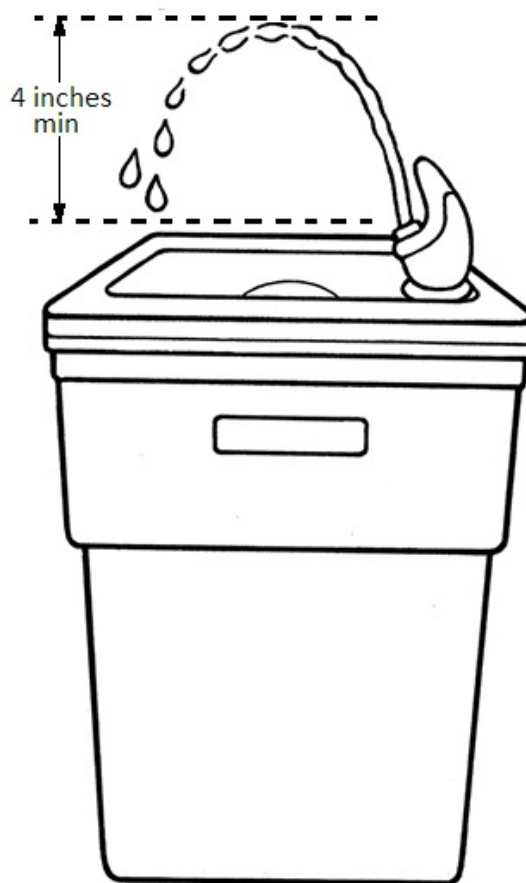
Finding #10 Continued

The water flow from the spout is too low..

2010 ADAS Section 602.6

Water flow 3 inches
high

Adjust water flow pressure to provide water flow 4 inches high minimum.

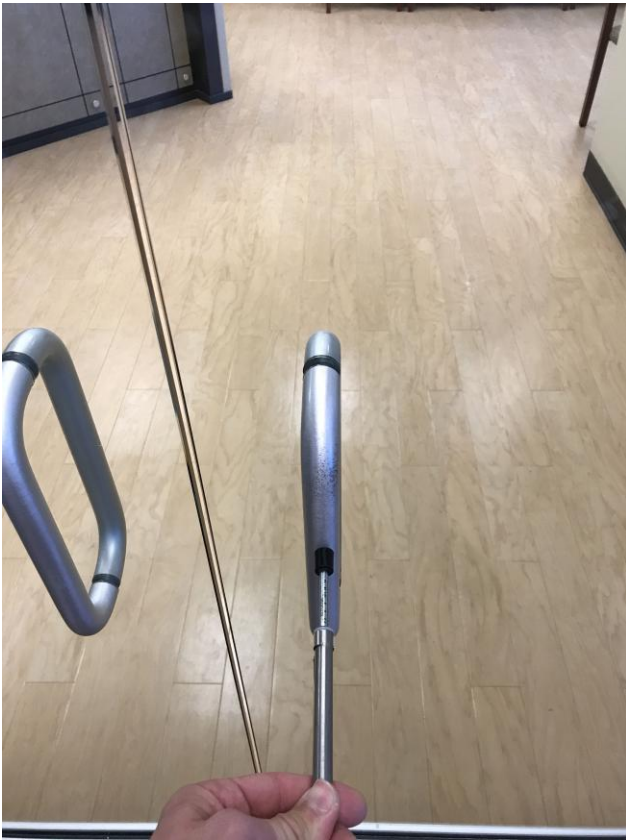
Finding #11 Continued

The door exceeds the maximum pressure to open the door.

2010 ADAS Section 404.2.9

Requires 10 pounds of pressure

Adjust door closer to 5 lbs. of pressure or less.

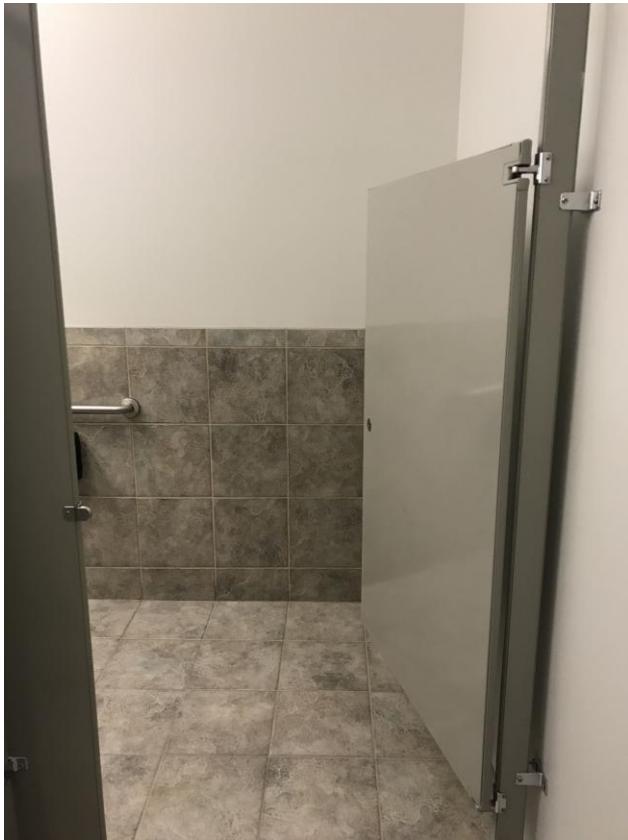
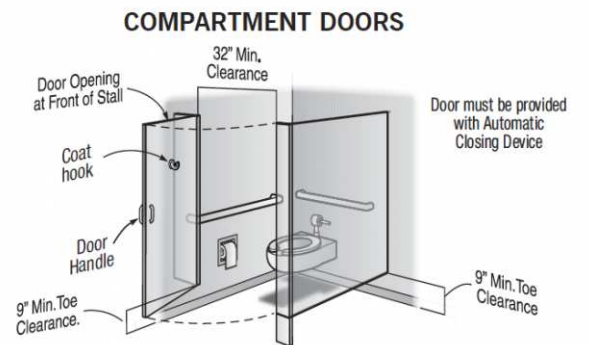
Finding #12 Continued

The compartment door is not self closing.

2010 ADAS Section 604.8.1.2

Compartment door
does not fully close

Adjust or install automatic closing hinges.

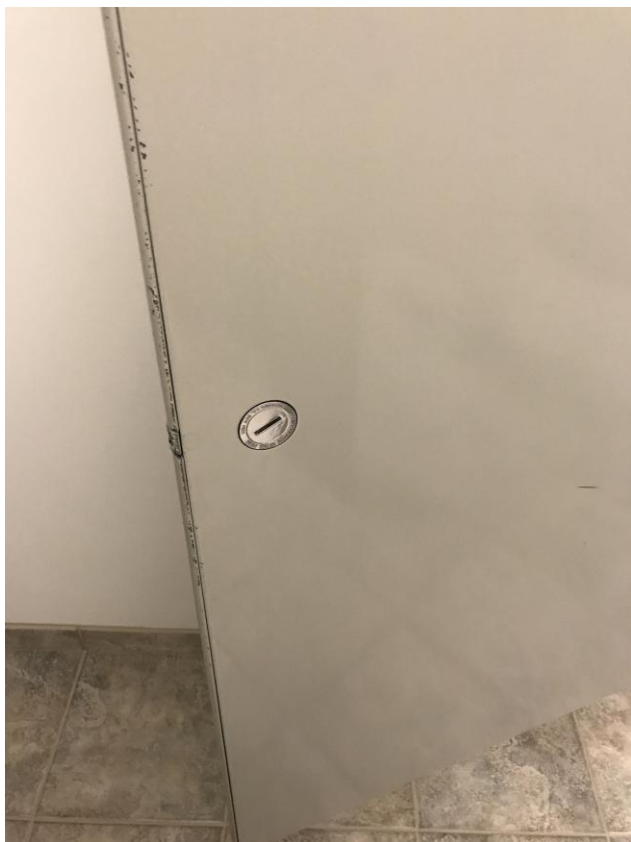
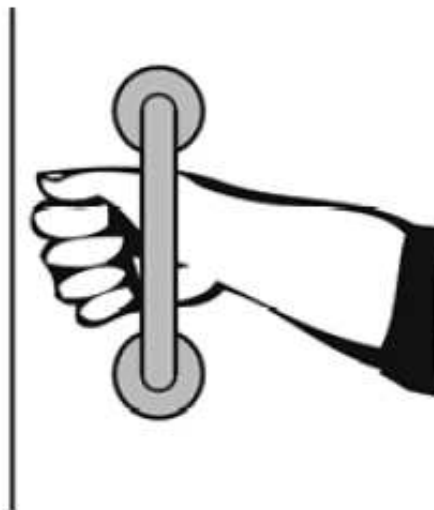
Finding #13 Continued

The water closet compartment door is missing a loop handle.

2010 ADAS Section 604.8.1.2

Missing both loop handles

Install loop or U-shape handles on the inside and outside of the compartment door.

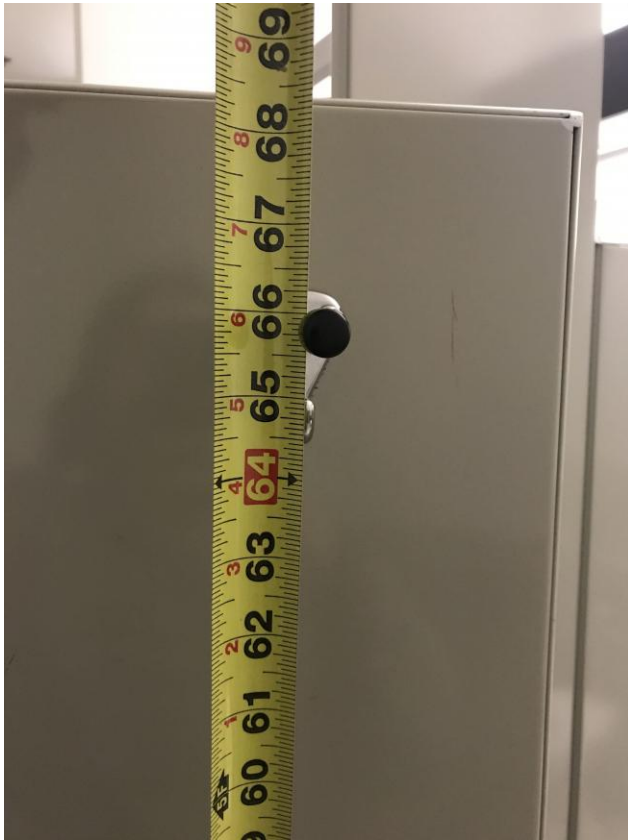
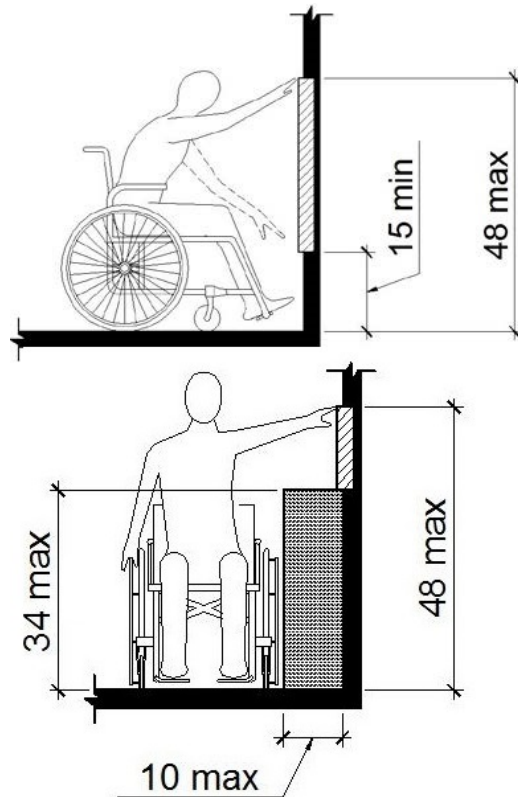
Finding #14 Continued

The coat hook is installed greater than 48 inches above the finished floor.

2010 ADAS Section 308.2.1

65.75 inches above
finished floor

Lower coat hook 19 inches minimum or install another coat hook not to exceed a maximum height of 48 inches above finished floor.

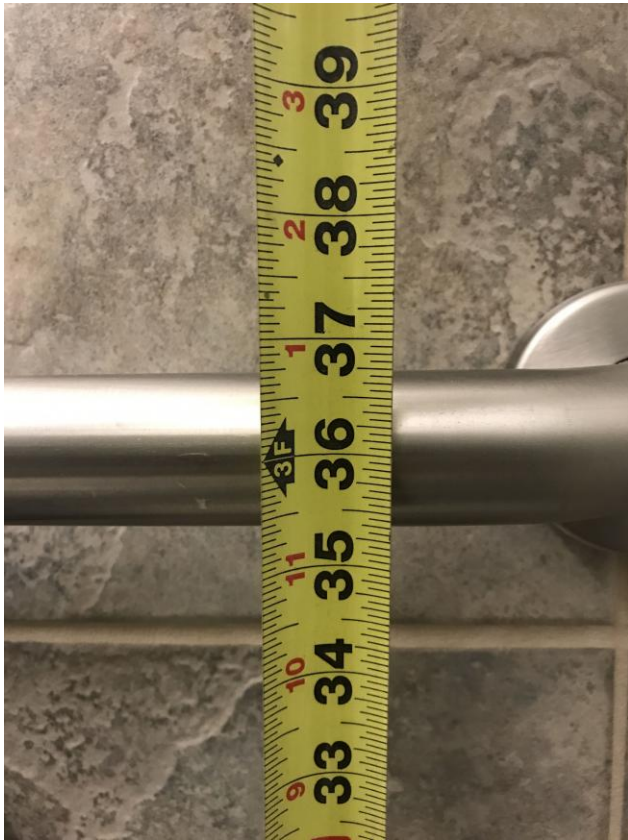
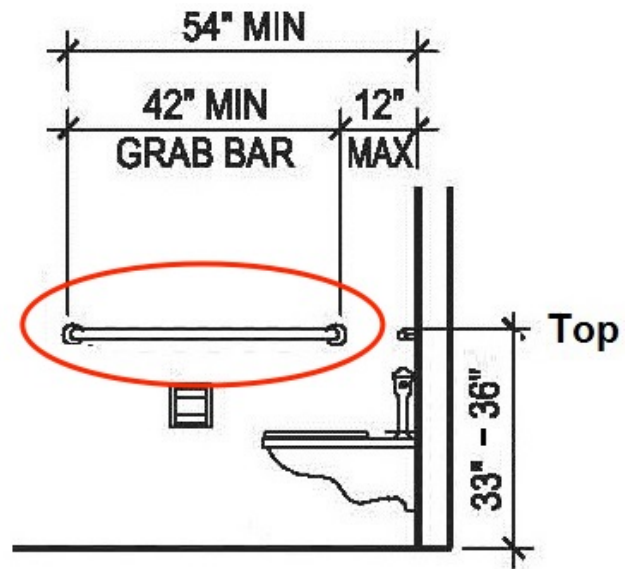
Finding #15 Continued

The side grab bar is too high.

2010 ADAS Section 609.4

36.75 inches above
finished floor

Reposition grab bar in a horizontal position 33 inches minimum and 36 inches maximum above the finished floor measured to the top of the gripping surface.

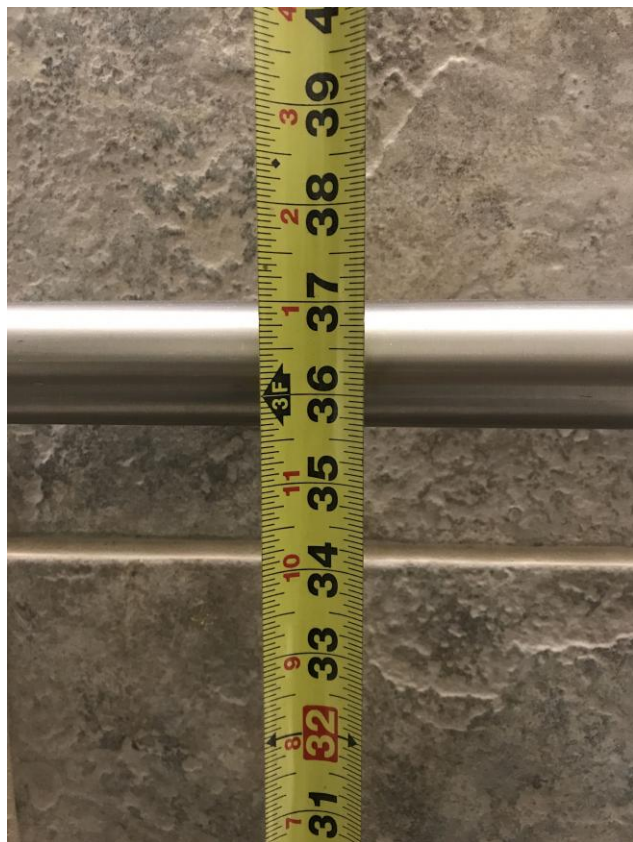
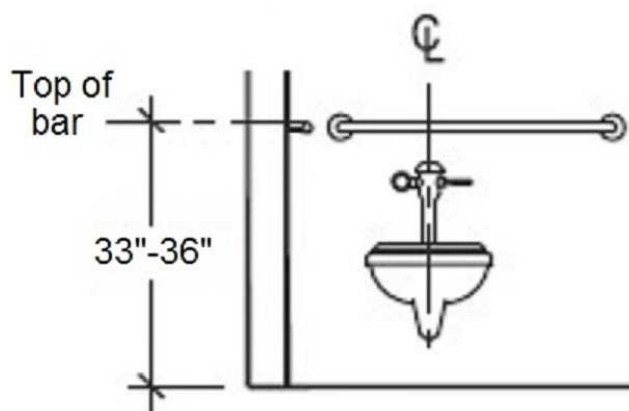
Finding #16 Continued

The rear grab bar is too high.

2010 ADAS Section 609.4

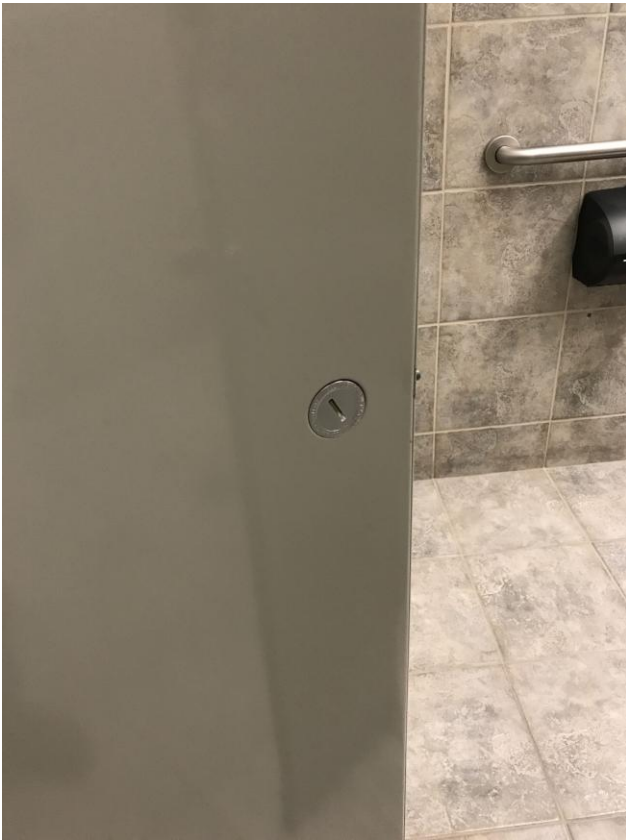
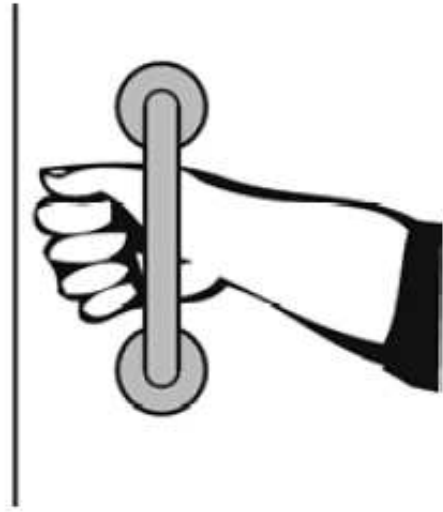
Finding #23 Continued

The water closet compartment door is missing a loop handle.

Missing both loop handles
