# **Site Accessibility Evaluation**

# 2948 E Fountain Blvd Colorado Springs, CO 80910

Accessibility Evaluation

Inspection Date: 08/23/2019 Inspector: David Mejia

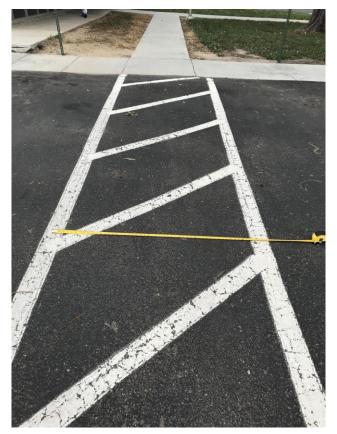
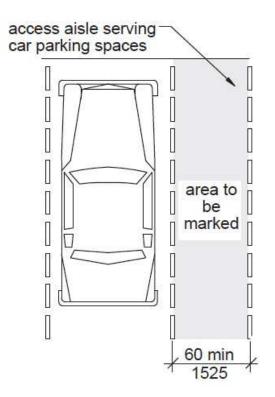
# Finding #1 Continued

The access aisle is not a minimum 5 feet wide.

A accessible parking stall's access aisle must be a minimum of 5 feet wide measured from centerline to centerline.

2010 ADAS Section 502.3.1 Access aisles serving car and van parking spaces shall be 60 inches (1525 mm) wide minimum.

52.5 inches in width

Re-stripe access aisle and ensure a 60 inch minimum measured to the centerline of the paint stripe.

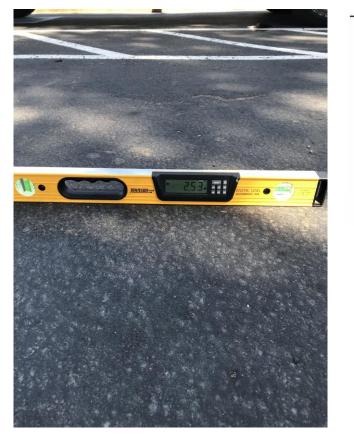
Finding 297756 Main Photo

The running slope (long dimension) of the accessible parking stall exceeds 2%.

The running slope in an accessible parking stall and the access aisle must not exceed 2%.

2010 ADAS Section 502.4

Van parking stall at 2.18 - 3.14 % running slope

Re-pave and re-stripe 2 parking stalls and 1 access aisle ensuring running slope does NOT exceed 2% (1:48).

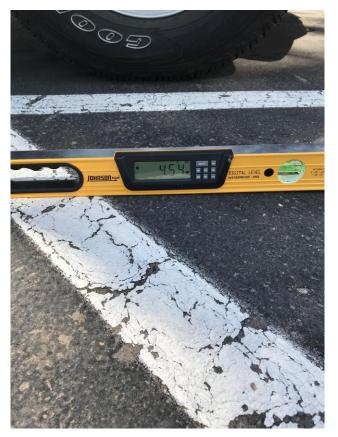
Finding 297757 Main Photo

The running slope (long dimension) of the access isle exceeds 2%.

The running slope in an accessible parking stall and the access aisle must not exceed 2%.

2010 ADAS Section 502.4

Running slope of access aisle between 2.14% and 4.54%

Re-pave and re-stripe 2 parking stalls and 1 access aisle ensuring running slope does NOT exceed 2% (1:48).

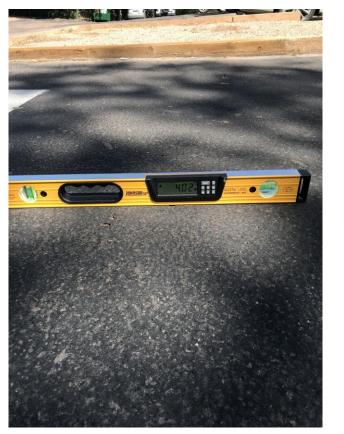
Finding 297758 Main Photo

The running slope (long dimension) of the accessible parking stall exceeds 2%.

The running slope in an accessible parking stall and the access aisle must not exceed 2%.

2010 ADAS Section 502.4

Accessible parking stall running slope between 3.14% - 4.00%

Re-pave and re-stripe 2 parking stalls and 1 access aisle ensuring running slope does NOT exceed 2% (1:48).

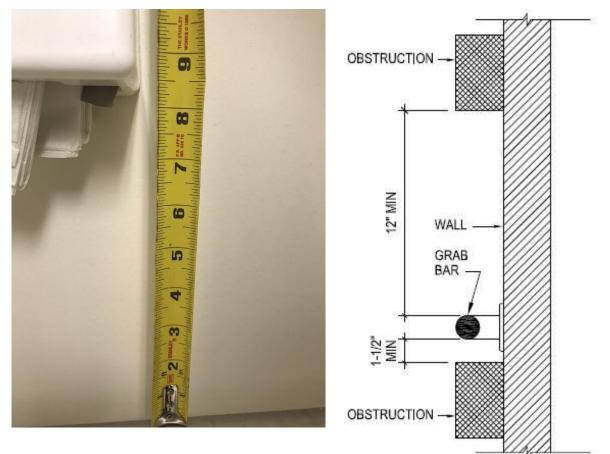
# Finding #5 Continued

The toilet seat cover dispenser is mounted too close to the top of the grab bar, minimizing the gripping surface.

#### 2010 ADAS Section 609.3

8.5 inches above rear grab bar

Relocate seat cover dispenser to have operable part between 15 inches minimum and 48 inches maximum above floor. May require relocation below rear or side grab bar at 1.5 inches minimum clearance below grab bar to meet compliance.

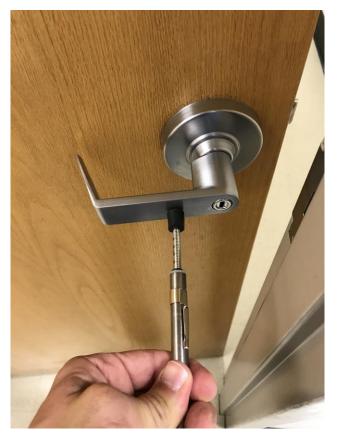
# Finding #6 Continued

The door exceeds the maximum pressure to open the door.

Interior doors shall have a maximum opening force of 5 pounds.

#### 2010 ADAS Section 404.2.9

Requires 9 lbs of pressure

Adjust door closer to 5 lbs of pressure or less.

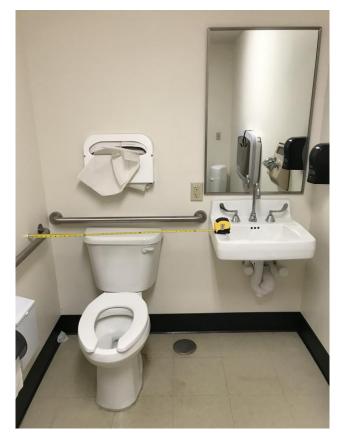
# Finding #7 Continued

The lavatory projects into the clear floor space required for the toilet.

The clear floor space is 60 inches along the back wall by 56 inches.

#### 2010 ADAS Section 604.3.2

Lavatory projects into the required clear floor space of the toilet

Pre-existing condition. In future renovation/remodel, ensure water closet minimum required clear floor space of 60 inches in width x 59 inches in depth is not obstructed by lavatory or other fixtures.

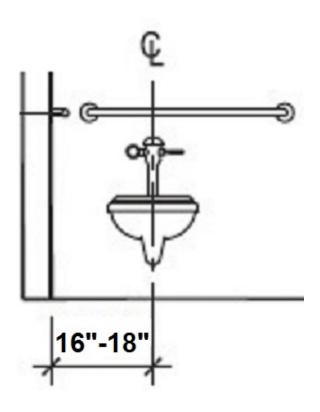
# Finding #8 Continued

The toilet is not located within the range allowed from the side wall or partition.

The centerline of the toilet must be 16 to 18 inches from the side wall.

#### 2010 ADAS Section 604.2

19 inches from the side wall

Adjust toilet to measure between 16 inches minimum and 18 inches maximum from side wall.

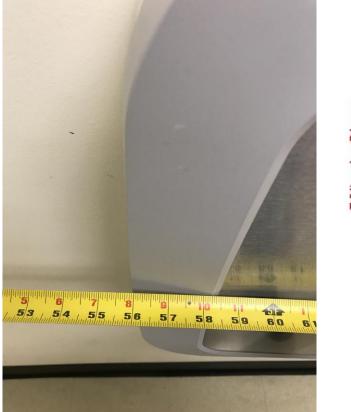
# Finding #9 Continued

The clear floor space around the toilet is obstructed by the baby changing station.

No fixtures are allowed in the clear floor space required for the toilet.

#### 2010 ADAS Section 604.3.2

Baby changing station protrudes 4 inches into required clear floor space of toilet

Reposition baby changing station 4 inches minimum away from the required clear floor space of the toilet.

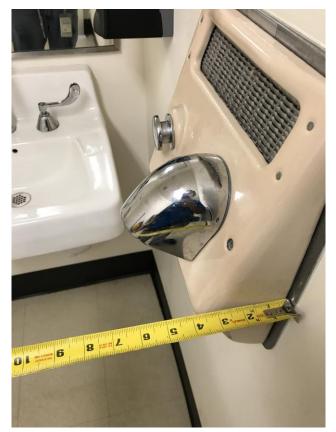
# Finding #10 Continued

The lavatory's clear floor space is obstructed by the hand dryer.

The wall mounted hand dryer projects 6 inches from the wall and encroaches into the required 30 inches by 48 inches clear floor space.

2010 ADAS Section 606.2 A clear floor space complying with 305, positioned for a forward approach, and knee and toe clearance complying with 306 shall be provided.

Hand dryer projects into lavatory's clear floor space

Remove hand dryer due to protruding into the required clear floor space of the lavatory. Also, a paper towel dispenser already exists.

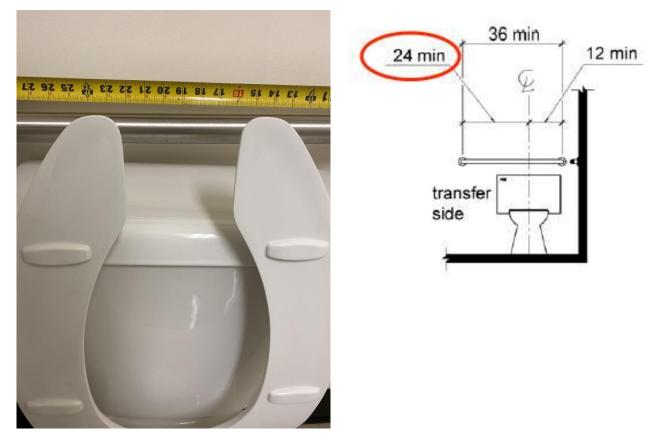
Finding 299523 Main Photo

The rear grab bar does not extend adequately past the toilet on the wide side.

The rear grab bar must be a minimum of 36 inches long and extend from the centerline of the toilet 12 inches minimum on wall side and 24 inches minimum on the wide side.

The rear wall grab bar shall be 36 inches (915 mm) long minimum and extend from the centerline of the water closet 12 inches (305 mm) minimum on one side and 24 inches (610 mm) minimum on the other side.

19 inches from center of toilet

Re-position rear grab bar to extend 12 inches minimum on wall side and 24 inches minimum on the transfer side measured from the centerline of the toilet.

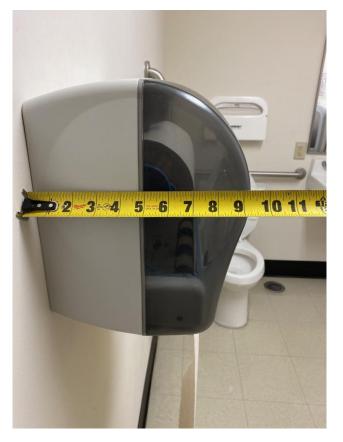
Finding 299524 Main Photo

The paper towel dispenser's operation mechanism is too high off the floor.

Dispensers must have all operable parts a maximum of 48 inches above the floor.

2010 ADAS Section 308.2.1

Paper towel dispenser protrudes 9.5 inches into circulation path

Remove paper towel dispenser as it protrudes more than 4 inches from wall and could potentially be a safety hazard. Also, there is an electric hand dryer installed near the lavatory.

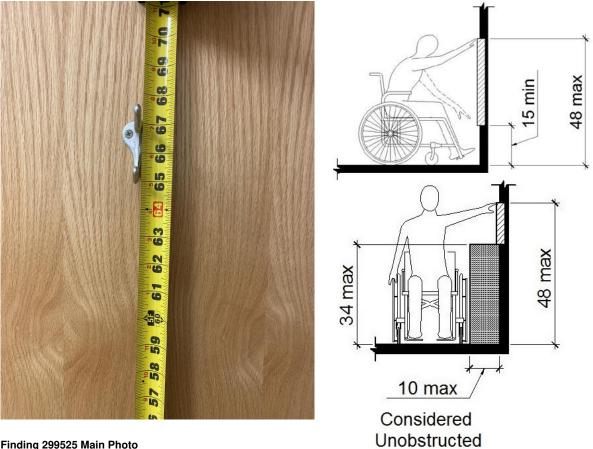
Finding 299525 Main Photo

The coat hook is installed greater than 48 inches above the finished floor.

Where a forward reach is unobstructed, the high forward reach shall be 48 inches maximum above the finished floor.

#### 2010 ADAS Section 308.2.1

Coat hook at 66 inches above finish floor

Lower coat hook 20 inches minimum or install another coat hook not to exceed a maximum height of 48 inches above finished floor.

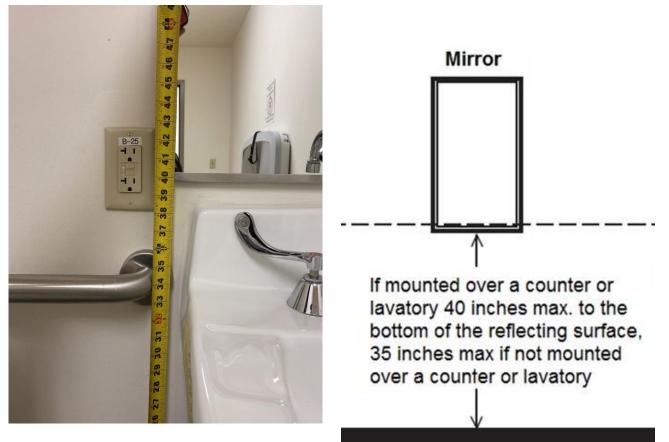
Finding 299526 Main Photo

The mirror is mounted too high.

Mirrors must have the bottom edge of the reflecting surface a maximum of 40 inches above the floor if above a sink or counter. Mirrors not located above lavatories or countertops shall be installed with the bottom edge of the reflecting surface 35 inches maximum above the finish floor or ground.

#### 2010 ADAS Section 603.3

Mirror height at 40.25 inches above finished floor

Lower mirror to a maximum of 40 inches above finished floor measured to the bottom edge of the reflective surface. Recommend lowering mirror 1 inch.

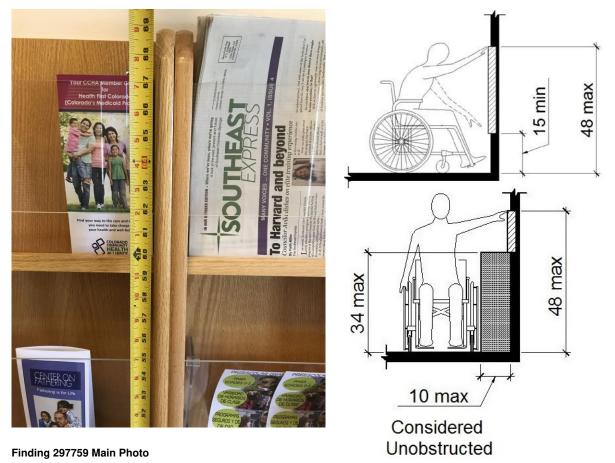
# Finding #15 Continued

The informational shelf is positioned too high for either a side or front approach.

#### 2010 ADAS Section 308.2.1

#### 2010 ADAS Section 308.3.1

Top shelf brochures at 68 inches above finished floor

Lower informational shelf to provide access to brochures or reconfigure brochures to ensure a reach range of no more that 48 inches above finished floor.

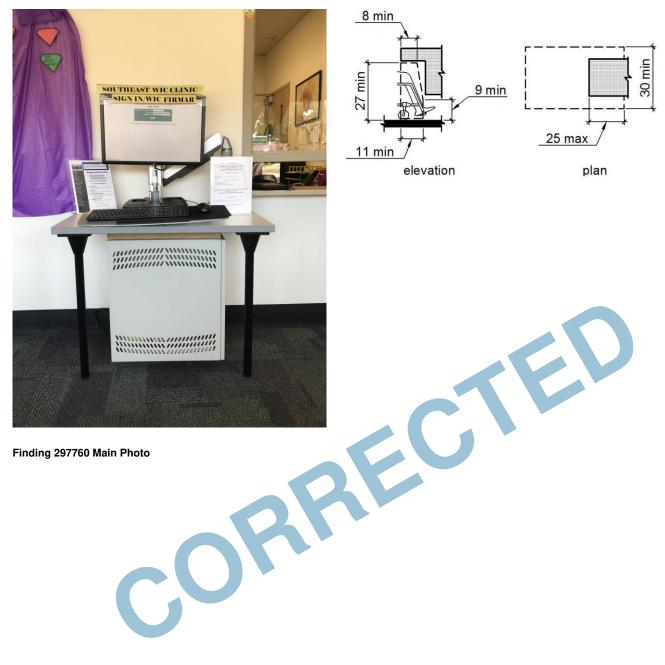
# Finding #16 Continued

The knee clearance not compliant.

The knee clearance shall be 11 inches deep minimum at 9 inches above the finish floor or ground, and 8 inches deep minimum at 27 inches above the finish floor or ground and 30 inches wide minimum.

#### 2010 ADAS Section 306.3.3

No knee or toe clearance provided underneath desk

Move computer to the side of desk to provide knee clearance underneath desk.
