# Site Accessibility Evaluation

## Americans with Disabilities Act Title II (Public Services: State and Local Government)

### **Widefield Park**

**Accessibility Evaluation**

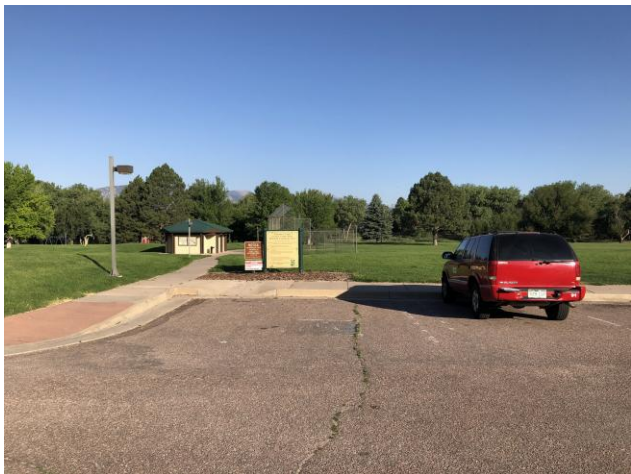
Finding 174004 Main Photo

There are not enough accessible stalls

There are 0 accessible parking stalls including 0 designated for a van.

There should be a minimum of 2 accessible parking stalls including a minimum of 1 van accessible stalls.

No accessible parking stalls

Repave and re-stripe parking lot to provide accessible parking stalls, access aisle connecting to main path of travel and install parking signs with the international symbol of accessibility.

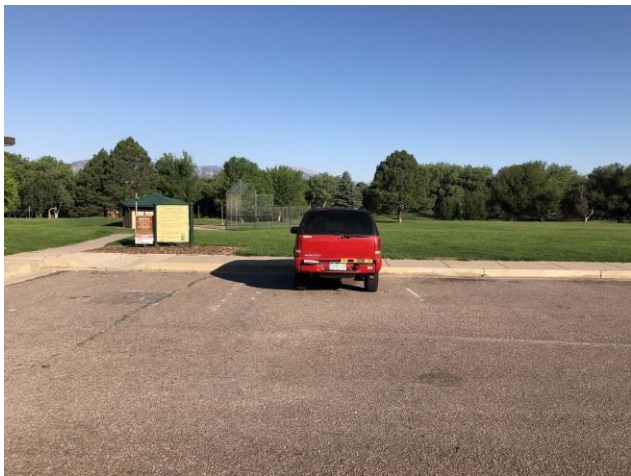
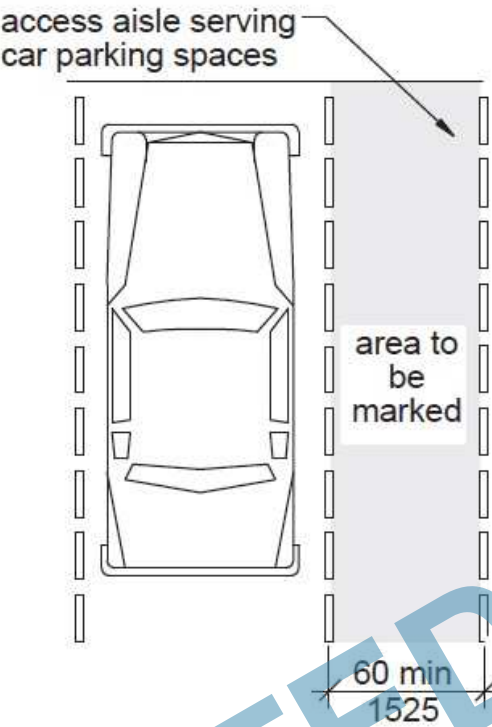
Finding 174005 Main Photo

The access aisle is missing at the accessible parking stall.

No accessible aisle

Stripe access aisle in between 2 accessible parking stalls.

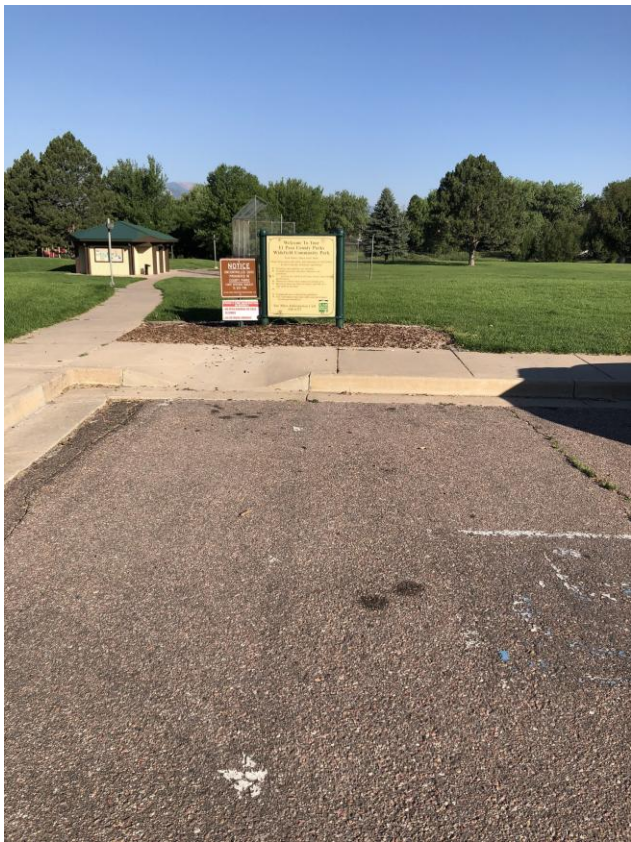
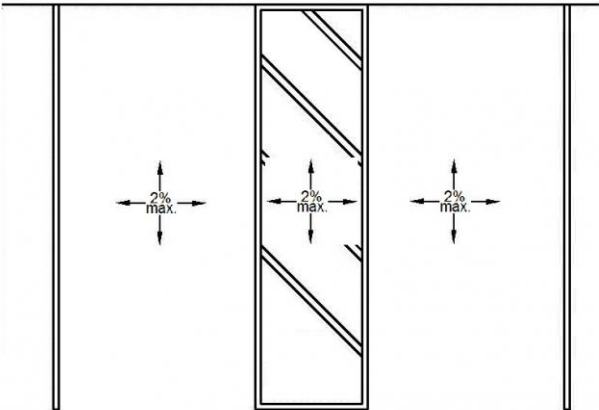
Finding 174006 Main Photo

The access aisle for the accessible parking stall contains a built up curb ramp which results in significant slopes greater than 2 percent.

No curb ramp into accessible route

Remove existing curb ramp and build new curb ramp in line with new access aisle to meet 2010 ADA standards.

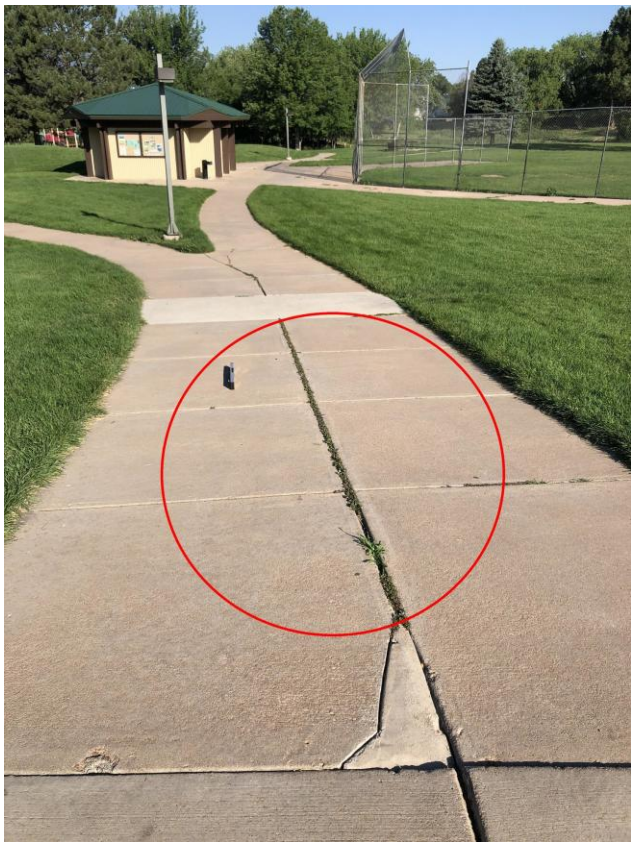
Finding 174007 Main Photo

The accessible route between the public bathrooms entrances and the accessible parking on the site contains running slopes greater than 5% and has not been constructed as a ramp (i.e. handrails, wheel guides, etc.).

Certain sections of circulation path up to 8.66% running slope 50ft from parking lot sidewalk

Level path of travel to 5% maximum to meet current ADA standards.

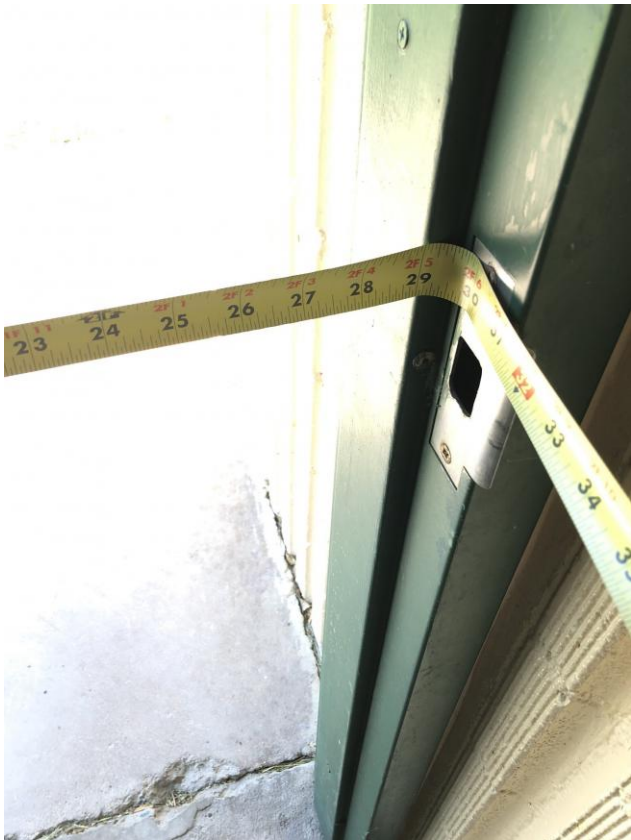
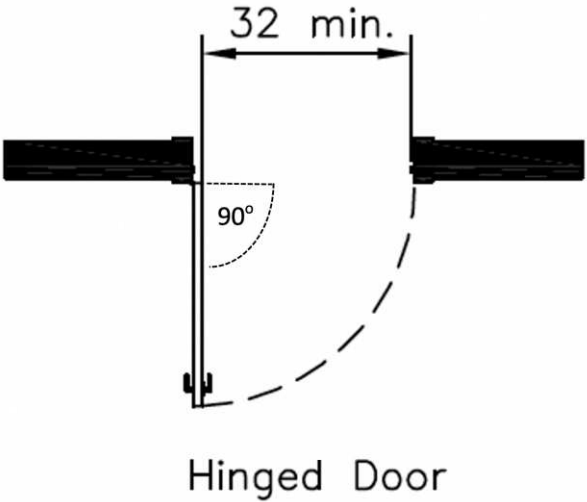
Finding 174008 Main Photo

The door opening does not provide at least 32 inches between the face of the door and the opposite stop.

29 inches opening  
width

Reconfigure door opening to meet compliance. Due to the existing and type of structure, it may be structurally infeasible.

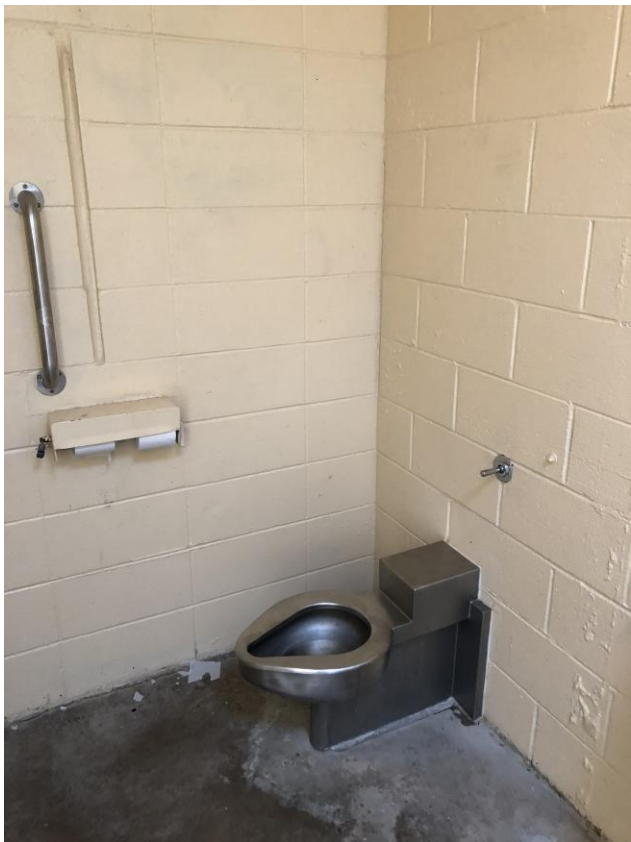
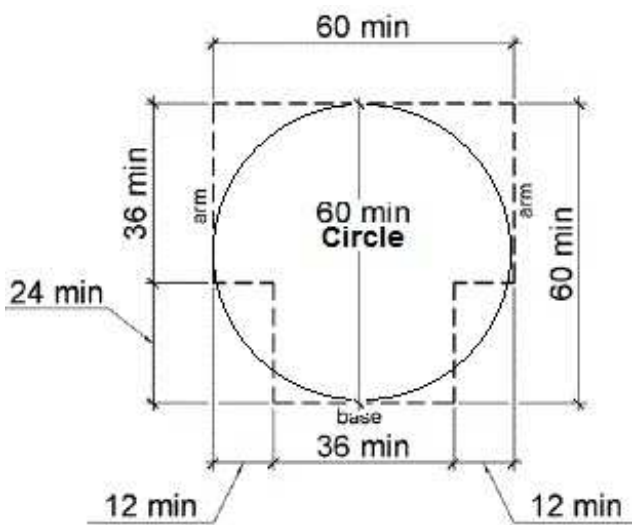
Finding 174086 Main Photo

Compliant turning space has not been provided.

54 inches in diameter

Alter toilet, urinal and lavatory to ensure a 60 inch radius is provided.

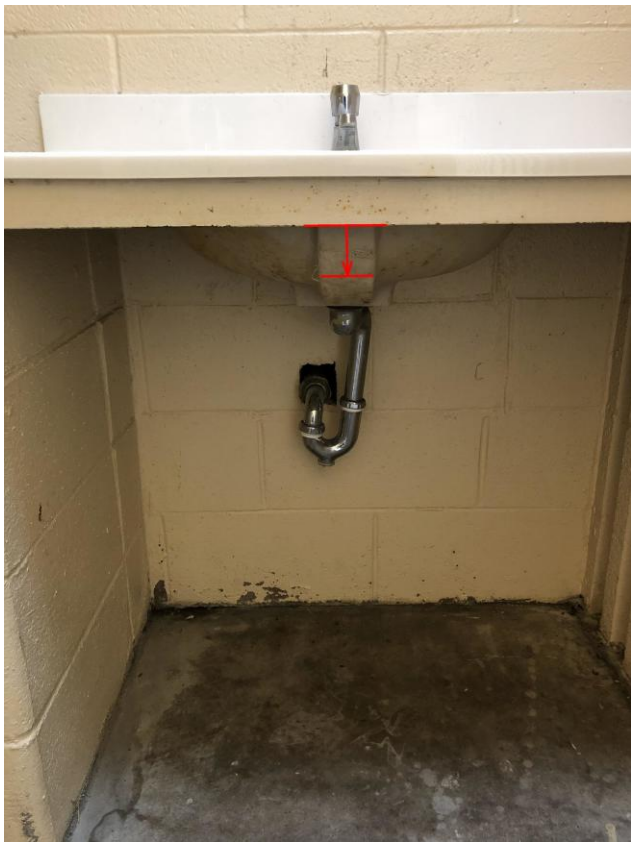
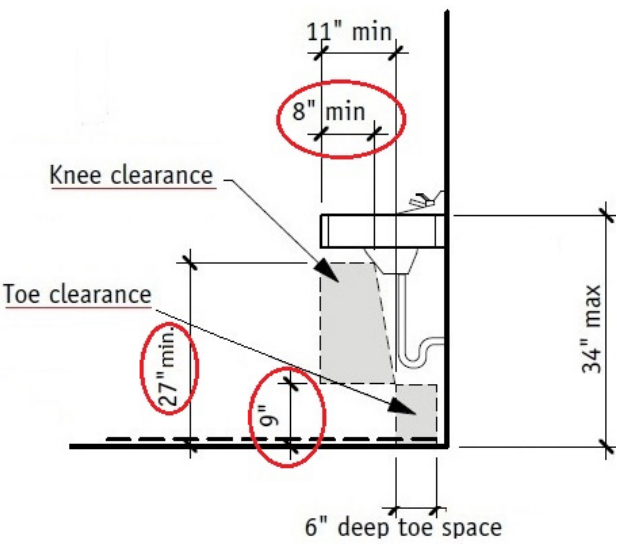
Finding 174144 Main Photo

The apron at the sink projects too low to the floor.

Measures only 4 inches back from the front edge

Replace lavatory with one that provides a minimum height from the bottom edge of no less than 27 inches above finished floor and 8 inches minimum in depth for knee clearance.

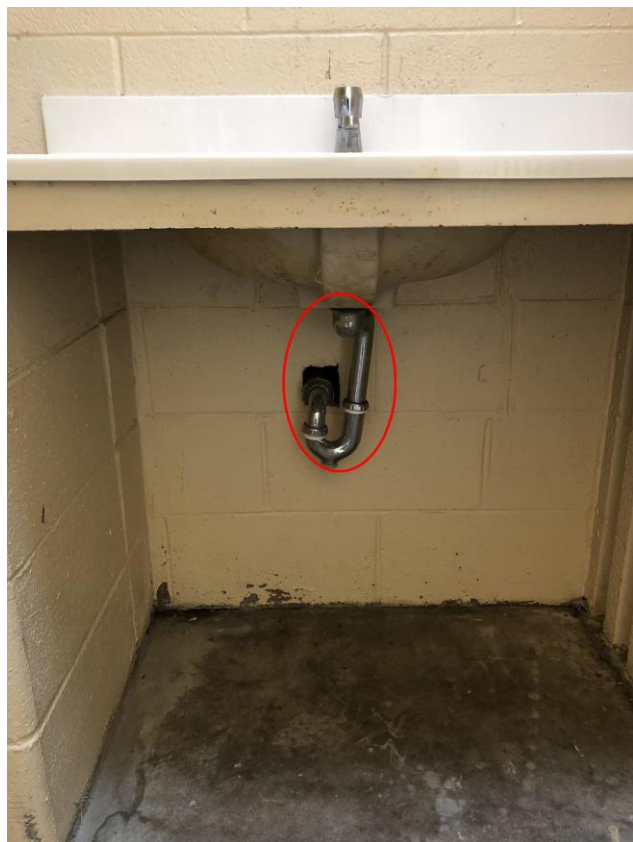
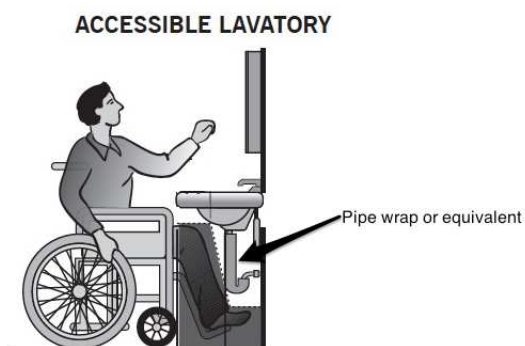
Finding 174163 Main Photo

The water and drain pipes under the lavatory are not adequately insulated.

Drain pipes not insulated

Insulate drain pipes underneath lavatory.

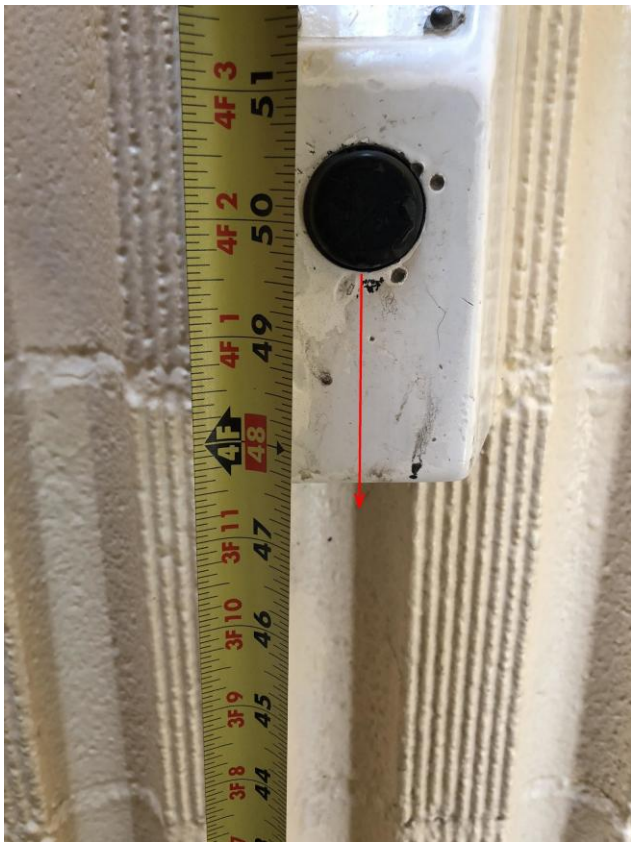
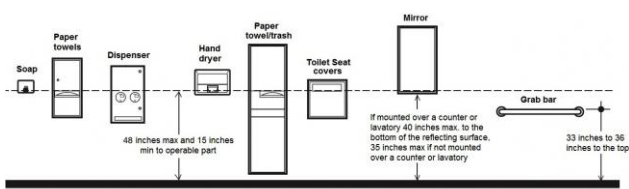
Finding 174549 Main Photo

The hand dryer dispenser's operation mechanism is too high off the floor.

50.5 inches from the ground

Lower hand dryer 3 to 4 inches to meet compliance. 48 inches maximum height above finished floor for operable parts (sensor).

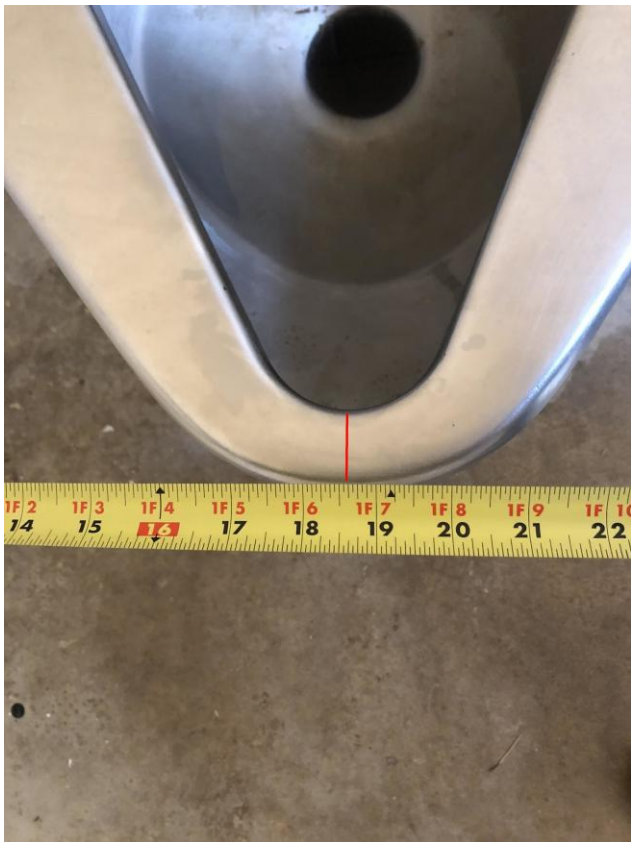
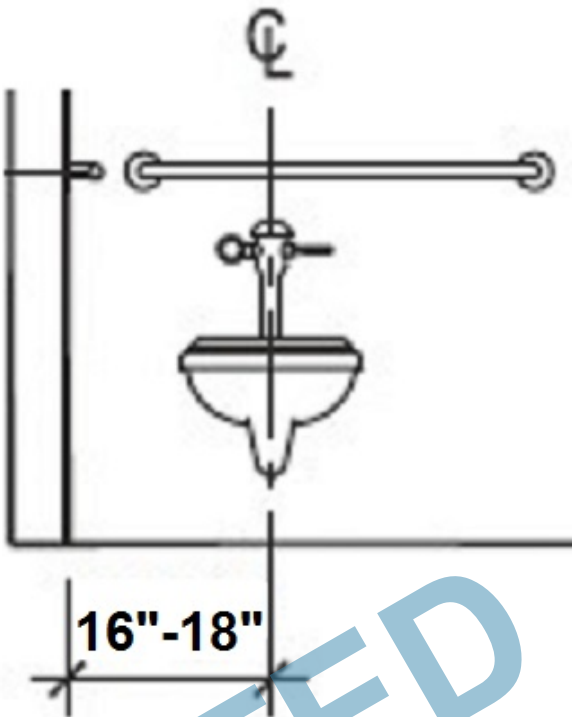
Finding 174559 Main Photo

The toilet is not located within the range allowed from the side wall or partition.

18.5 inches from side wall

Re-position toilet between 16 inches minimum and 18 inches maximum from centerline of toilet to side wall. May require plumbing alteration.

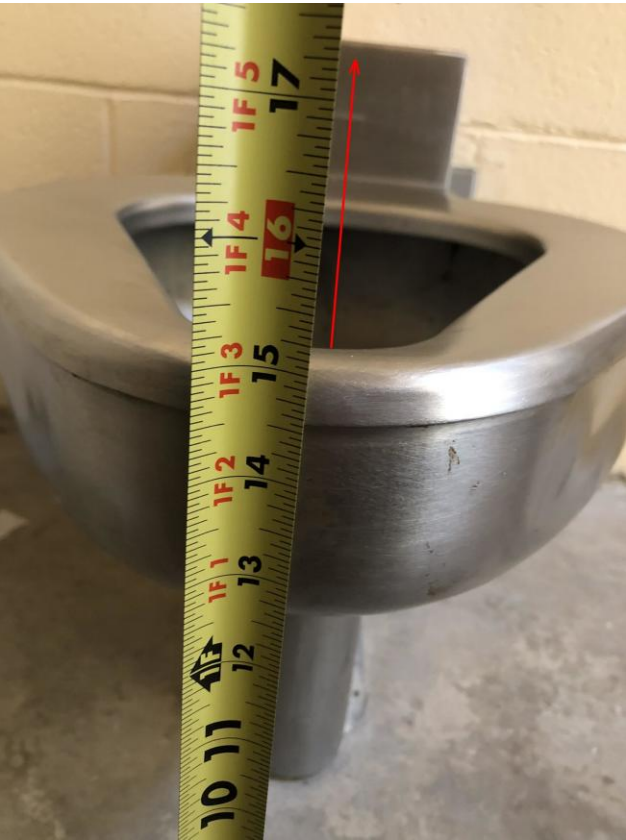
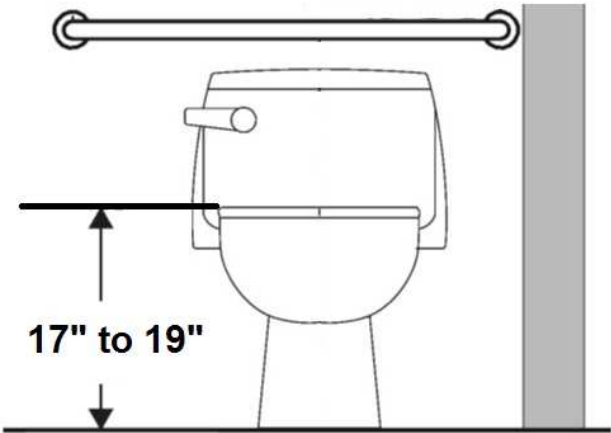
Finding 174571 Main Photo

The toilet seat is not located within the range allowed off the floor.

15 inches

Adjust toilet height, replace toilet or replace toilet seat with one that will meet the minimum height of 17 inches but no more than maximum height of 19 inches.

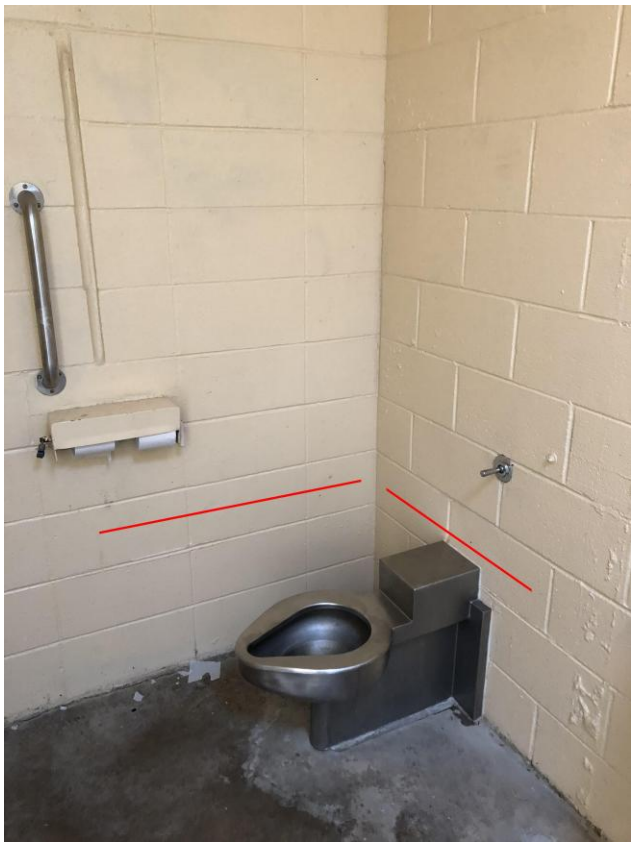
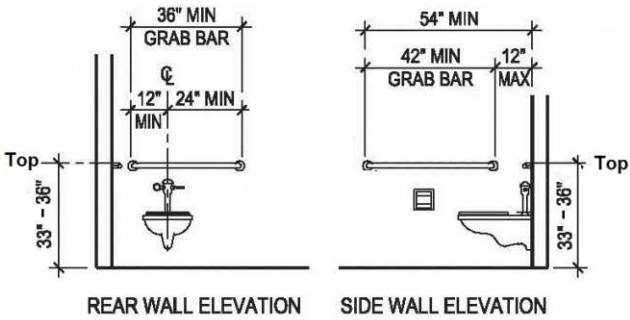
Finding 174578 Main Photo

Accessible toilets must have grab bars installed.

Missing grab bars

Install 1 side and 1 rear grab bar at 36 inches maximum above finished floor measured to the top of the gripping surface. Please see finding details for compliant measurements.

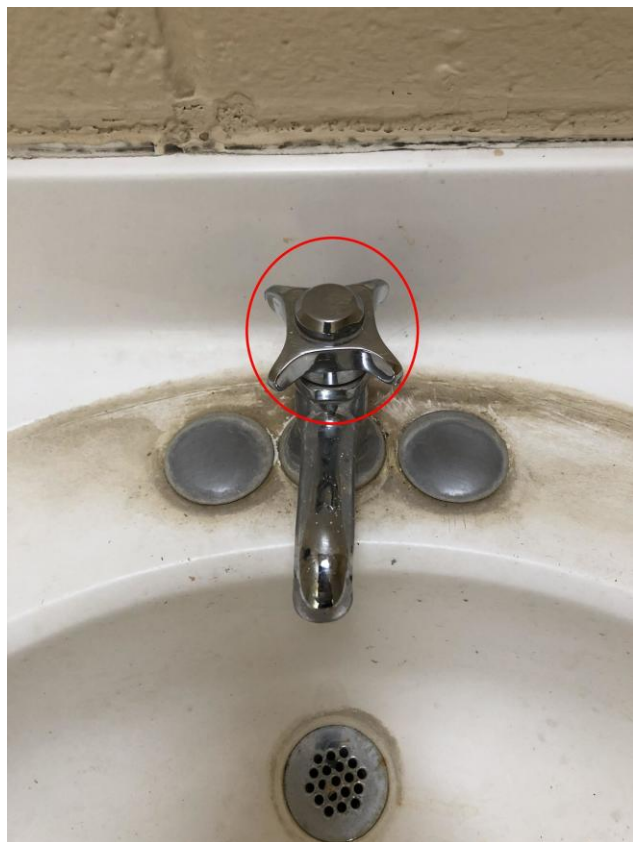
Finding 174236 Main Photo

The faucet controls require twisting of the wrist.

Faucet controls  
require tight grasping  
and twisting of the  
wrist

Install lever type faucet controls that do not require tight grasping, pinching or twisting of the wrist.

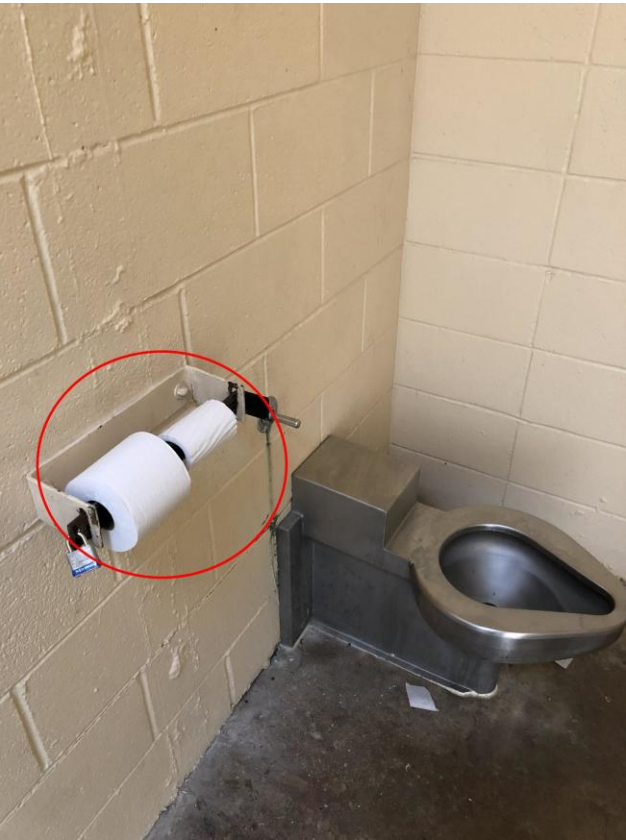
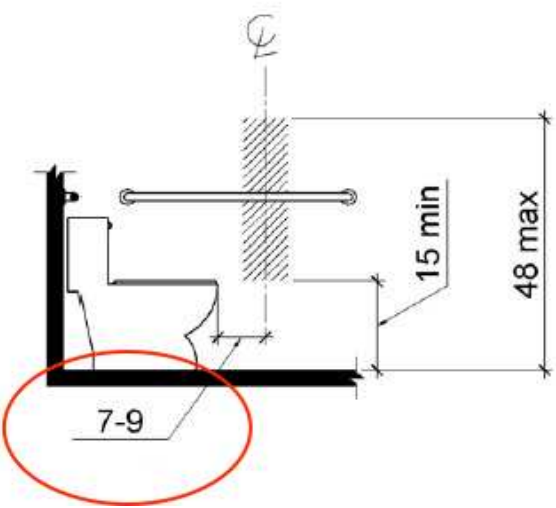
Finding 174582 Main Photo

The toilet paper is not installed within the compliant range.

Rear wall

Relocate and ensure toilet paper dispenser is between 7 inches minimum to 9 inches maximum in front of water closet measured to centerline of the dispenser. If toilet paper dispenser is installed above side grab bar ensure there is 12 inches of clearance minimum above side grab bar but no more than 48 inches in height measured from the floor to the center of the paper roll. If installed below grab bar ensure there is 1.5 inches clearance minimum but no less than 15 inches in height measured from the floor to the center of the paper roll.

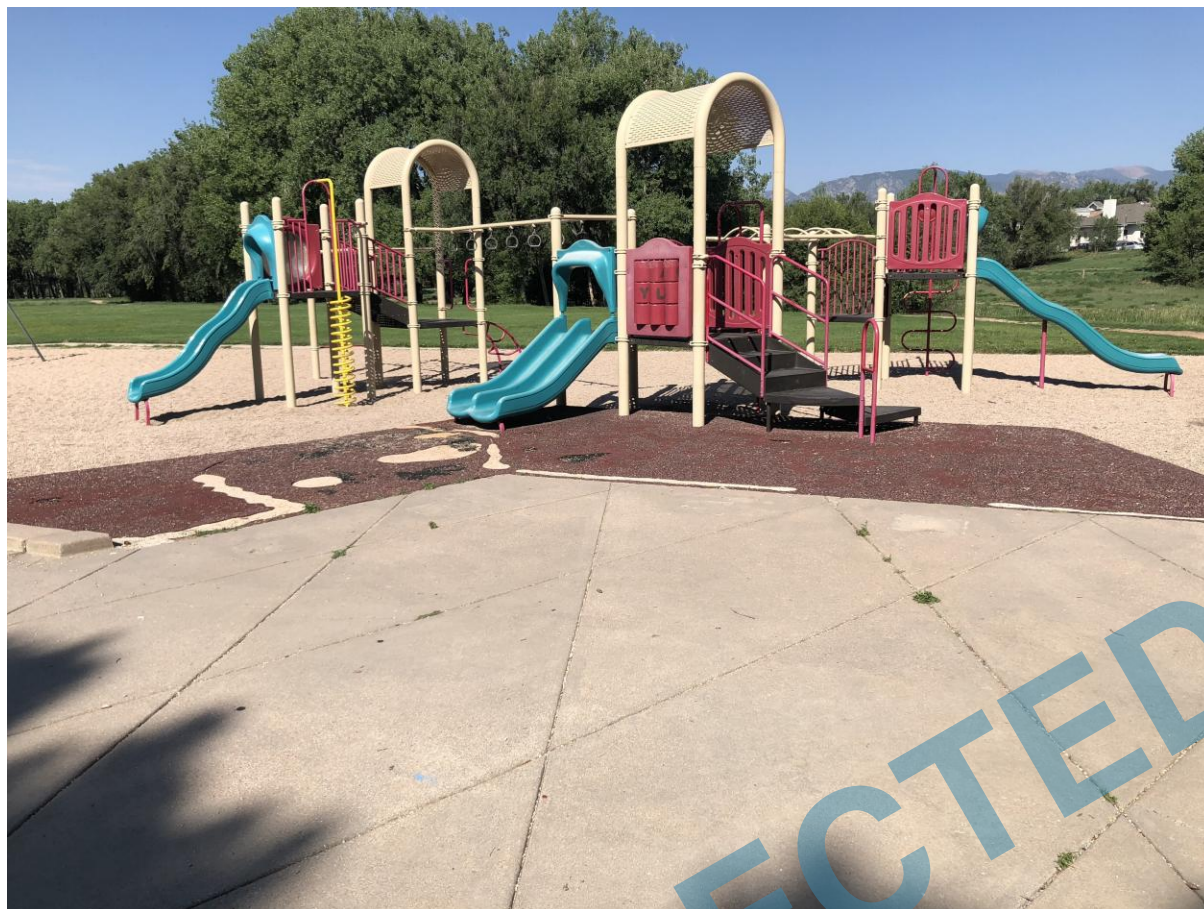
Finding 174688 Main Photo

There are not enough accessible elevated play components.

Only 2 elevated play components are on an accessible route

Ensure access to 50% of the elevated play components are on an accessible route and/or transfer system.

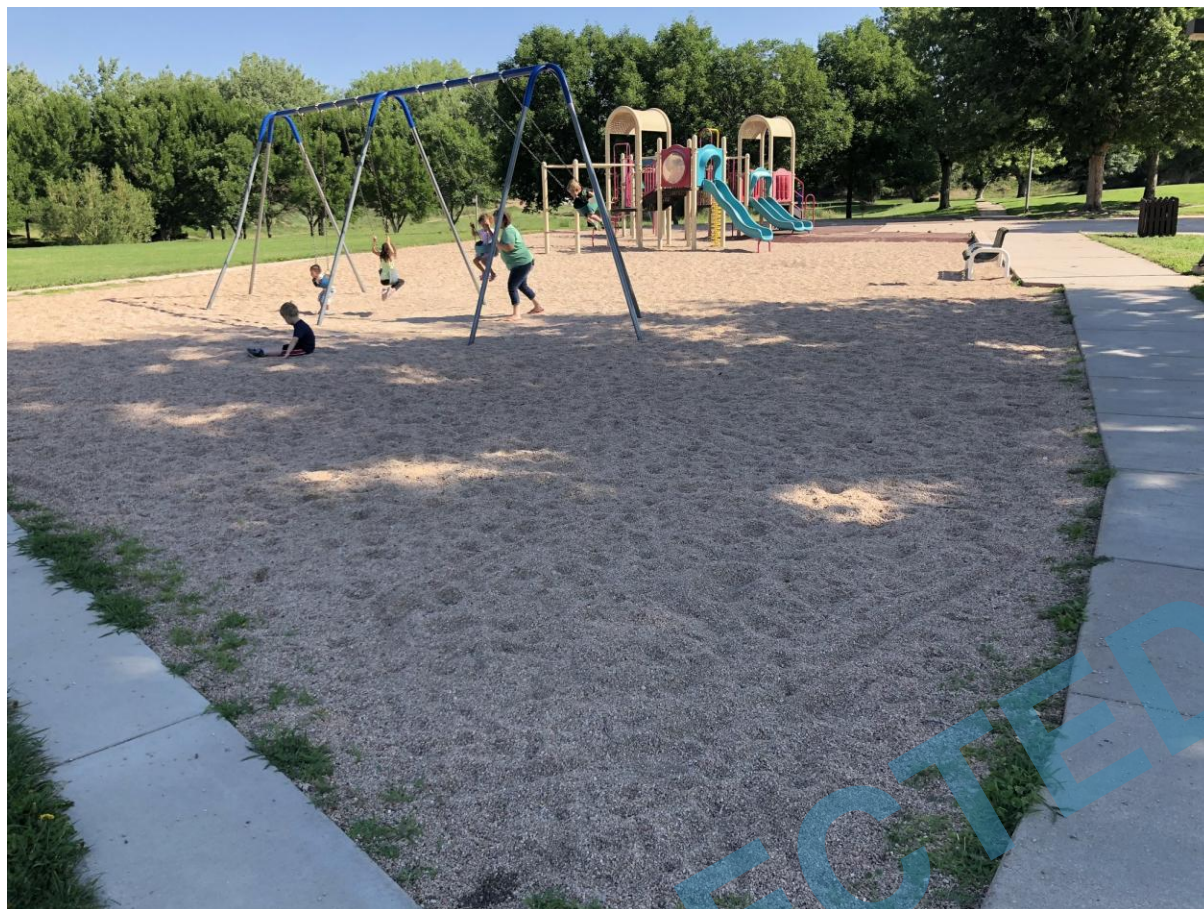
**Finding 174690 Main Photo**

A minimum of one of each type of ground level play components is not on an accessible route.

No accessible route  
ground level play  
components
