# **Site Accessibility Evaluation**

**Costilla Parking Garage**

50 E Costilla St **Colorado Springs, CO** 80903

**Accessibility Evaluation**

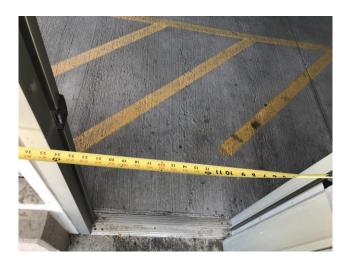
Finding 297249 Main Photo

The door opening does not provide at least 32 inches between the face of the door and the opposite stop.

2010 ADAS Section: 404.2.3 25.25 inches in width.

Door located on northeast corner of Tejon and Costilla

Hinged Door

Install door frame and door that provides a minimum width of 32 inches. Projections into the clear opening width between 34 inches and 80 inches above the finish floor or ground shall not exceed 4 inches.

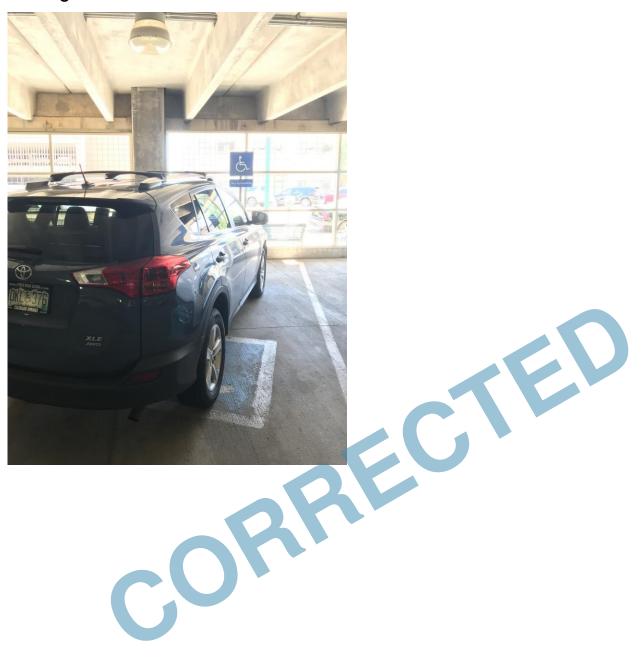
## 4th Floor Accessible Parking Stall/s

Replace all accessible parking stalls signage (ADA).

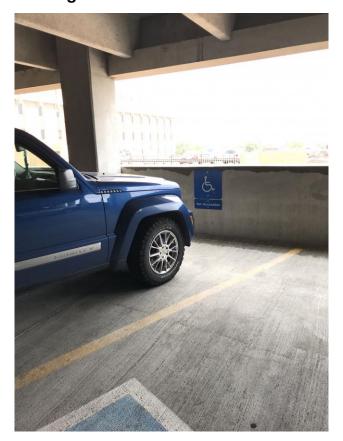
Finding 297287 Main Photo

The access aisle is on the driver's side of the stall.

2010 ADAS Section: 502.3.4 Access aisle on

driver's side (angled

parking stall)

Remove "van accessible" signage from 2nd stall. Van access aisles must be on passenger side for angled parking stalls.
