**Re: Fox Run Regional Park Playground Audits,
Oak Meadows and Pine Meadows**

Oak Meadows Playground

Pine Meadows Playground

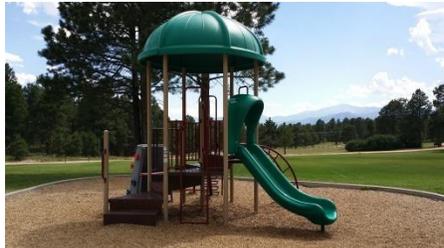
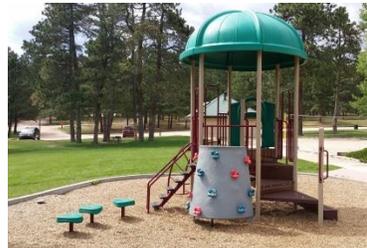
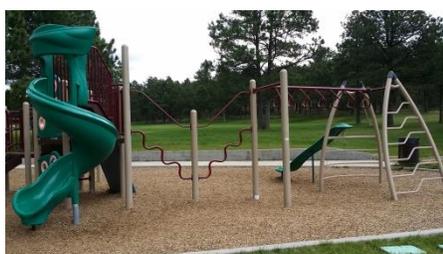
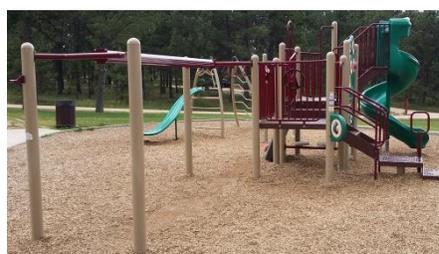
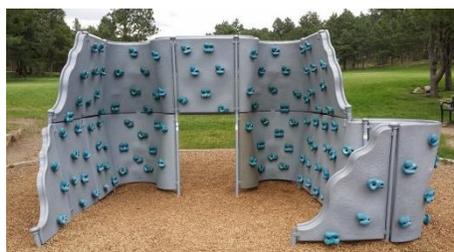
This playground has three separate play areas near to each other. One area has a small composite structure designed for children 2 to 5 years of age, the second area has a composite structure for 5 to 12 years of age, and the third area has a freestanding rock climbing structure. All are manufactured by GameTime. The safety surfacing material is engineered wood fiber, contained by concrete borders.

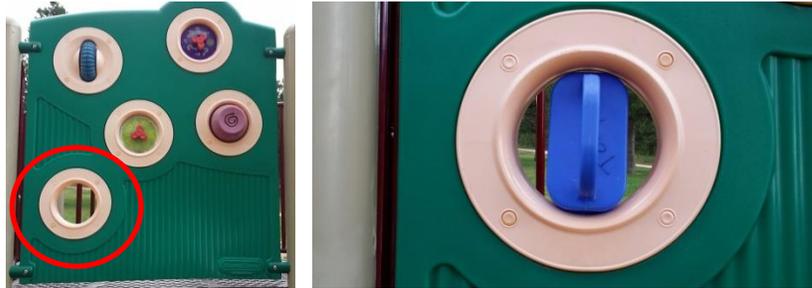
1. If not already developed, the owner of this play equipment should add this to their maintenance responsibilities.
2. There is a play component missing from a play panel on the 5-12 composite structure which allows the torso probe to pass through but not the head probe. This creates a head entrapment hazard.

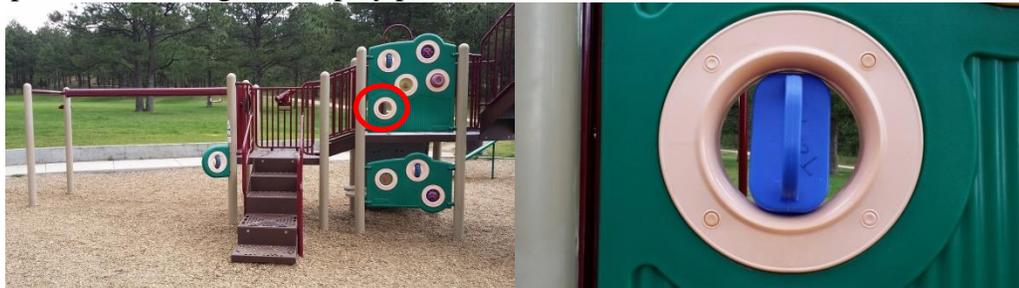
1. One head entrapment hazard exists on the 5-12 composite structure where a play component is missing from a play panel.

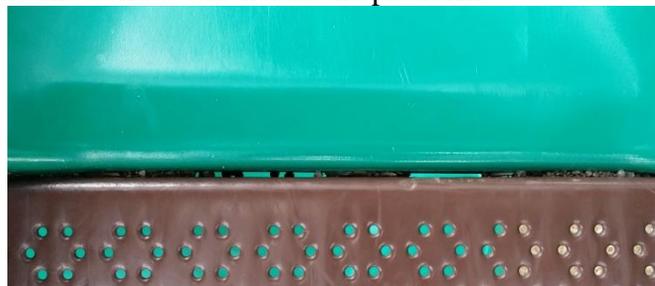
1. Slides should not have any spaces or gaps that could trap strings, clothing, etc. between the platform and the start of the slide chute (CPSC 5.3.6.2). The spiral slide has a gap at the top where the slide chute attaches to the platform.

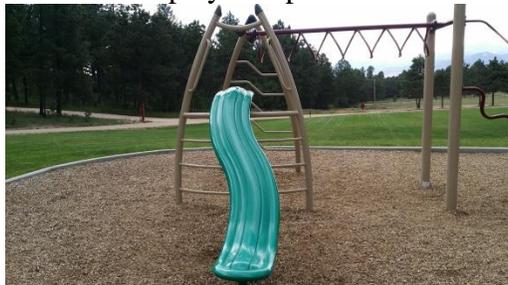
1. This glider slide does not meet ASTM standards applicable to slides. CPSC has issued a recall to other play equipment manufactures due to multiple injuries. Other play equipment manufacturers have issued a recall on this type of play component and have instructed for the removal of the play component.

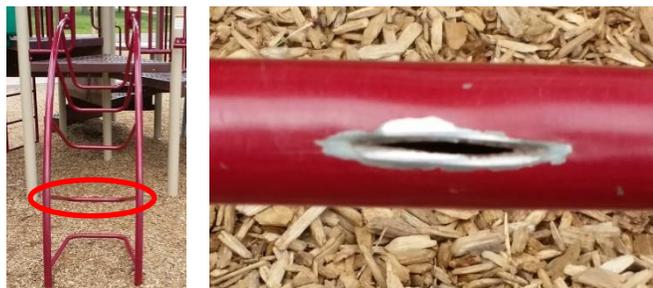
1. There is a rigid climber on the 2-5 composite structure. The second from the bottom rung is split/broken.

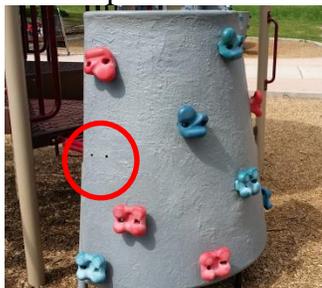
2. The rock climbing wall on the 2-5 composite structure is missing a handhold.

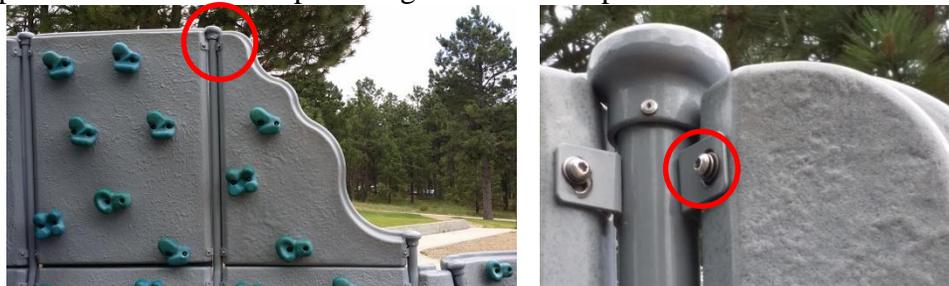
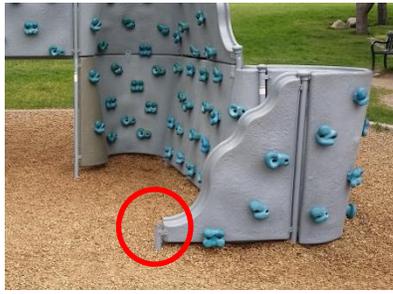
3. The rock climbing wall structure has a loose bolt at the top of the wavy end section, top level. It also has a cap missing from the first post at the front bottom.

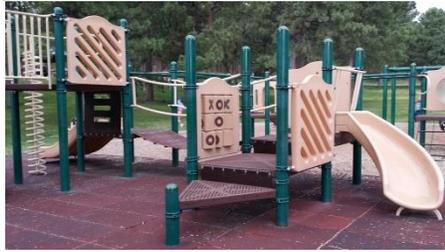
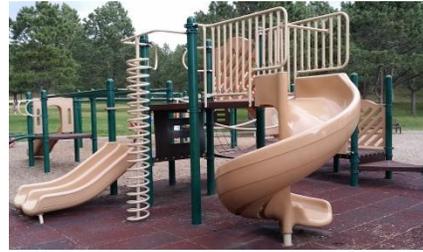
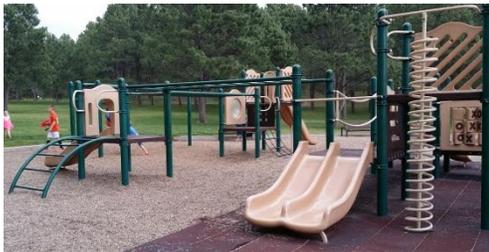
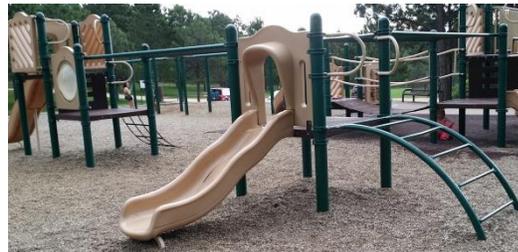
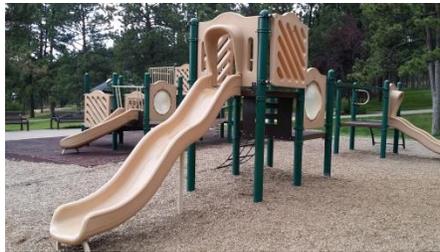
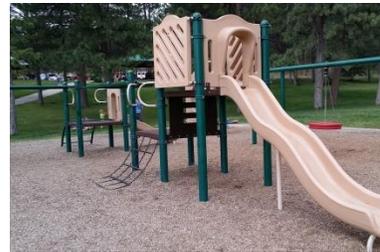
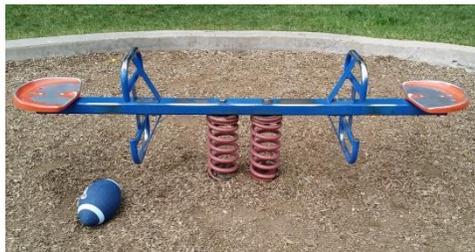
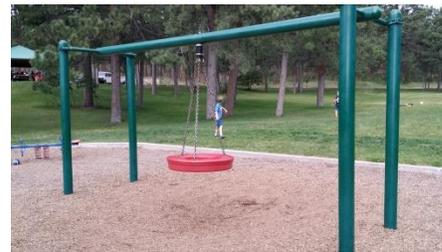
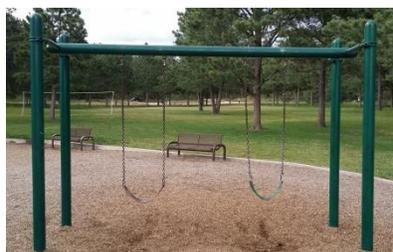
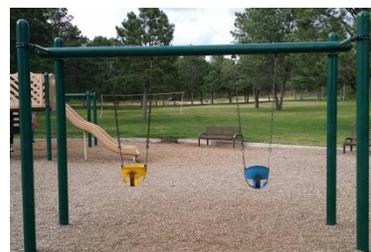
There is one play area with a large composite structure designed for children 2 to 12 years of age, a spring teeter, a tire swing, and two single bay swing structures (one has 2 belt seats and the other has 2 bucket seats). All equipment is manufactured by Little Tikes. The safety surfacing material is engineered wood fiber contained by a concrete border and there are also rubber tiles present.

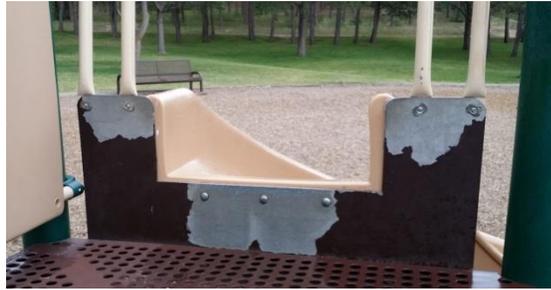
1. There is peeling paint at the ends of the clatter bridge and at the entrance to the elbow slide.

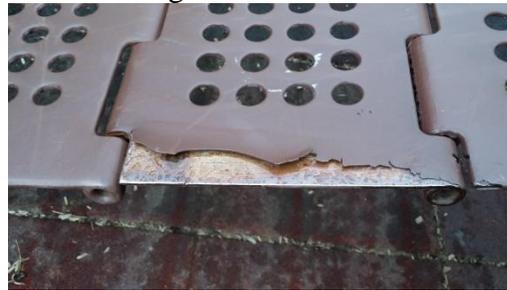
2. Coating is peeling on the clatter bridge.

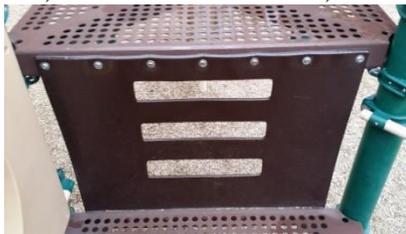
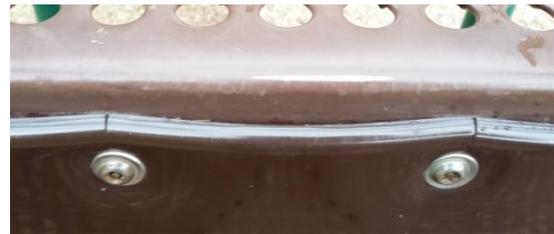
3. Infill panels cover the space between steps or platforms. There are several infill panels that are cracked along the perimeter where bolts attach them to the structure. The cracked infill panels are located at the main entrance, the next level up at the main entrance, near the double slide, and near the chain climber.

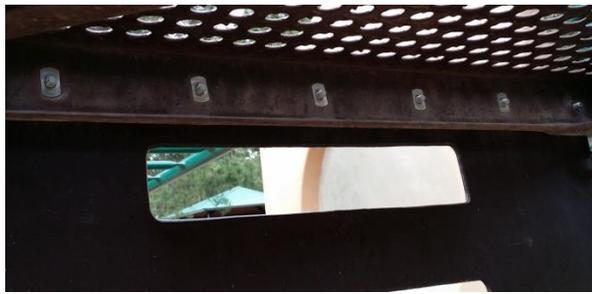
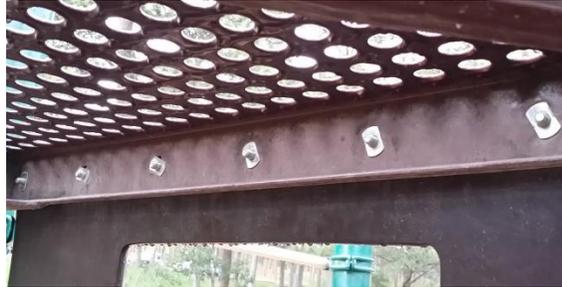
1. Below two decks there are protruding bolts where infill panels are attached.

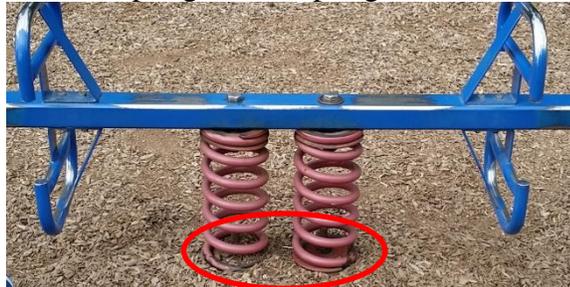
2. The bolts at the bottom of the springs of the spring teeter are loose.

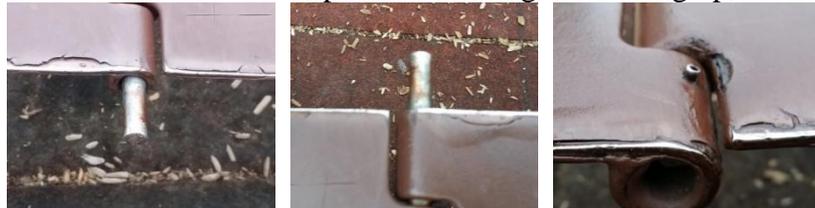
1. If not already developed, the owner of this play equipment should add this to their maintenance responsibilities.
2. Clatter bridge sections are connected using rods. The rods are then held in place with pins. A few of the rods on this structure's clatter bridge are missing their pins so they are sliding out to one side. Another pin for this bridge is sticking up, and is sharp.

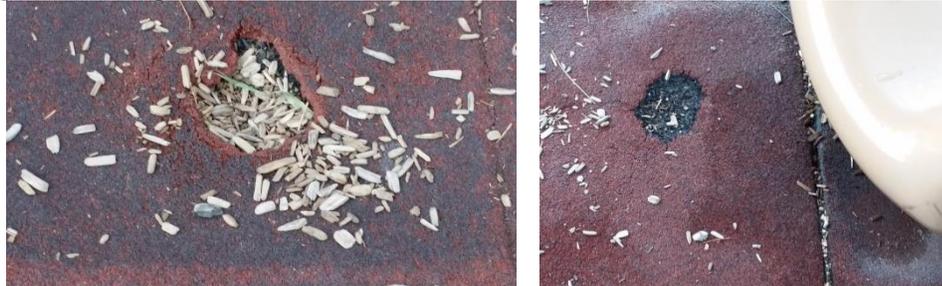
1. Engineered wood fiber must be maintained at a minimum depth of 9 inches to provide adequate fall protection. The depth of the engineered wood fiber around the composite structure is 5 inches by the tall wavy slide, 8 inches by the short wavy slide, and averaging 7 inches around the rest of the structure. For the spring teeter and the bucket swings, the depth is adequate at 9 inches. Below the belt swing seats it is 6 inches and below the tire swing it is only 4 inches.
2. The rubber tiles are an approved safety surfacing as well; however, they are separating, peeling, and damaged.

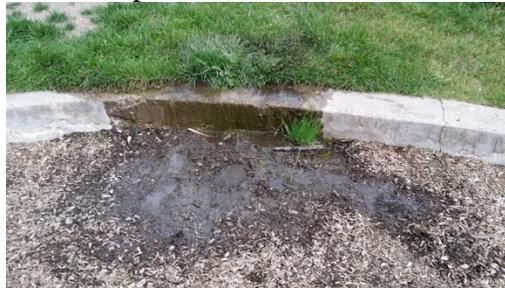
3. Along the border, there is water leaking into the play area that has become mossy and muddy. The source of the leaking water should be repaired and that section of the safety surfacing cleaned and/or replaced.

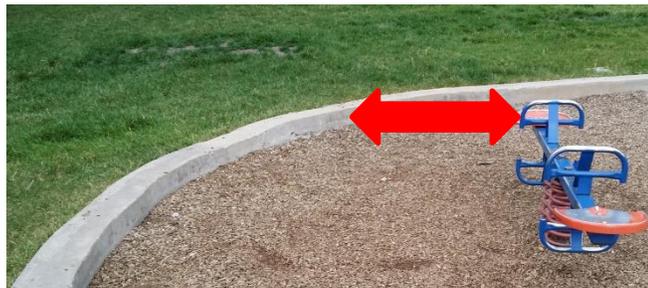
1. Between the spring teeter and the concrete border there should be a 6 foot use zone with safety surfacing material. It is only 5'6" to the concrete border from one seat and 5'7" to the border from other seat.

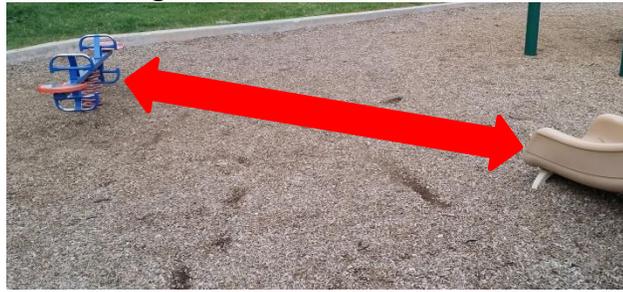
2. On the other side of the spring teeter it should have a 6 foot use zone and the slide should have a 6 foot use zone. Because a slide's use zones may not overlap with

another play structure, there should be a total of 12 feet between them. The spring teeter's use zone is encroaching into the slide's use zone.

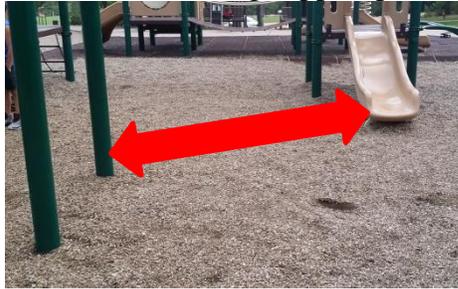
3. The same issue exists between the support post of the tire swing and the slide. There should be 12 feet there between the tire swing support post and the slide bed.

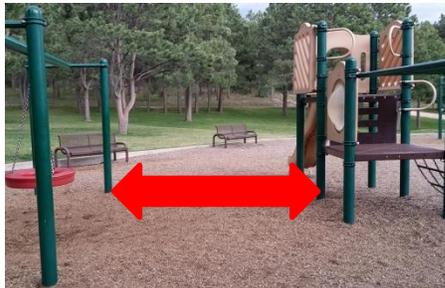
4. Where the tire swing swings out during use requires a larger use zone. The use zone is equal to the vertical distance between the tire seat and the pivot plus 6 feet (CPSC 5.3.8.4.1). No other structure's use zone may overlap with a tire swing use zone. Between the composite structure, which requires a 6 foot use zone itself, and the tire swing there is only 12 feet. Not enough space was provided between the two structures; the composite structure's use zone encroaches the tire swing's use zone.

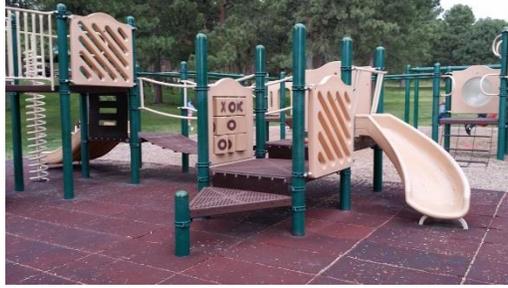
1. A transfer platform is for individuals to transfer from a wheelchair or other mobility device onto the play structure. Although there is a transfer platform, there should be at least one means of support for transferring. This does not meet current standards.

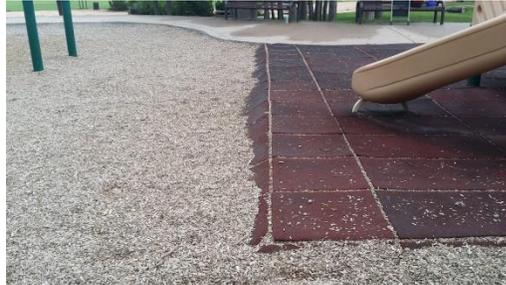
2. The vertical change in level between the two safety surfaces should not exceed 1/2 inch.

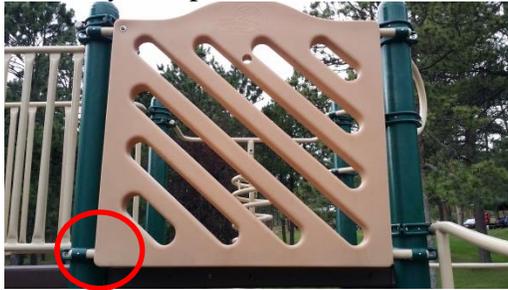
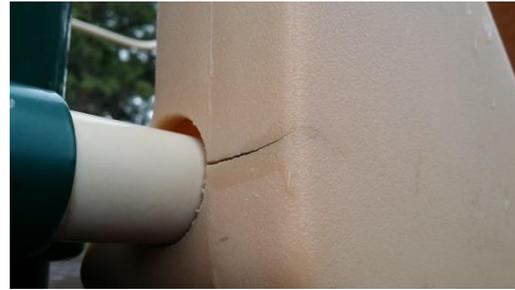
1. A barrier by the spiral slide is cracked in the bottom corner.

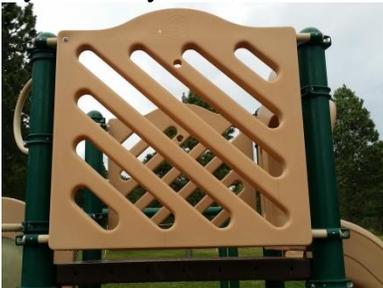
2. By the wavy slide, a barrier is cracked in both bottom corners.

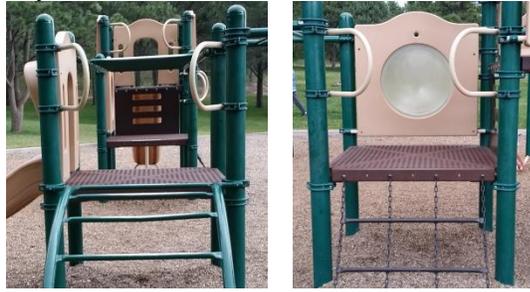
3. Guardrails and Barriers with an access opening to a play component should have an opening no greater than 15 inches (ASTM 7.5.5.2; CPSC 5.1.3). Nearly all of the openings with the loop styled handles exceed 15 inches.

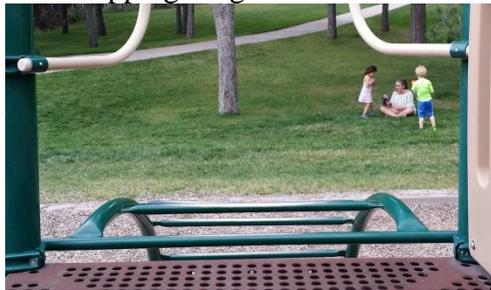
1. The final stepping surface of a climber shall not be above the platform it serves (ASTM 7.4.3). The final stepping rung of the arch climber is above the platform.

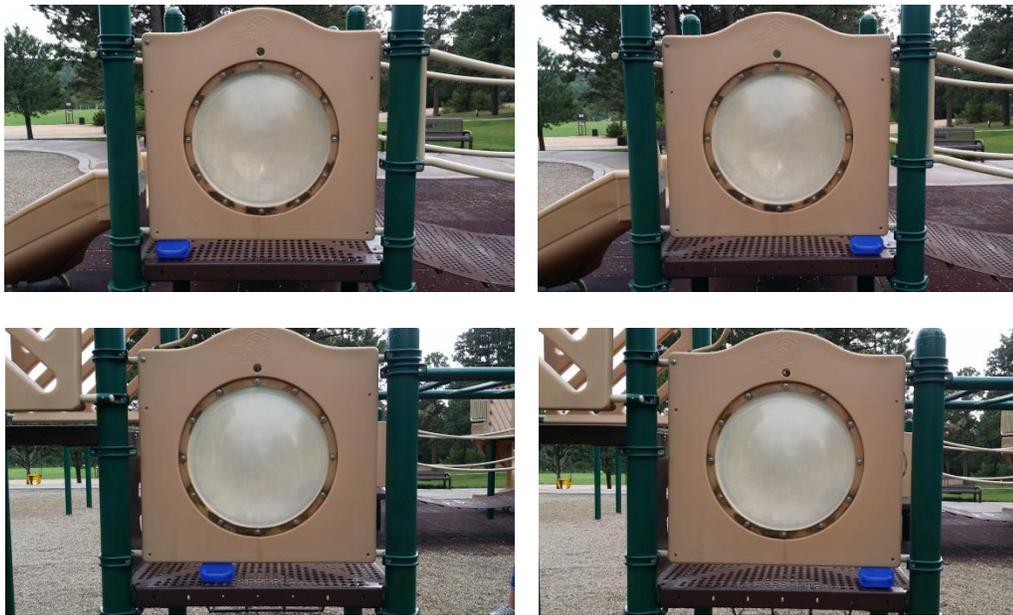
1. There is a head entrapment hazard below each of the two bubble panels on the composite structure. Pictures below show where the torso probe was able to pass through.

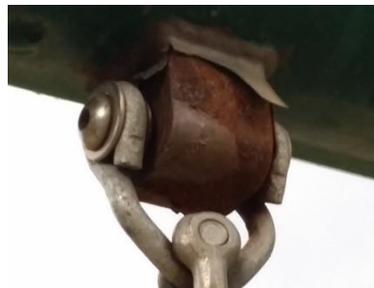
2. Hangers require bearings, bushings, or other means of reducing friction and wear (ASTM 8.6.3). Bearings for the red belt seat and the blue bucket seat are worn. They should be replaced before the friction breaks through the hangers.
3. The swing hangers are rusted.

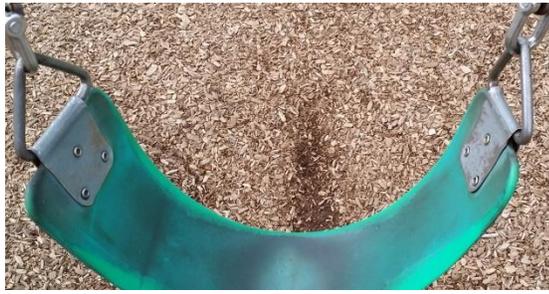
4. There is sharp metal at the ends of the green belt seat.

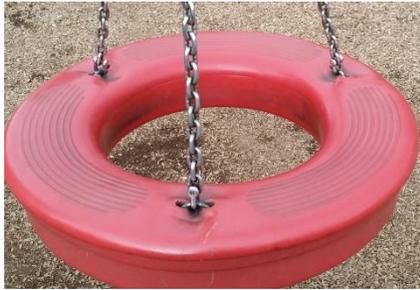
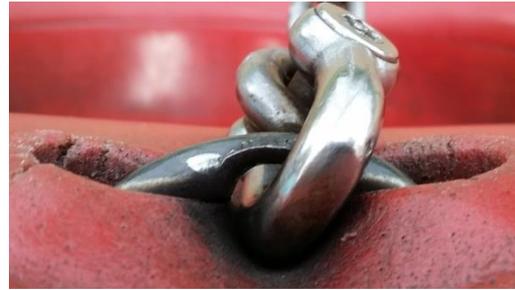
1. U-bolts are used to attach the tire to the suspension chains. The u-bolts on this tire swing are worn extremely thin. The tire swing should be removed until the u-bolts can be replaced.
