Site Accessibility Evaluation

DOT Calhan Office

1010 Golden St **Calhan, CO 80808**

Accessibility Evaluation

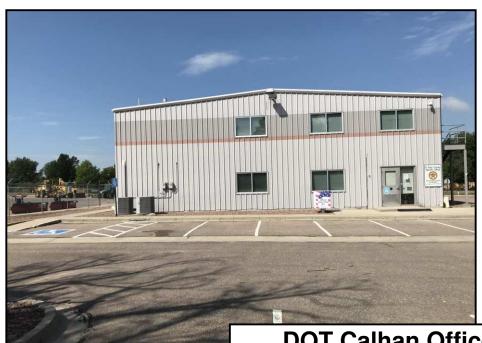
Finding: 1

The ramps slope exceeds the maximum running slope (direction of travel) allowable of 8.33%.

2010 ADAS Section 405.2

Ramp runs shall have a running slope not steeper than 1:12.

2010 ADAS Section: 405.2 19.20 % running slope

Create new concrete ramp and remove existing detachable metal ramp. New ramp at 4 feet in length would meet ADA compliance at 8.33%.

1 (High): Should be completed immediately. (Includes; Findings that have little or no cost, were in violation of the codes at the time of construction, or pose an imminent safety threat)
