Site Accessibility Evaluation

Office of Emergency Management

**3755 Mark Dabling Blvd
Northeast Colorado
Springs, CO 80907**

Accessibility Evaluation

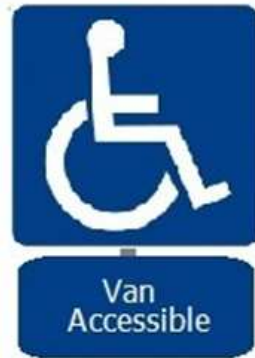
Finding 224783 Main Photo

Finding: 2

The van stall is missing a sign identifying it as a van accessible stall.

No van accessible stalls nor International symbol of accessibility.

Install 2 van accessible signs to include posts, van accessible signs and international symbol of accessibility near the front of the building. Also re-stripe and ensure both van parking stalls and access aisle have no more than 2% running and cross slope.

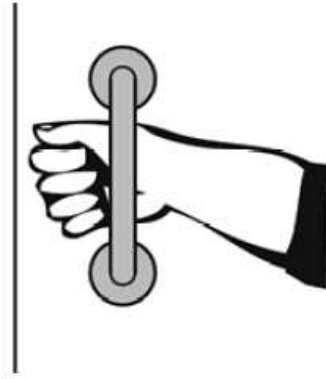
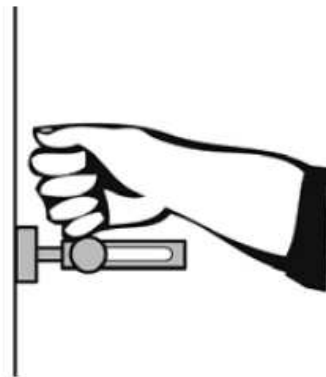
Finding 299386 Main Photo

The water closet compartment door is missing a loop handle on the outside.

Compartment door
missing outside loop
handle

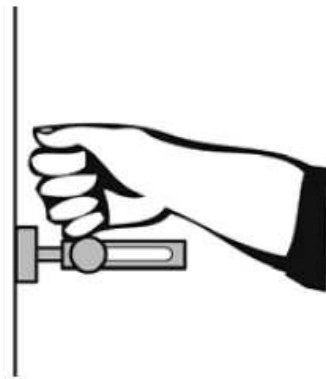
Finding 299395 Main Photo

The water closet compartment door is missing a loop handle on the outside.

Compartment door
missing outside loop
handle
