Site Accessibility Evaluation

Americans with Disabilities Act Title II (Public Services: State and Local Government)

County Professional Building

***Inspection Date: 07/24/2017
Inspector: David Mejia***

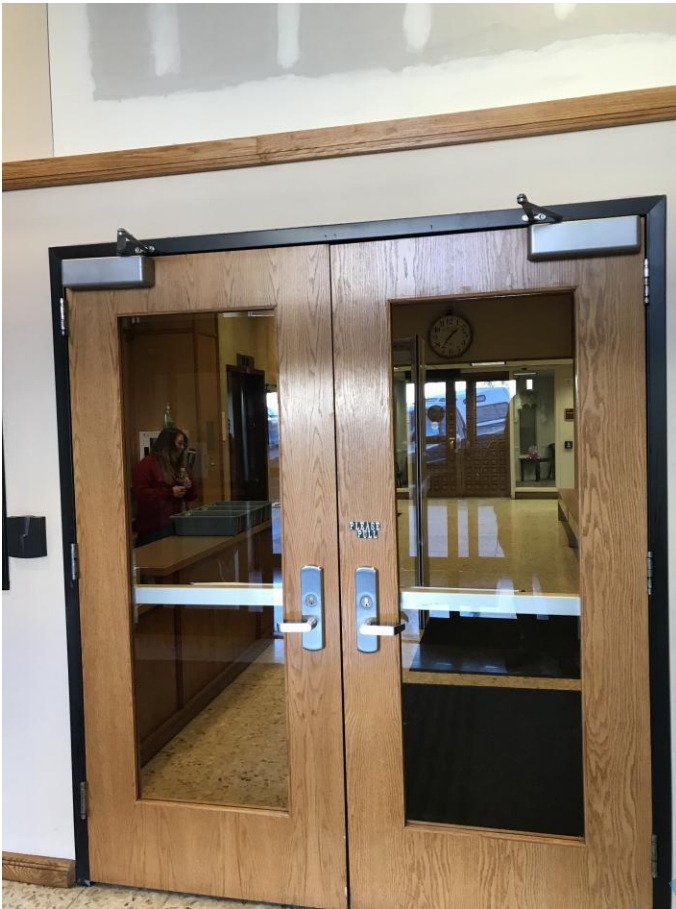
Finding 299101 Main Photo

Doors to main lobby/security desk area are ADA compliant but due to a unique and special circumstance they are not practical for an employee with a qualified disability.

Doors to main
lobby/security desk
are accessible

Employee Accommodation: Install automatic door opener to main lobby/security desk for employee access due to qualified disability.

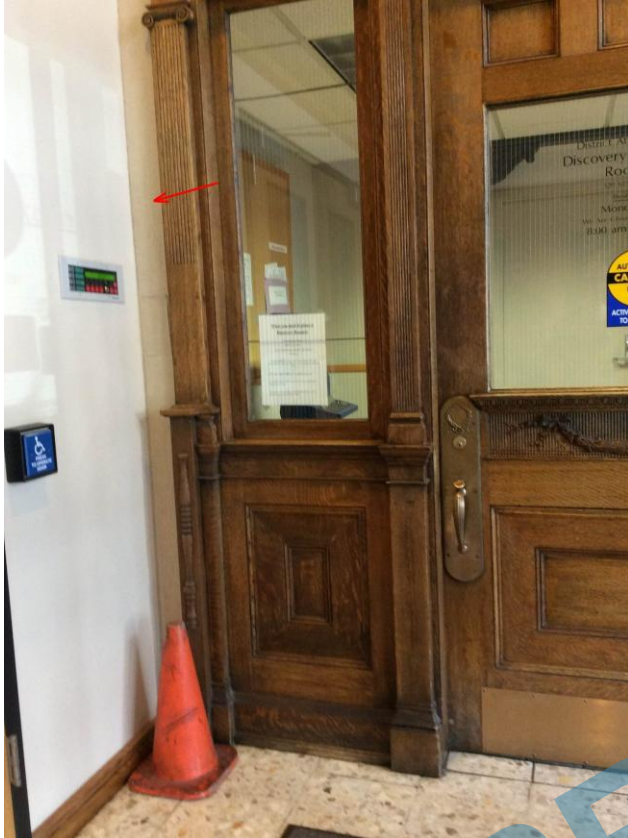
Finding 25852 Main Photo

Compliant room identification signs are missing on the strike side of the door.

2010 ADAS Section: 216.2, 703.4.2

No room identification sign

Submit a work order to have sign installed adjacent to front as depicted in photo.

Corrective Action: W/O 381203 submitted. Completed 2/24/2017.

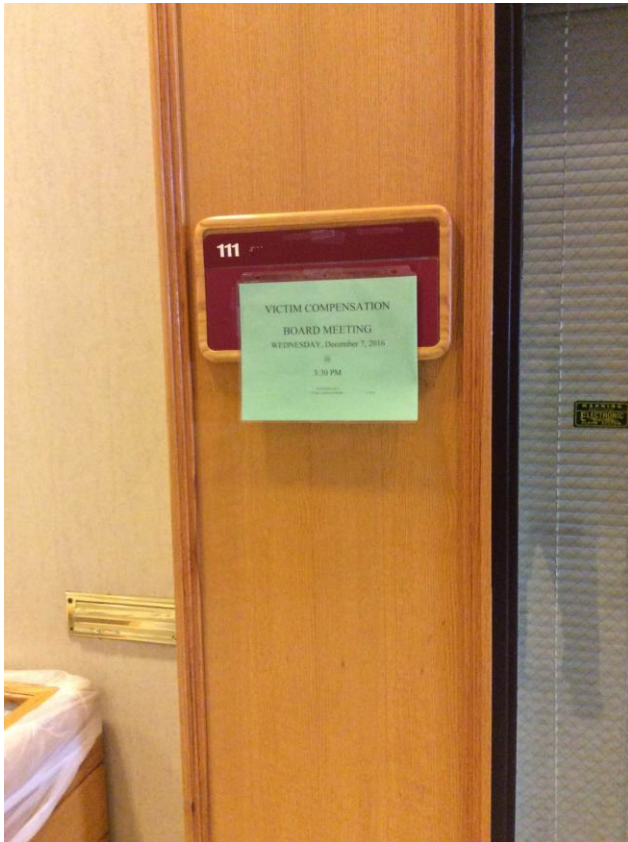
Finding 25855 Main Photo

The wall sign is mounted too high.

2010 ADAS Section: 703.4.1

62 inches
high/character missing

Submit work order to have proper sign installed at proper height.

Corrective Action: W/O 381215 completed 381215.

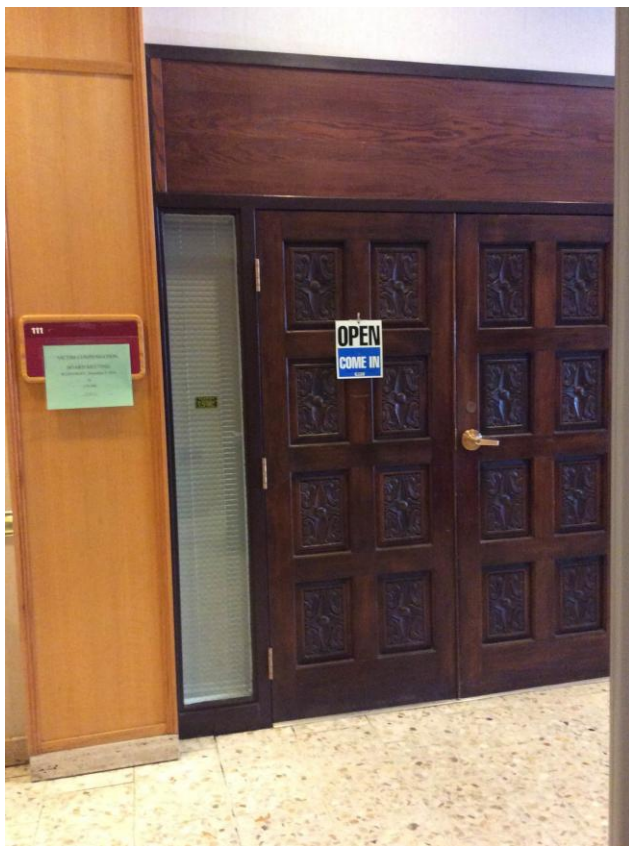
Finding 25854 Main Photo

The door opening does not provide at least 32 inches between the face of the door and the opposite stop.

2010 ADAS Section: 404.2.3

Double door, each side
opens 29 inches

Submit a work order to have doors adjusted/replaced. Bill Dieter spoke w/Kim Short, she said that the public no longer uses this area and that when the public goes through security they are directed to the reception area in room 101 straight down the hall.

Corrective Action: W/O 381260 submitted. Corrective Action no longer needed due to process change.

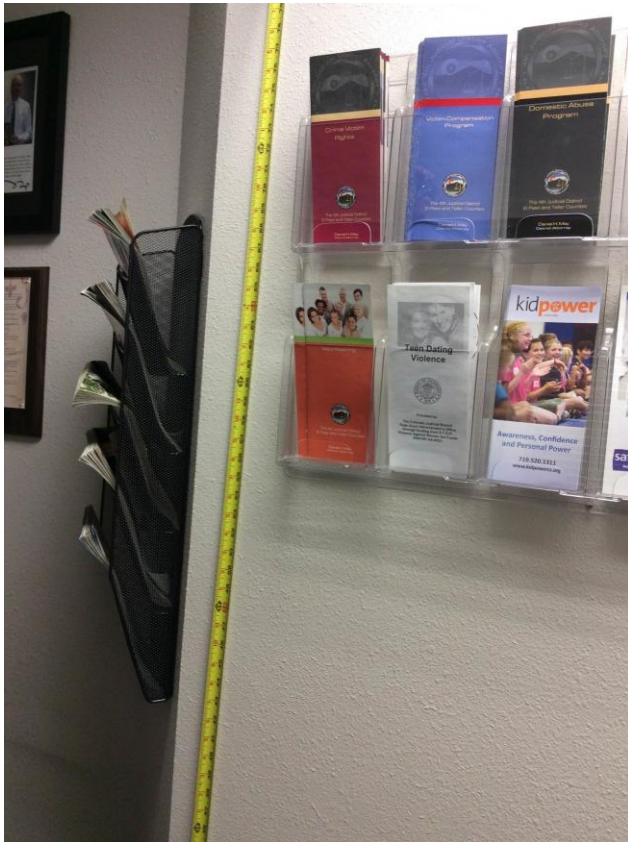
Finding 25857 Main Photo

The clear floor space only allows for a forward approach and the brochure rack is out of reach range.

2010 ADAS Section: 308.2.2

Brochure rack located
behind chair

Lower brochure rack to a maximum reach of 44 inches or move to different location.

Corrective Action: W/O 381214 completed 02/09/2017.

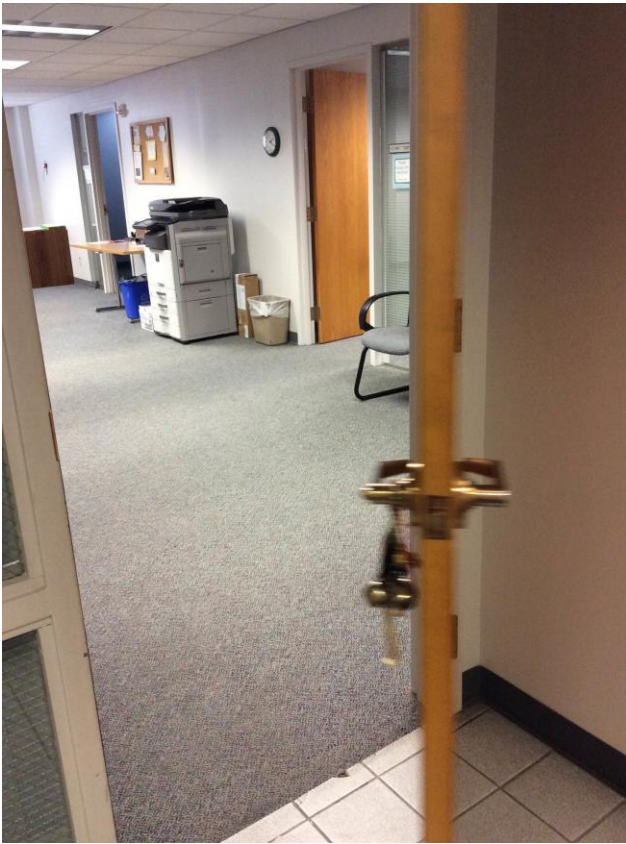
Finding 25877 Main Photo

The door is equipped with a door closer and returns to a closed position too quickly.

2010 ADAS Section: 404.2.8.1

4 seconds to closed position

Adjust door closer to allow a minimum of 5 seconds to move from the open position at 90 degrees to 12 degrees from the latch/locking mechanism.

Corrective Action: W/O 381213 completed 2/9/2017.

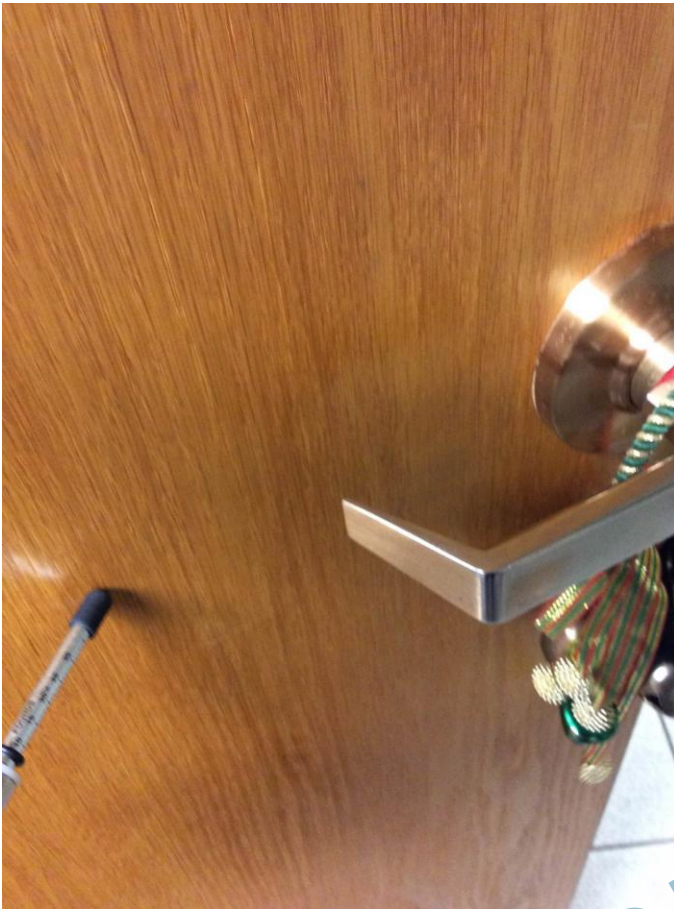
Finding 25878 Main Photo

The force required to operate the door hardware exceeds the maximum.

2010 ADAS Section: 309.4

7 lbs of force required

Adjust door closer to 5 lbs. of pressure or less.

Corrective Action: W/O 381213 completed 2/9/2017.

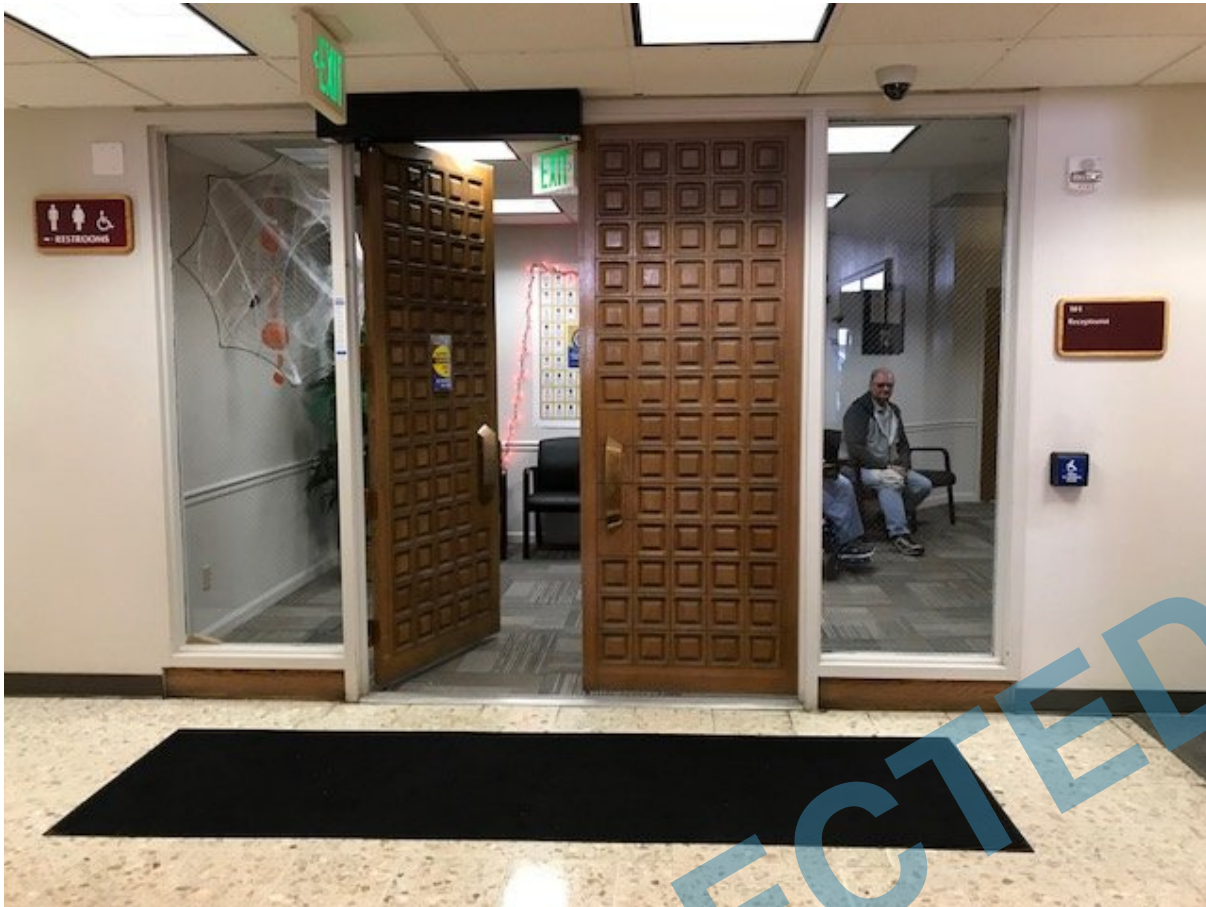
Finding 298412 Additional Photo

Doors to reception area are ADA compliant but due to a unique and special circumstance they are not practical for an employee with a qualified disability.

Doors to reception are accessible

Employee Accommodation: Install automatic door opener to Reception Area (Suite 101) for employee access due to qualified disability.

Corrective Action: Work order #405804 submitted for correction. Completed on 10/9/17.

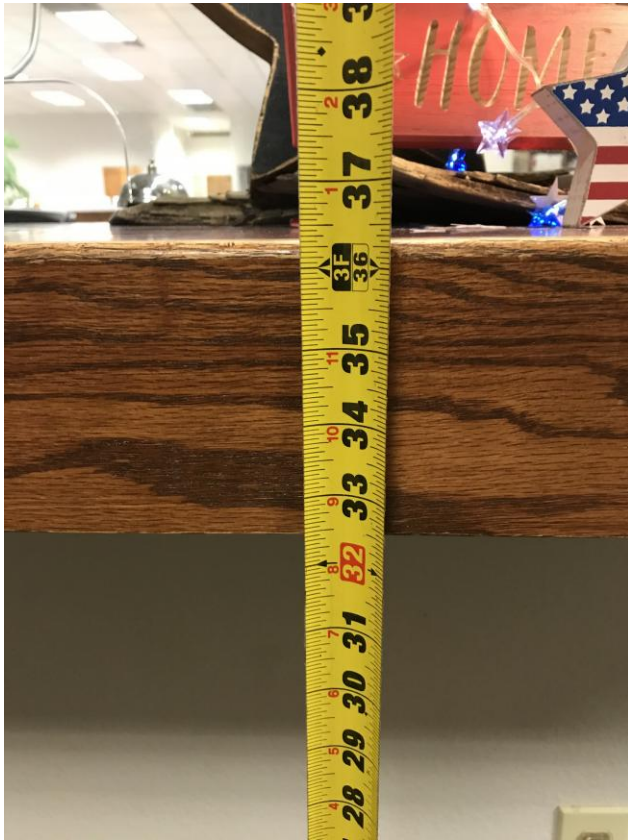
Finding 299326 Main Photo

The transaction counter is too high.

2010 ADAS Section: 904.4.1

36.25 inches above
finished floor

Install new counter section that measures 36 inches maximum in height from the finish floor and lengthen that section of the counter to 36 inches minimum. A clear floor or ground space shall be provided for either a parallel or forward approach complying with section 305 and/or 306 respectively.

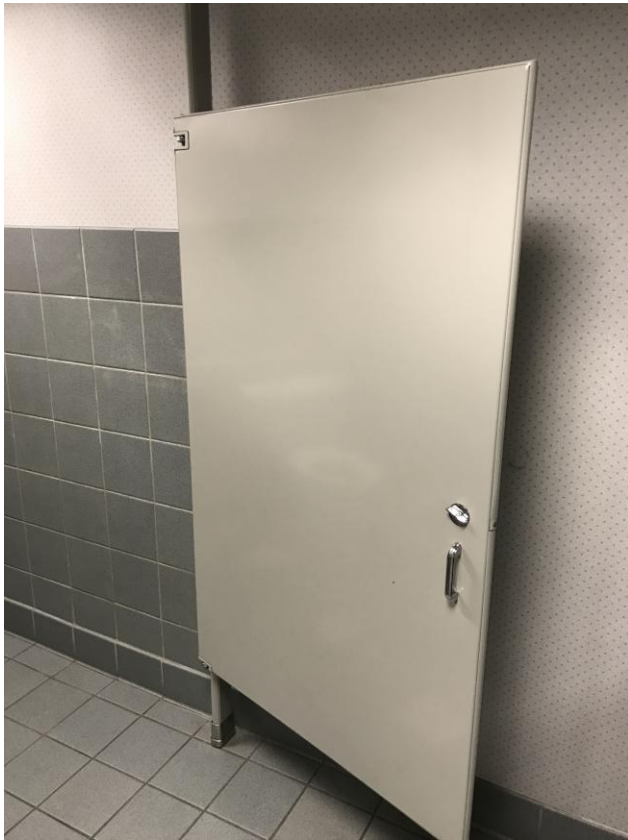
Finding 299121 Main Photo

The water closet compartment door is missing a loop handle on the outside.

Missing loop handle
on outside of door

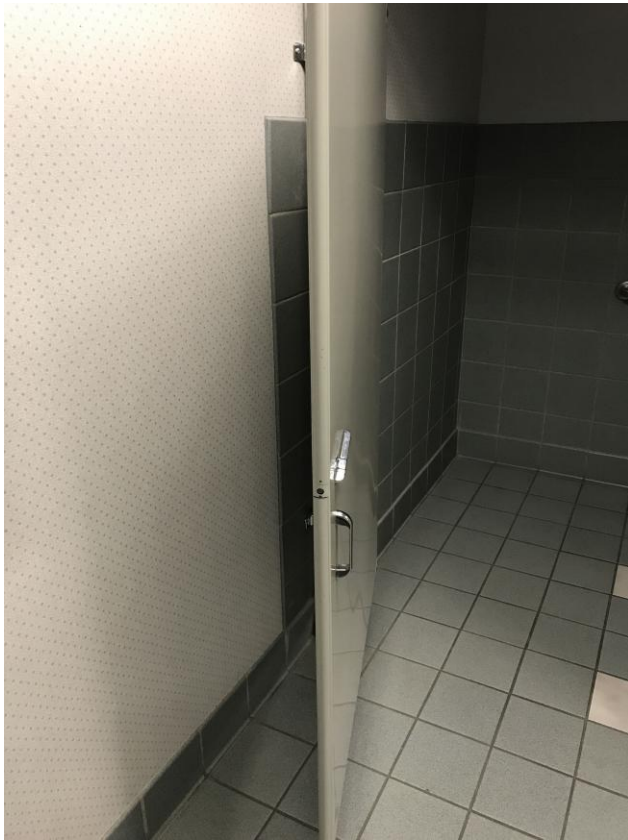
Finding 299131 Main Photo

The water closet compartment door is missing a loop handle on the outside.

Missing loop handle
on outside of door

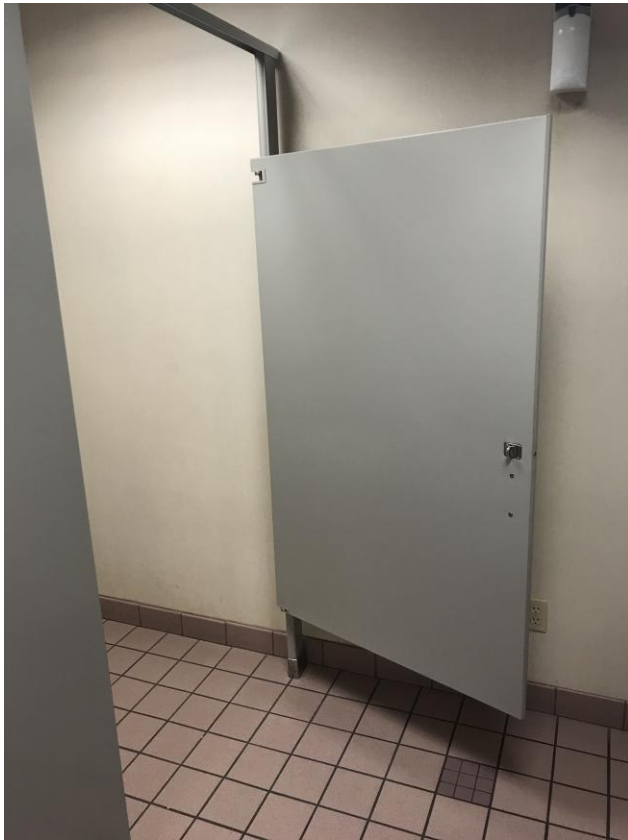
Finding 299105 Main Photo

The water closet compartment door is missing a loop handle on the inside.

Missing loop handle
on inside of door
